ANNUAL REPORT FOR 2013

**Middle Fork Creek Site A Mitigation Site
Madison County
TIP No. R-2518A
COE Action ID: SAW-2007-2197-357/300
DWR #: 20071134**

Prepared By:
Natural Environment Section & Roadside Environmental Unit
North Carolina Department of Transportation
November 2013

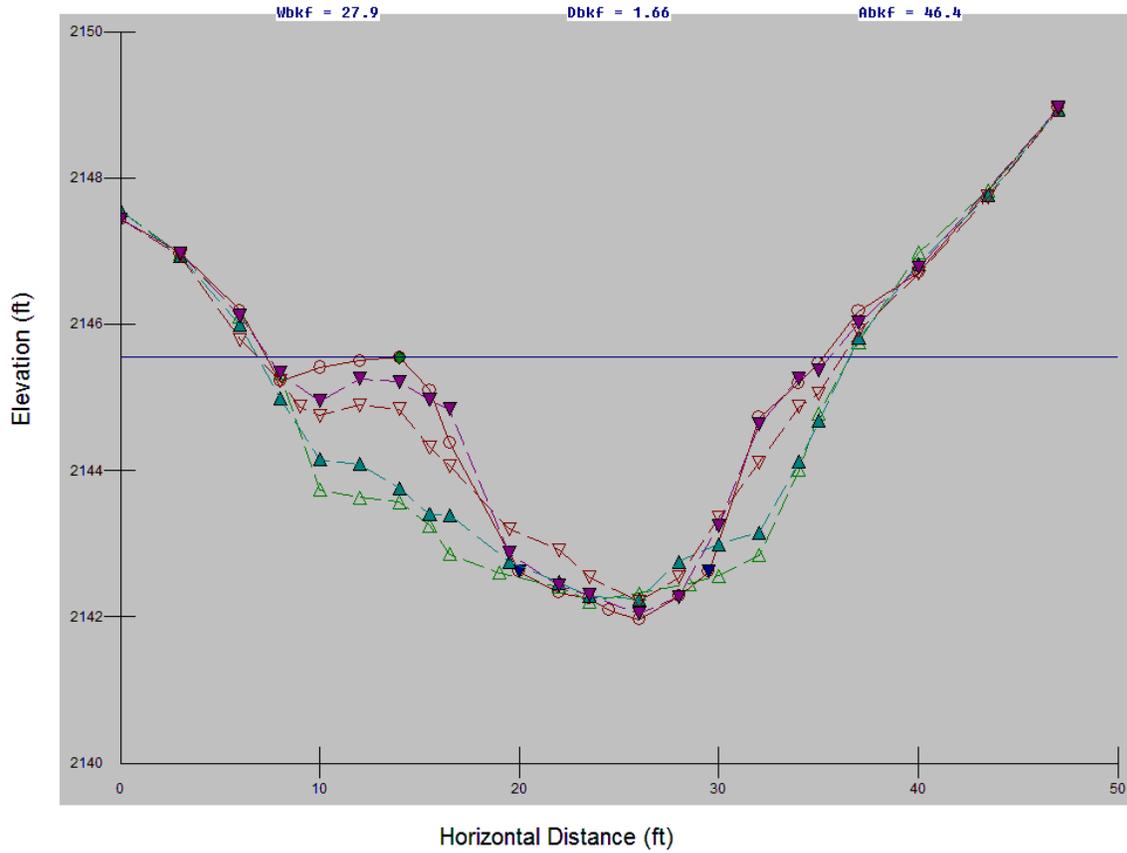
R-2518A Site A XS#1 @ STA 240+05

Site A: Cross-Section #1 (Pool) Abbreviated Morphological Summary					
	2010	2011	2012	2013	2014
Bankfull Cross Sectional Area (ft²)	24.28	31.38	37.74	45.61	
Maximum Bankfull Depth (ft.)	1.85	2.68	3.21	3.59	
Bankfull Mean Depth (ft.)	1.11	1.25	1.72	2.17	
Bankfull Width (ft.)	21.94	25.17	21.97	21

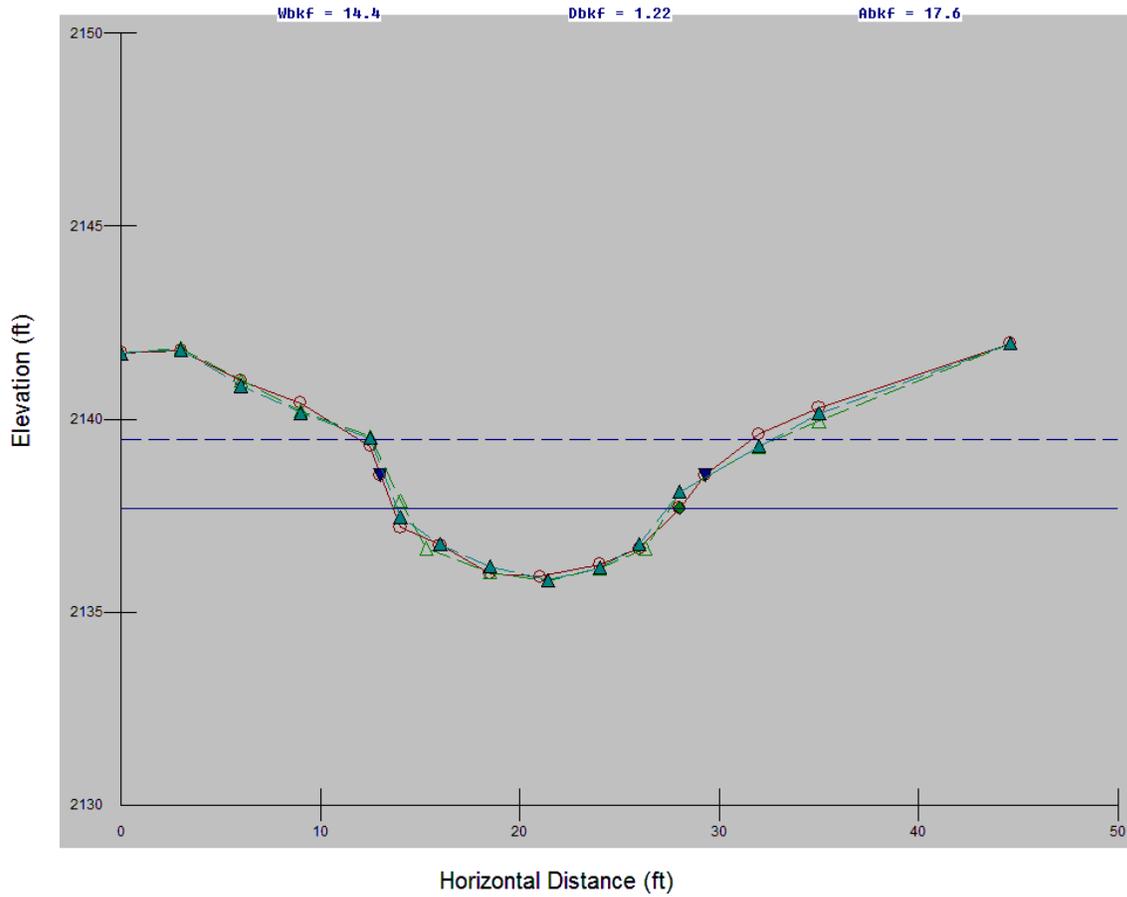
R-2518A Site A XS#2 @ STA 1158+00

Site A: Cross-Section #2 (Riffle) Abbreviated Morphological Summary				
	2011	2012	2013	2014
Bankfull Cross Sectional Area (ft ²)	23.87	22.57	17.56	
Maximum Bankfull Depth (ft.)	2.3	2.28	1.77	
Width of the Floodprone Area (ft.)	28.98	28.26	19.64	
Bankfull Mean Depth (ft.)	1.68	1.56	1.22	
Width/Depth Ratio	8.46	9.28	11.77	
Entrenchment Ratio	2.04	1.95	1.37	
Bankfull Width (ft.)	14.21	14.48	14.36

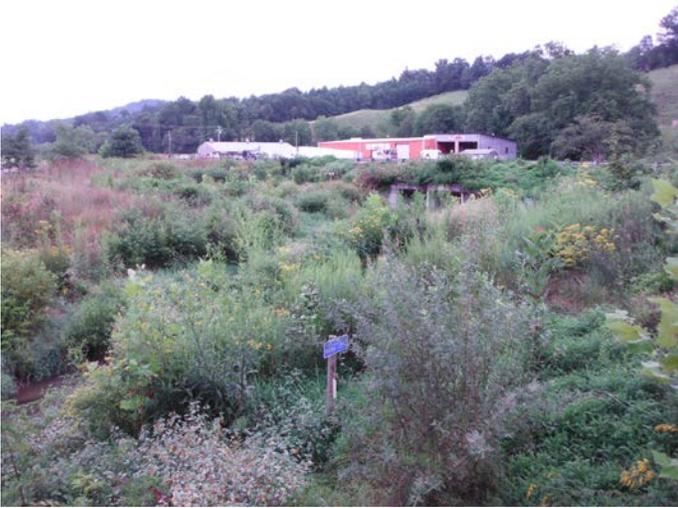
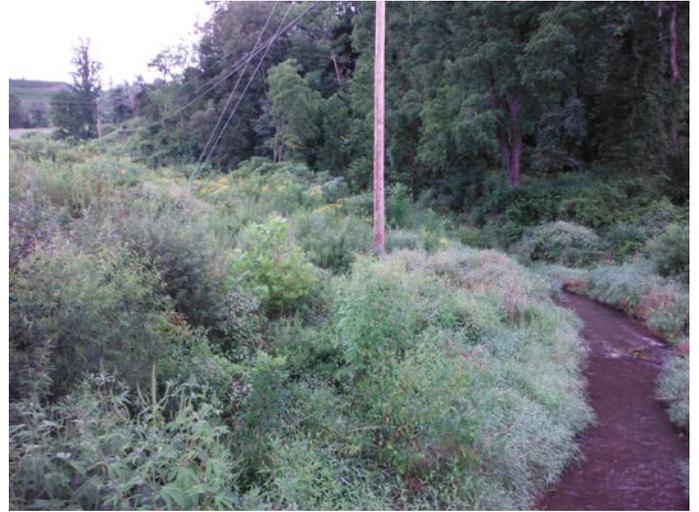
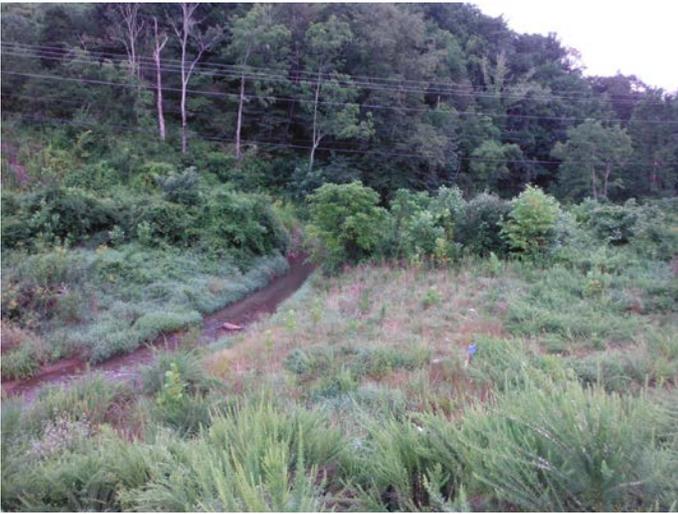
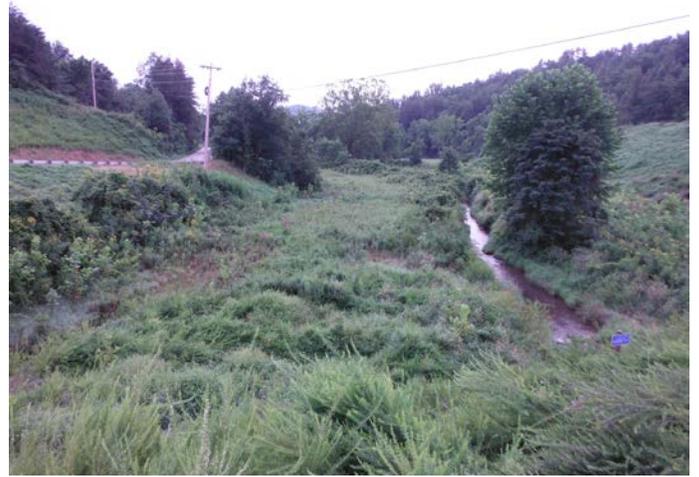
Vegetation Overview Photo

Streambank & Buffer Vegetation: The streambank reforestation was completed in March 2012. The Year 2 vegetation monitoring evaluation noted: Type I: Black Willow, Silky Dogwood and Type II: Sycamore, Green Ash, Tulip Poplar and White Oak were surviving at the time of the monitoring evaluation. NCDOT live staked some bare banks in the preservation area of Site A between PP#3 and PP#4 on February 12, 2013. The banks between PP#3 and PP#4 were vegetated during the 2013 monitoring evaluation. The powerline easement was noted during the 2012 monitoring evaluation as having been sprayed. It was noted during the 2013 monitoring evaluation that the powerline easement has started to re-vegetate.
