ANNUAL REPORT FOR 2014

**Middle Fork Creek Site A Mitigation Site
Madison County
TIP No. R-2518A
COE Action ID: SAW-2007-2197-357/300
DWR #: 20071134**

Prepared By:
Natural Environment Section & Roadside Environmental Unit
North Carolina Department of Transportation
November 2014

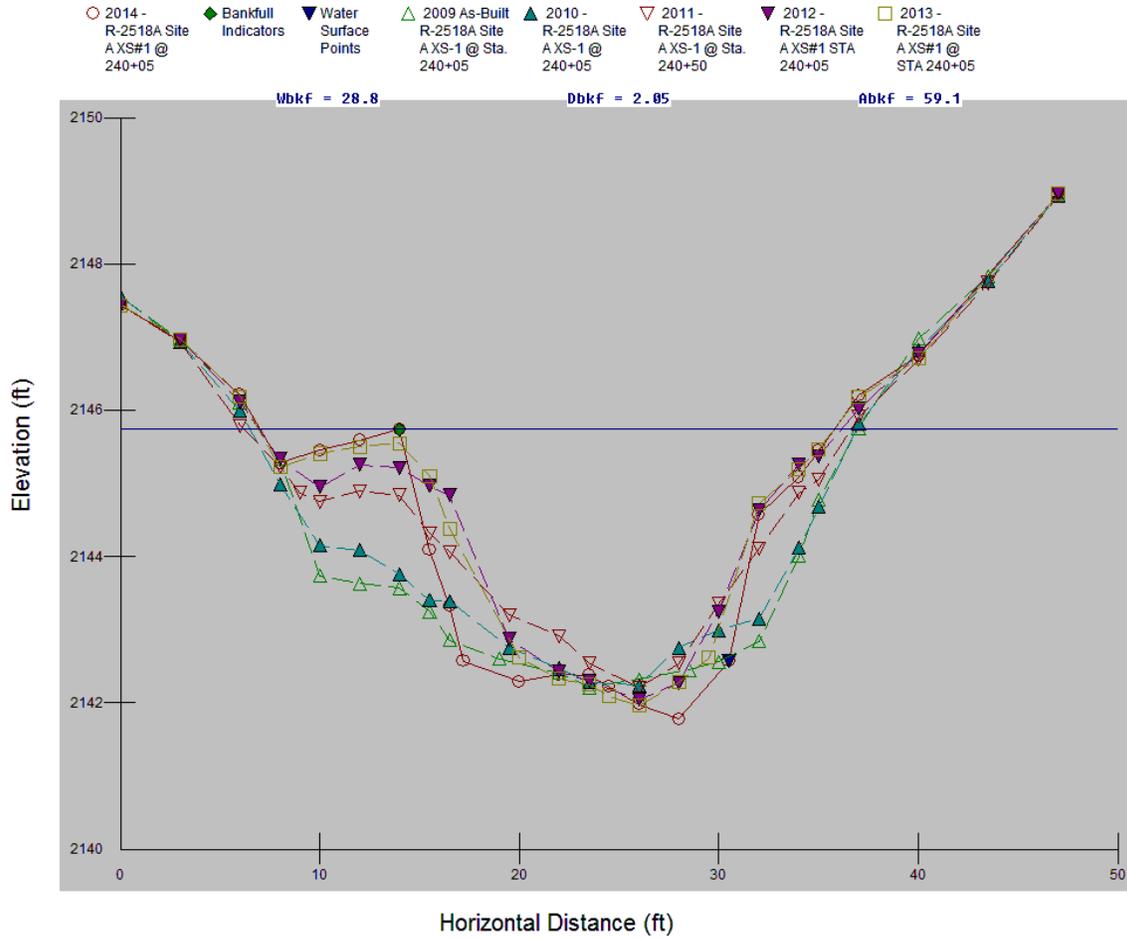
R-2518A Site A XS#1 @ 240+05

Based on comparisons of the As-Built to the monitoring data, all of the cross sections appear stable with little or no active bank erosion. Graphs of the cross sections are presented in Appendix A. Future survey data will vary depending on actual location of rod placement and alignment; however, this information should remain similar in appearance.

Site A: Cross-Section #1 (Pool) Abbreviated Morphological Summary					
	2010	2011	2012	2013	2014
Bankfull Cross Sectional Area (ft²)	24.28	31.38	37.74	45.61	57.53
Maximum Bankfull Depth (ft.)	1.85	2.68	3.21	3.59	3.96
Bankfull Mean Depth (ft.)	1.11	1.25	1.72	2.17	2.64
Bankfull Width (ft.)	21.94	25.17	21.97	21	21.79

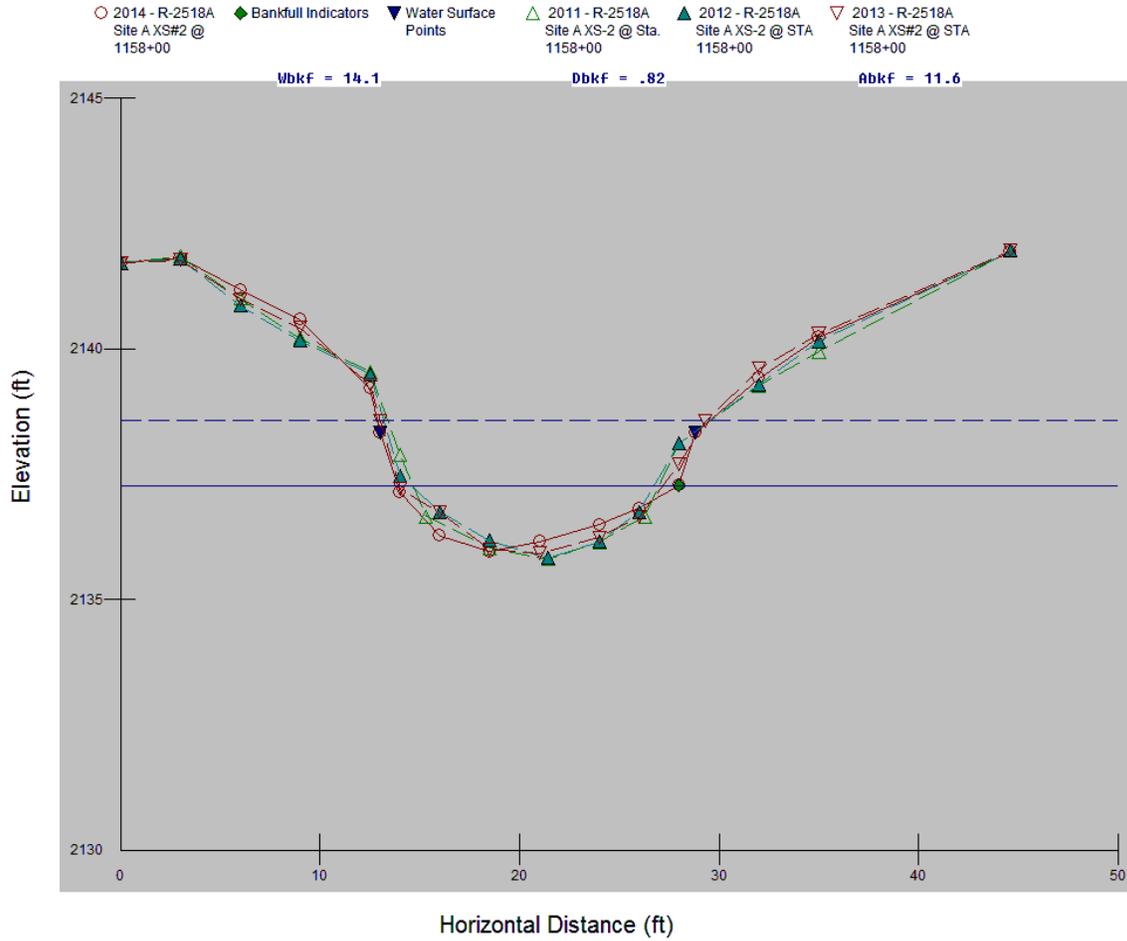
R-2518A Site A XS#2 @ 1158+00

Site A: Cross-Section #2 (Riffle) Abbreviated Morphological Summary				
	2011	2012	2013	2014
Bankfull Cross Sectional Area (ft ²)	23.87	22.57	17.56	11.6
Maximum Bankfull Depth (ft.)	2.3	2.28	1.77	1.31
Width of the Floodprone Area (ft.)	28.98	28.26	19.64	16.7
Bankfull Mean Depth (ft.)	1.68	1.56	1.22	0.82
Width/Depth Ratio	8.46	9.28	11.77	17.22
Entrenchment Ratio	2.04	1.95	1.37	1.18
Bankfull Width (ft.)	14.21	14.48	14.36	14.12

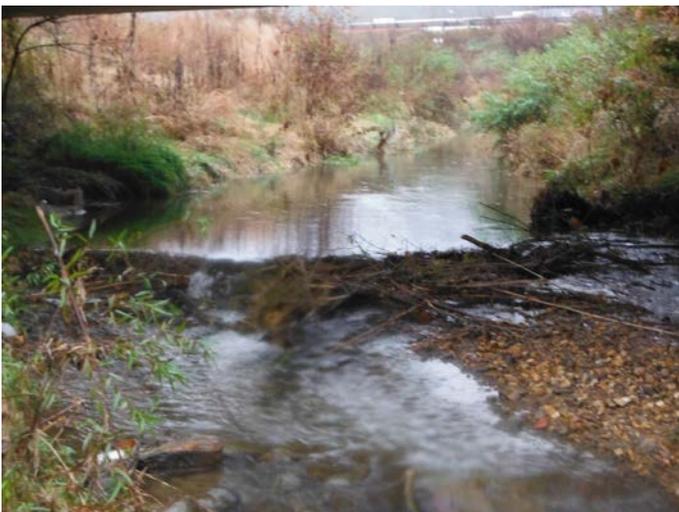
period. Beaver dams were noted upstream of Cross Section #1 and up and downstream of Cross Section #2 at Site A. USDA has been contacted to trap the beavers and remove the dams. Pebble counts were not required per the permit conditions and therefore were not completed. Two bankfull events were documented with a surface water gauge at Site A during the 2014 monitoring year.

Beaver dam upstream of Cross Section #1

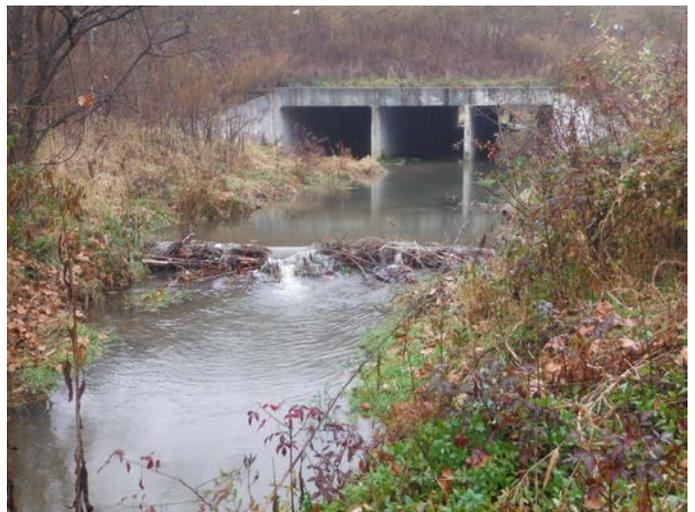
Beaver dam upstream of Cross Section #2

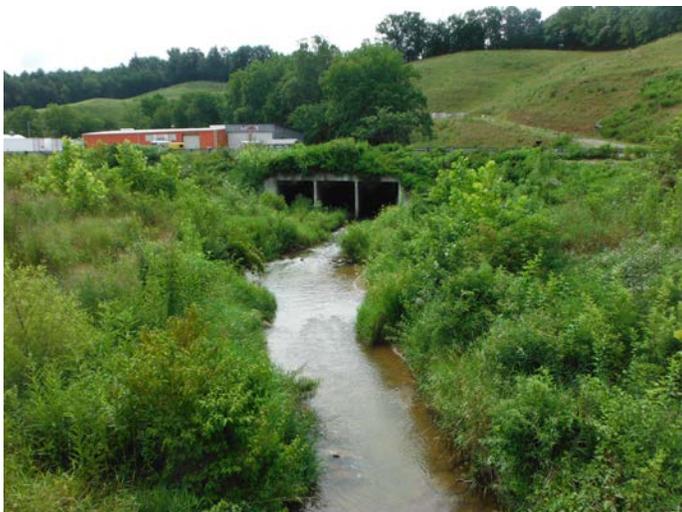
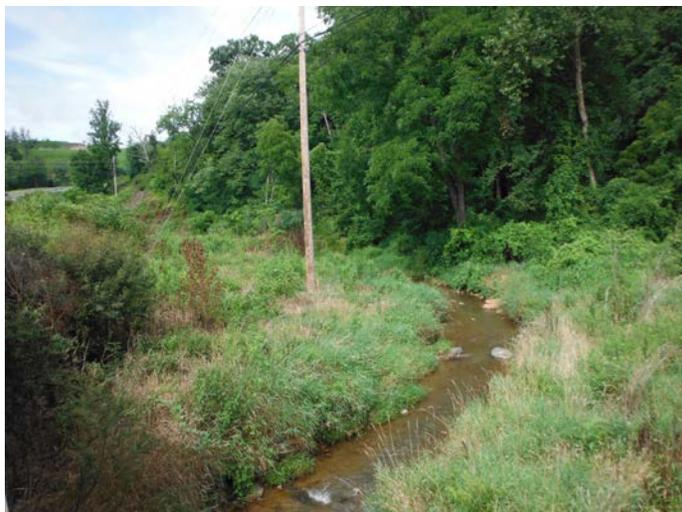
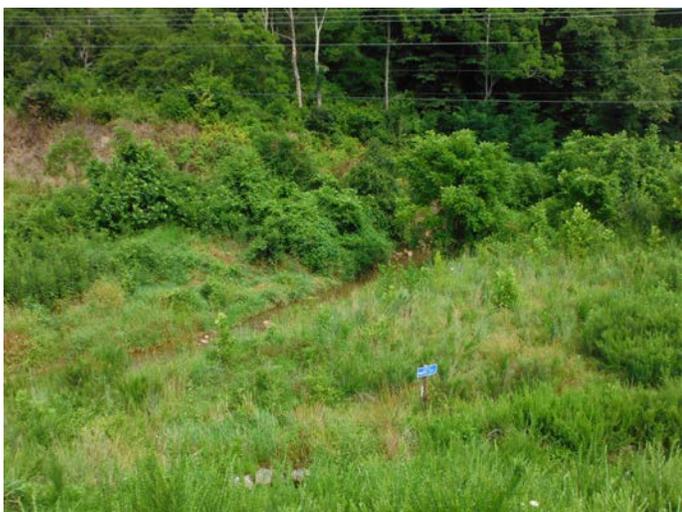
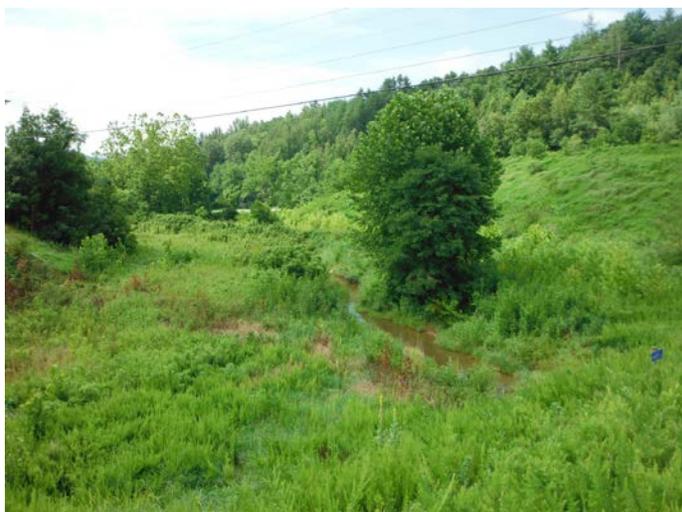
Vegetation Overview Photo

Streambank & Buffer Vegetation: The streambank reforestation was completed in March 2012. The Year 3 vegetation monitoring evaluation noted: Type I: Black Willow, Silky Dogwood and Type II: Sycamore, Green Ash, Tulip Poplar and White Oak were surviving at the time of the monitoring evaluation. It was noted during the 2014 monitoring evaluation that the power line easement within Site A had been sprayed. A small patch of Japanese Knotweed located adjacent to the bridge crossing at Sam Fox Road was sprayed on July 23, 2014.
