ANNUAL REPORT FOR 2013

**Middle Fork Creek Site E Mitigation Site
Madison County
TIP No. R-2518A
COE Action ID: SAW-2007-2197-357/300
DWR #: 20071134**

Prepared By:
Natural Environment Section & Roadside Environmental Unit
North Carolina Department of Transportation
November 2013

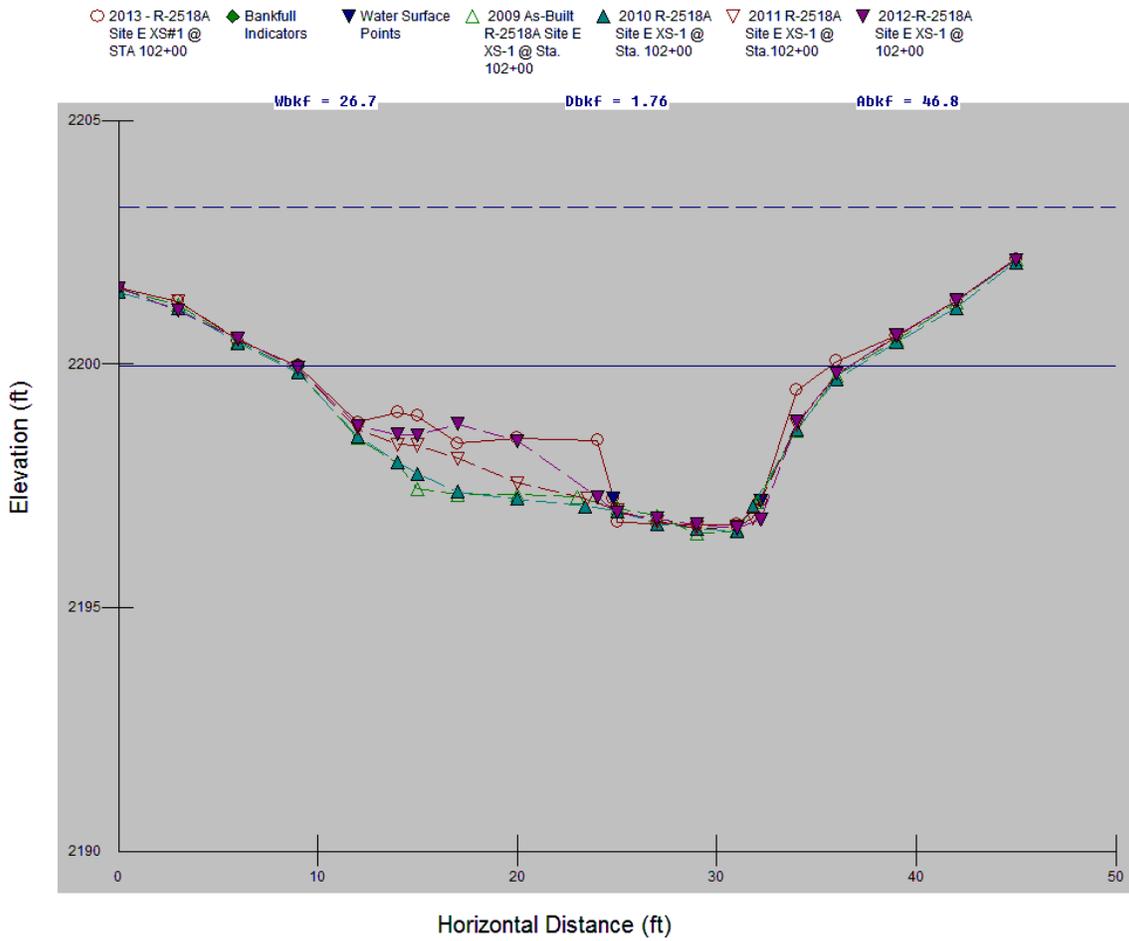
R-2518A Site E XS#1 @ STA 102+00

Site E: Cross-Section #1 (Riffle) Abbreviated Morphological Summary					
	2010	2011	2012	2013	2014
Bankfull Cross Sectional Area (ft ²)	59.32	56.44	50.89	46.83	
Maximum Bankfull Depth (ft.)	3.26	3.28	3.28	3.26	
Width of the Floodprone Area (ft.)	45	45	45	45	
Bankfull Mean Depth (ft.)	2.16	2.06	1.86	1.76	
Width/Depth Ratio	12.74	13.32	14.74	15.15	
Entrenchment Ratio	1.64	1.64	1.64	1.69	
Bankfull Width (ft.)	27.51	27.43	27.42	26.67

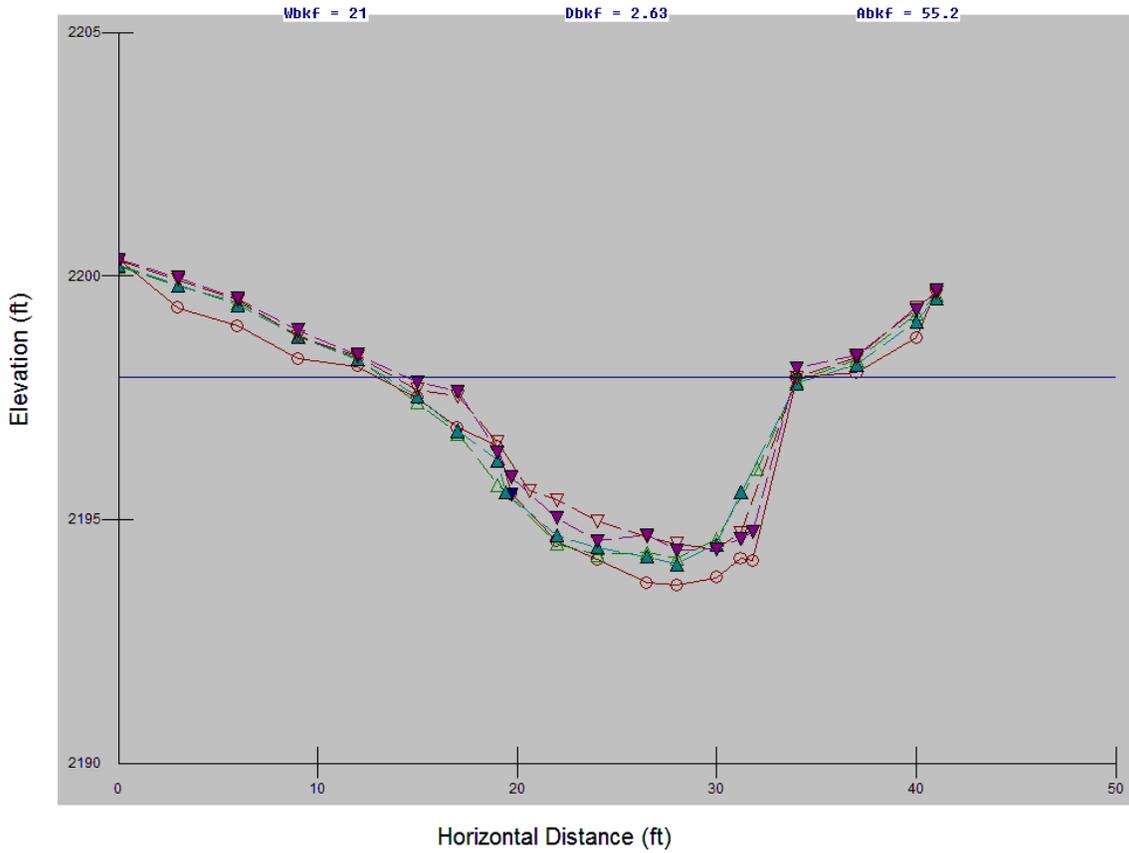
R-2518A Site E XS#2 @ STA 316+00

Site E: Cross-Section #2 (Pool) Abbreviated Morphological Summary					
	2010	2011	2012	2013	2014
Bankfull Cross Sectional Area (ft ²)	45.83	42.38	49.01	55.21	
Maximum Bankfull Depth (ft.)	3.72	3.52	3.74	4.27	
Bankfull Mean Depth (ft.)	2.28	2.11	2.38	2.63	
Bankfull Width (ft.)	20.07	20.07	20.55	20.97

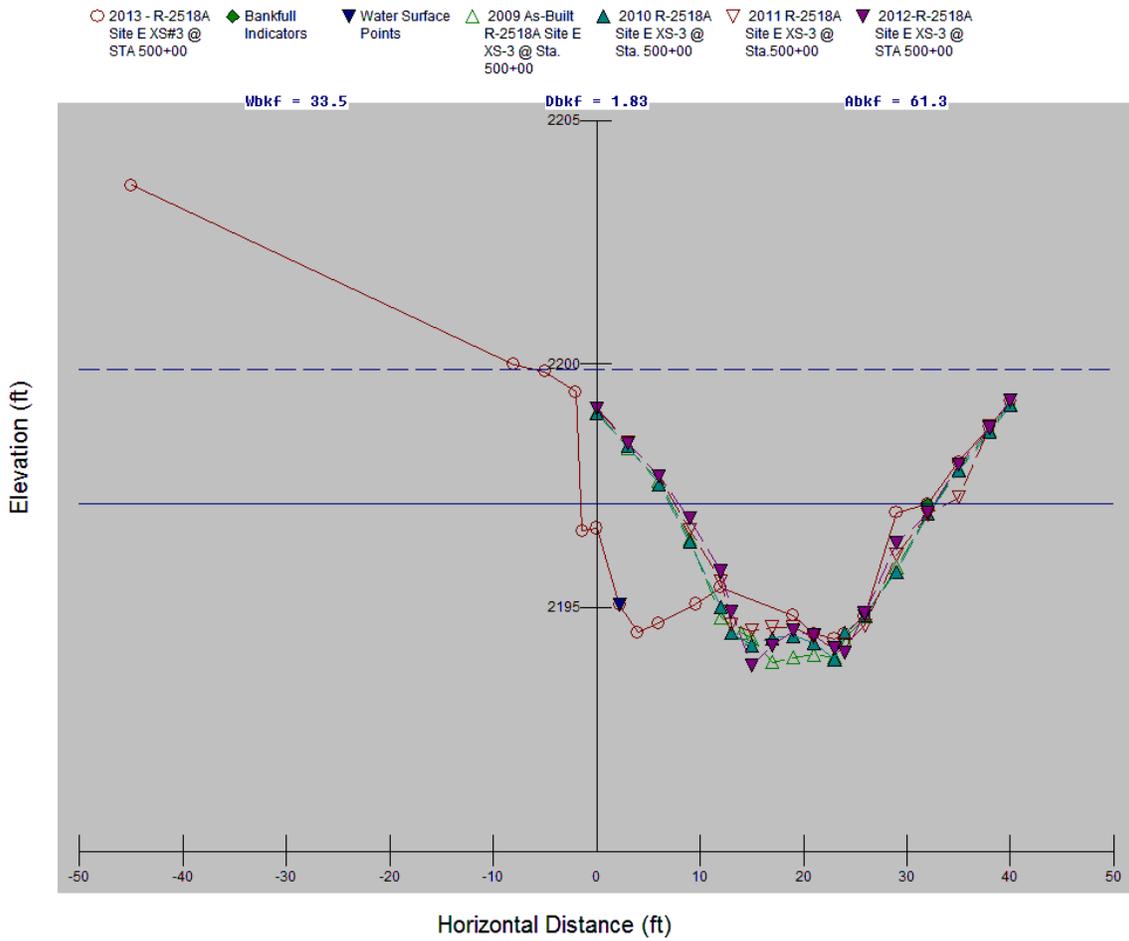
R-2518A Site E XS#3 @ STA 500+00

Based on comparisons of the As-Built to the monitoring data, all of the cross sections appear stable with little or no active bank erosion, except for, Cross Section #3 at Sta. 500+00 which has significant left bank erosion. Graphs of the cross sections are presented in Appendix A. Future survey data will vary depending on actual location of rod placement and alignment; however, this information should remain similar in appearance. The longitudinal profile showed that the channel bed was stable for the 2013 monitoring evaluation but is experiencing left bank erosion at Stations 395+00, 500+00 (XS#3), and 720+00. These areas of bank erosion were live staked on February 12, 2013 to help stabilize these areas. Pebble counts were not required per the permit conditions and therefore were not completed. Multiple bankfull events were documented at Site E during the 2013 monitoring year.

Site E: Cross-Section #3 (Riffle) Abbreviated Morphological Summary					
	2010	2011	2012	2013	2014
Bankfull Cross Sectional Area (ft ²)	62.4	63.57	62.14	61.27	
Maximum Bankfull Depth (ft.)	3.59	3.53	3.89	2.76	
Width of the Floodprone Area (ft.)	40	40	40	45.8	
Bankfull Mean Depth (ft.)	2.22	2.13	2.2	1.83	
Width/Depth Ratio	12.64	14.03	12.86	18.32	
Entrenchment Ratio	1.43	1.34	1.41	1.37	
Bankfull Width (ft.)	28.06	29.89	28.3	33.52

The Middle Fork Creek Site E Mitigation Site has not met the required monitoring protocols for the fourth formal year of monitoring on the stream but has met the required monitoring protocols for the second formal year of monitoring on the planted vegetation. NCDOT plans to repair the eroded banks by the Spring of 2014 and replant any disturbed areas from the stream repairs at Site E. NCDOT will continue monitoring the Middle Fork Creek Site E Mitigation Site in 2014.

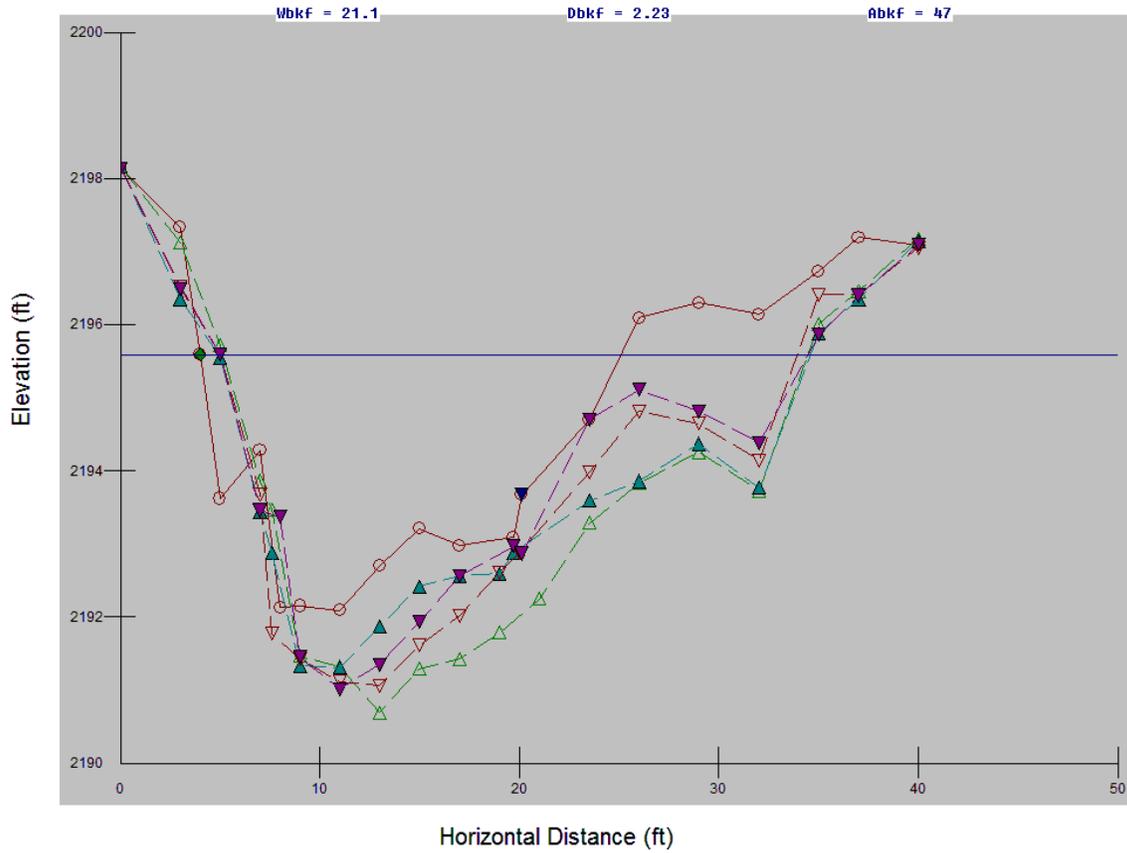
R-2518A Site E XS#4 @ STA 805+00

Site E: Cross-Section #4 (Pool) Abbreviated Morphological Summary					
	2010	2011	2012	2013	2014
Bankfull Cross Sectional Area (ft ²)	69.95	70.4	62.52	46.96	
Maximum Bankfull Depth (ft.)	4.24	4.53	4.58	3.5	
Bankfull Mean Depth (ft.)	2.37	2.43	2.12	2.23	
Bankfull Width (ft.)	29.53	28.92	29.45	21.1

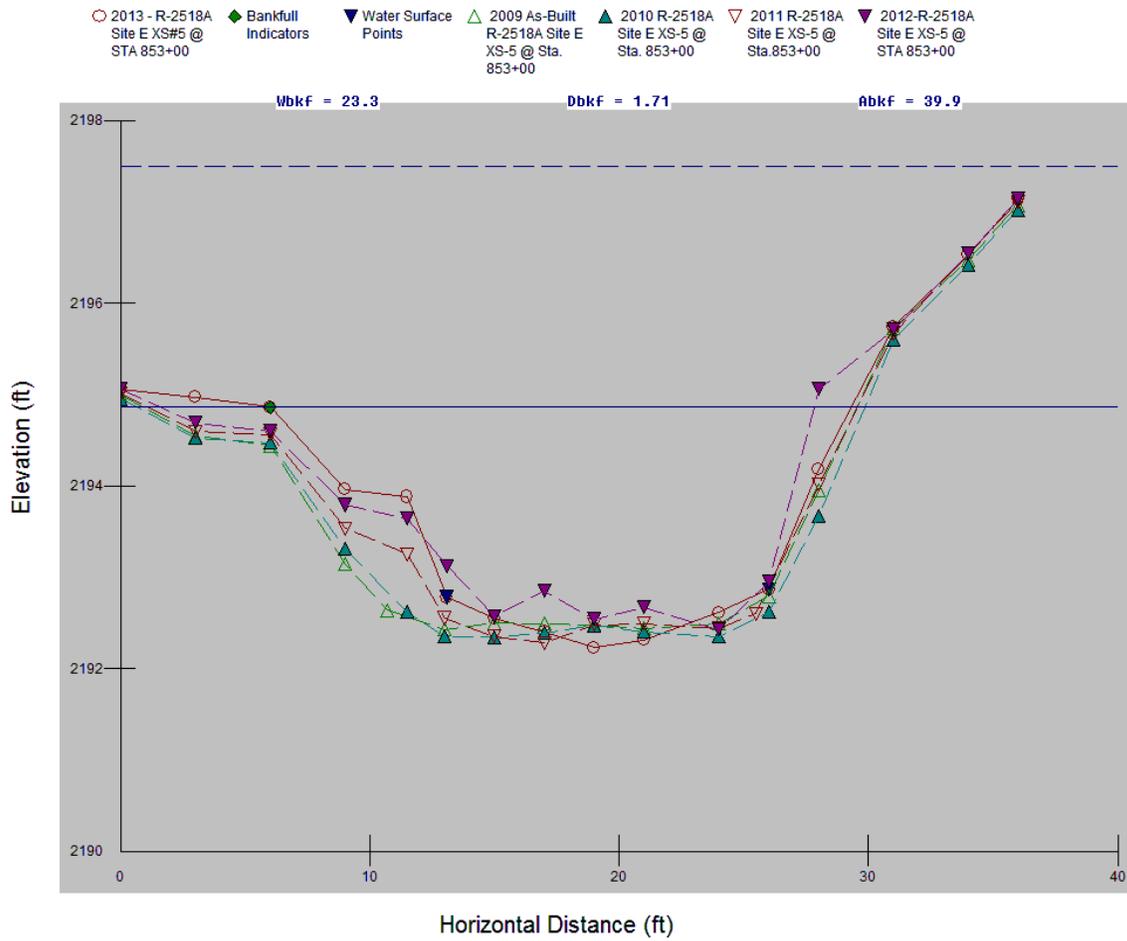
R-2518A Site E XS#5 @ STA 853+00

Site E: Cross-Section #5 (Riffle) Abbreviated Morphological Summary					
	2010	2011	2012	2013	2014
Bankfull Cross Sectional Area (ft ²)	38.49	36.94	31.55	39.91	
Maximum Bankfull Depth (ft.)	2.13	2.28	2.17	2.63	
Width of the Floodprone Area (ft.)	34.6	35.05	34.77	36	
Bankfull Mean Depth (ft.)	1.66	1.61	1.46	1.71	
Width/Depth Ratio	14	14.28	14.77	13.63	
Entrenchment Ratio	1.49	1.52	1.61	1.54	
Bankfull Width (ft.)	23.24	22.99	21.56	23.31

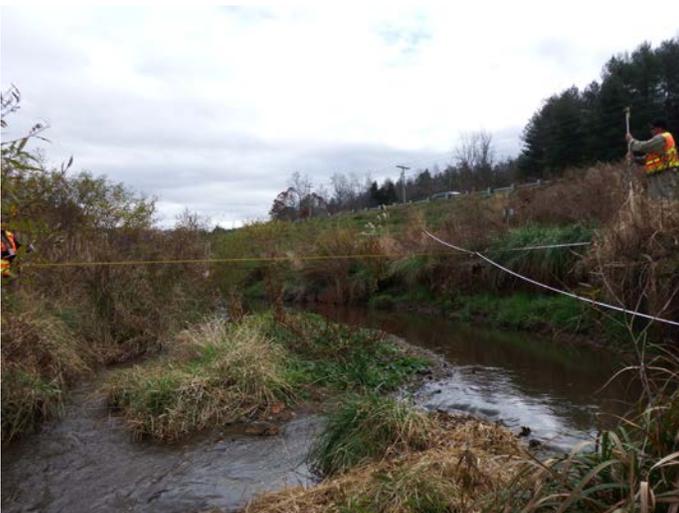
Photo Point #3 (Upstream)
Left bank erosion @ long. profile Sta. 500+00
November 2013

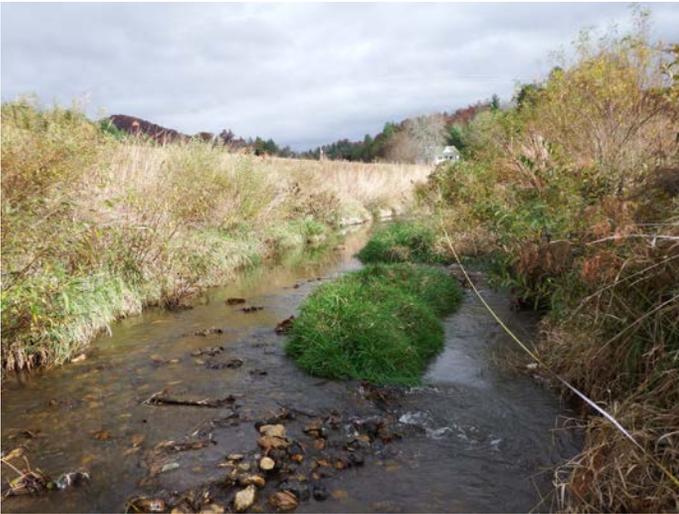
Left bank erosion @ long. profile Sta. 395+00

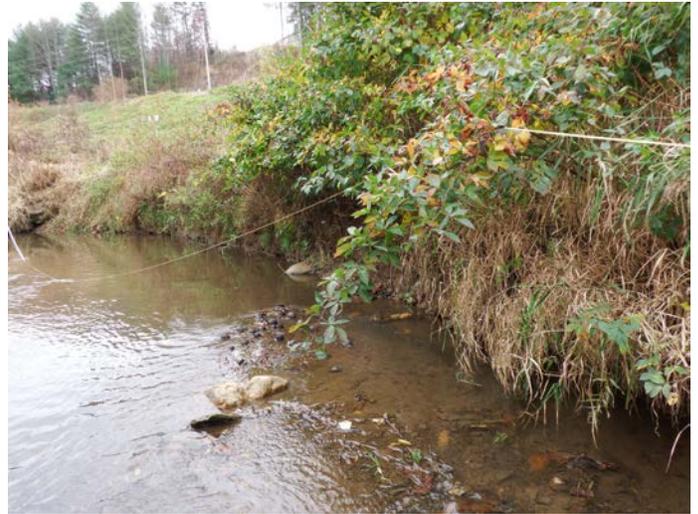
Left bank erosion @ long. profile Sta. 720+00

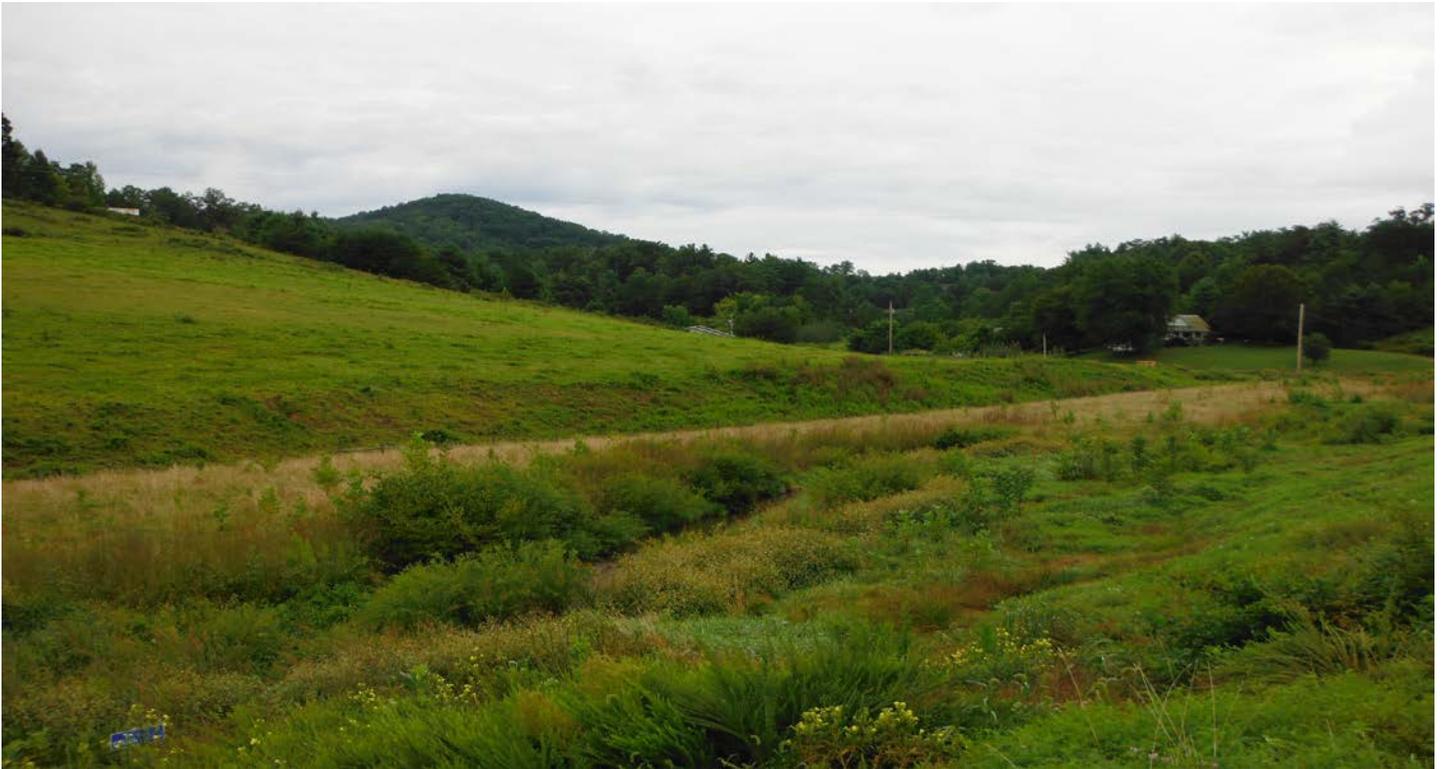
Vegetation Overview Photo (Looking Upstream)

Streambank & Buffer Vegetation: The streambank reforestation was completed in March 2012. The Year 2 vegetation monitoring evaluation noted: Type I: Black Willow, Silky Dogwood, and Type II: Sycamore, Green Ash, Tulip Poplar and White Oak were surviving at the time of the monitoring evaluation.
