ANNUAL REPORT FOR 2014

**Middle Fork Creek Site E Mitigation Site
Madison County
TIP No. R-2518A
COE Action ID: SAW-2007-2197-357/300
DWR #: 20071134**

Prepared By:
Natural Environment Section & Roadside Environmental Unit
North Carolina Department of Transportation
November 2014

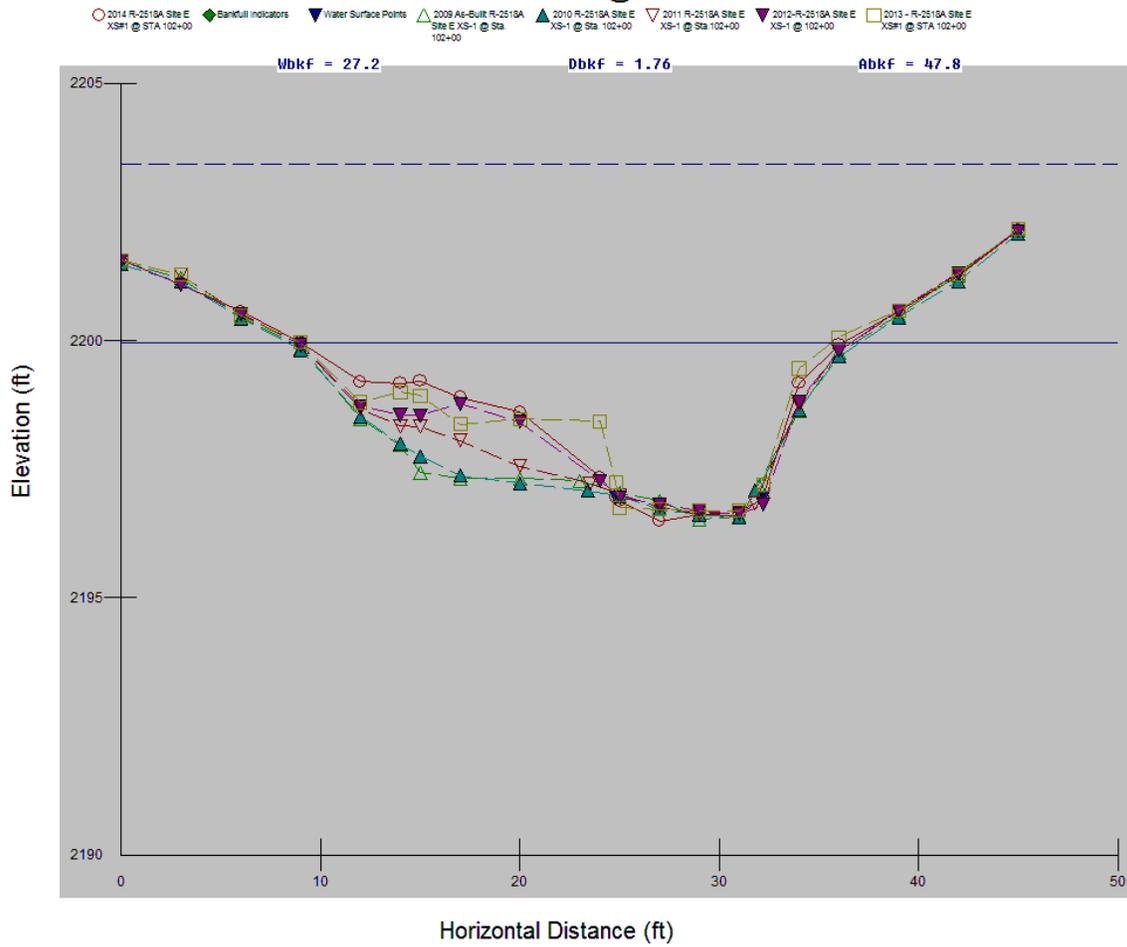
R-2518A Site E XS#1 @ STA 102+00

Site E: Cross-Section #1 (Riffle) Abbreviated Morphological Summary					
	2010	2011	2012	2013	2014
Bankfull Cross Sectional Area (ft ²)	59.32	56.44	50.89	46.83	47.83
Maximum Bankfull Depth (ft.)	3.26	3.28	3.28	3.26	3.47
Width of the Floodprone Area (ft.)	45	45	45	45	45
Bankfull Mean Depth (ft.)	2.16	2.06	1.86	1.76	1.76
Width/Depth Ratio	12.74	13.32	14.74	15.15	15.47
Entrenchment Ratio	1.64	1.64	1.64	1.69	1.65
Bankfull Width (ft.)	27.51	27.43	27.42	26.67	27.23

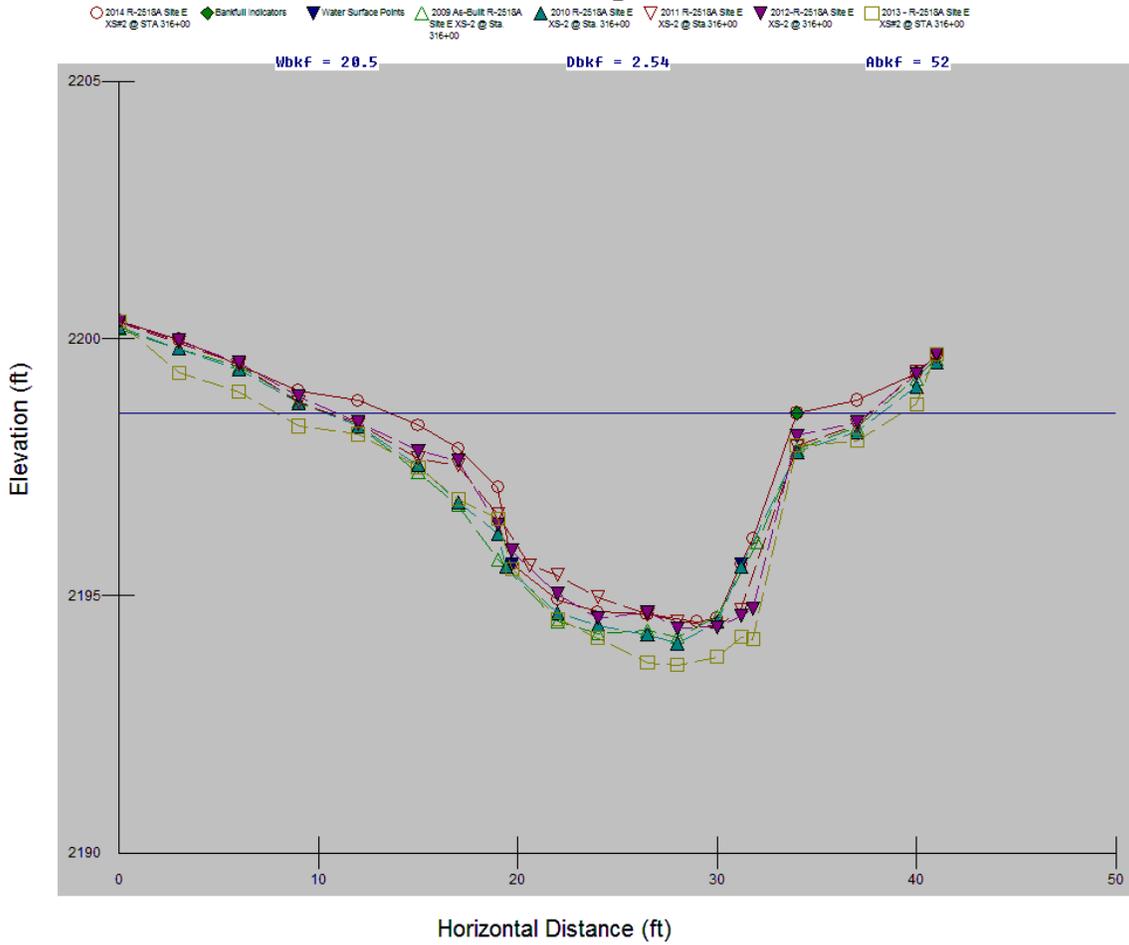
R-2518A Site E XS#2 @ STA 316+00

Site E: Cross-Section #2 (Pool) Abbreviated Morphological Summary					
	2010	2011	2012	2013	2014
Bankfull Cross Sectional Area (ft ²)	45.83	42.38	49.01	55.21	51.97
Maximum Bankfull Depth (ft.)	3.72	3.52	3.74	4.27	4.06
Bankfull Mean Depth (ft.)	2.28	2.11	2.38	2.63	2.54
Bankfull Width (ft.)	20.07	20.07	20.55	20.97	20.47

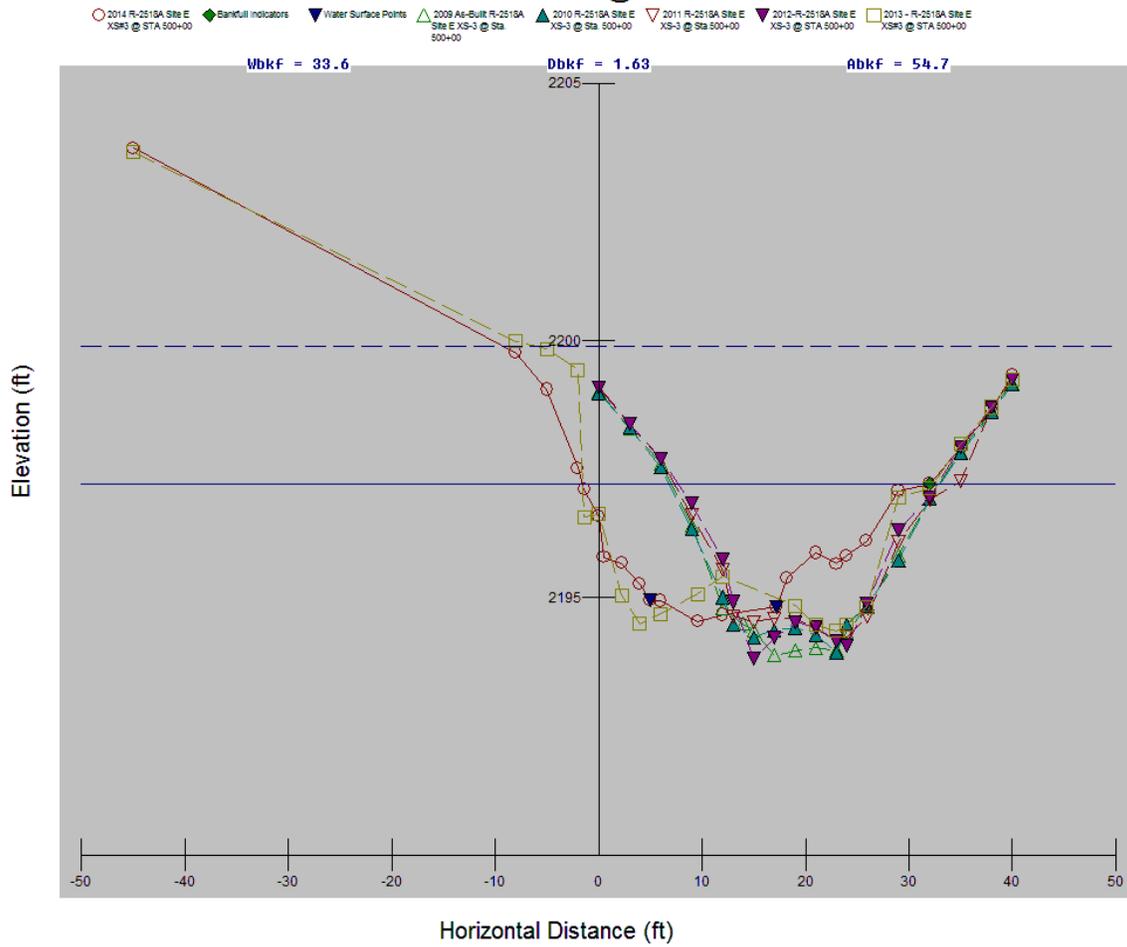
R-2518A Site E XS#3 @ STA 500+00

Site E: Cross-Section #3 (Riffle) Abbreviated Morphological Summary					
	2010	2011	2012	2013	2014
Bankfull Cross Sectional Area (ft ²)	62.4	63.57	62.14	61.27	54.7
Maximum Bankfull Depth (ft.)	3.59	3.53	3.89	2.76	2.68
Width of the Floodprone Area (ft.)	40	40	40	45.8	49.3
Bankfull Mean Depth (ft.)	2.22	2.13	2.2	1.83	1.63
Width/Depth Ratio	12.64	14.03	12.86	18.32	20.6
Entrenchment Ratio	1.43	1.34	1.41	1.37	1.47
Bankfull Width (ft.)	28.06	29.89	28.3	33.52	33.57

*The left end pin at Cross Section #3 had to be reset due to stream repairs completed in June 2014.

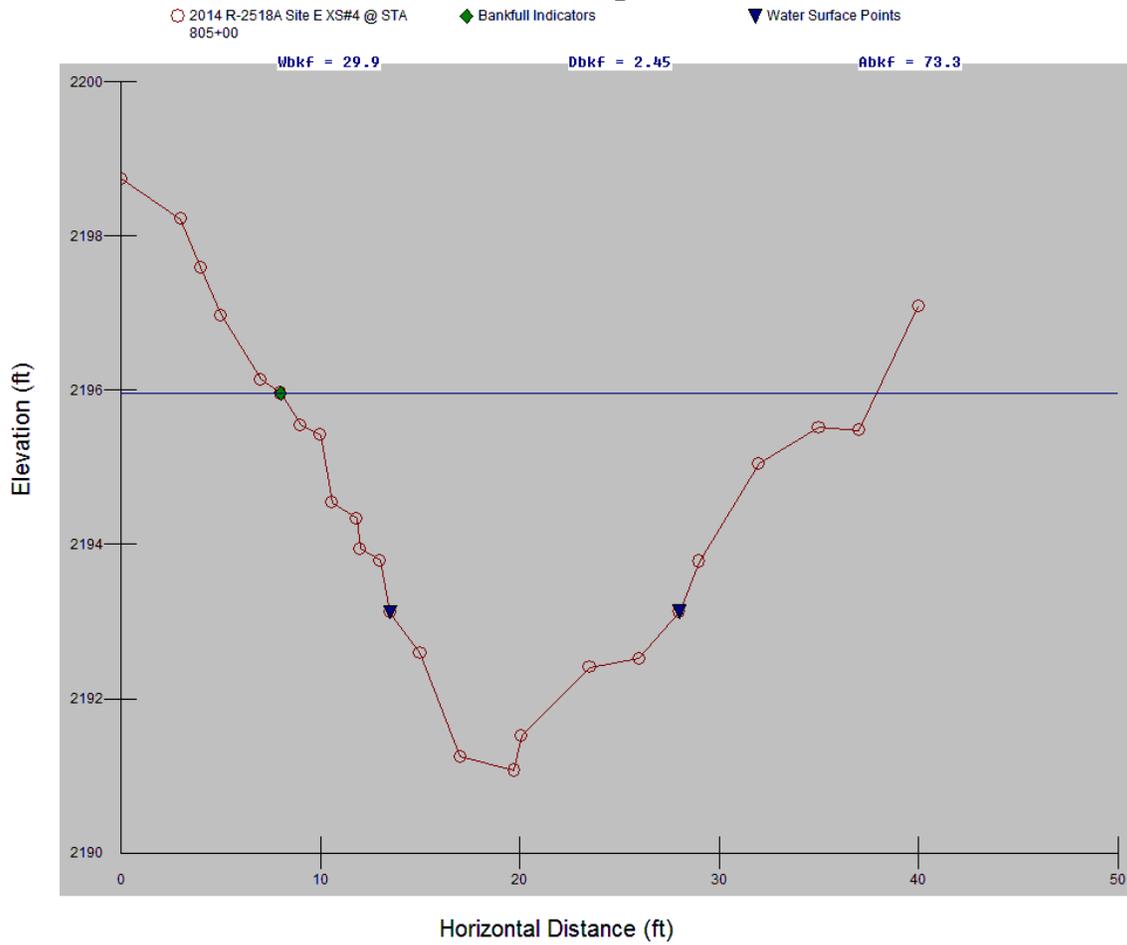
R-2518A Site E XS#4 @ STA 805+00

Site E: Cross-Section #4 (Pool) Abbreviated Morphological Summary					
	2010	2011	2012	2013	2014
Bankfull Cross Sectional Area (ft ²)	69.95	70.4	62.52	46.96	73.26
Maximum Bankfull Depth (ft.)	4.24	4.53	4.58	3.5	4.89
Bankfull Mean Depth (ft.)	2.37	2.43	2.12	2.23	2.45
Bankfull Width (ft.)	29.53	28.92	29.45	21.1	29.89

*Cross Section #4 had to be reset after the stream repairs were completed in June 2014, so therefore, the 2014 monitoring data was not overlaid with the previous monitoring years.

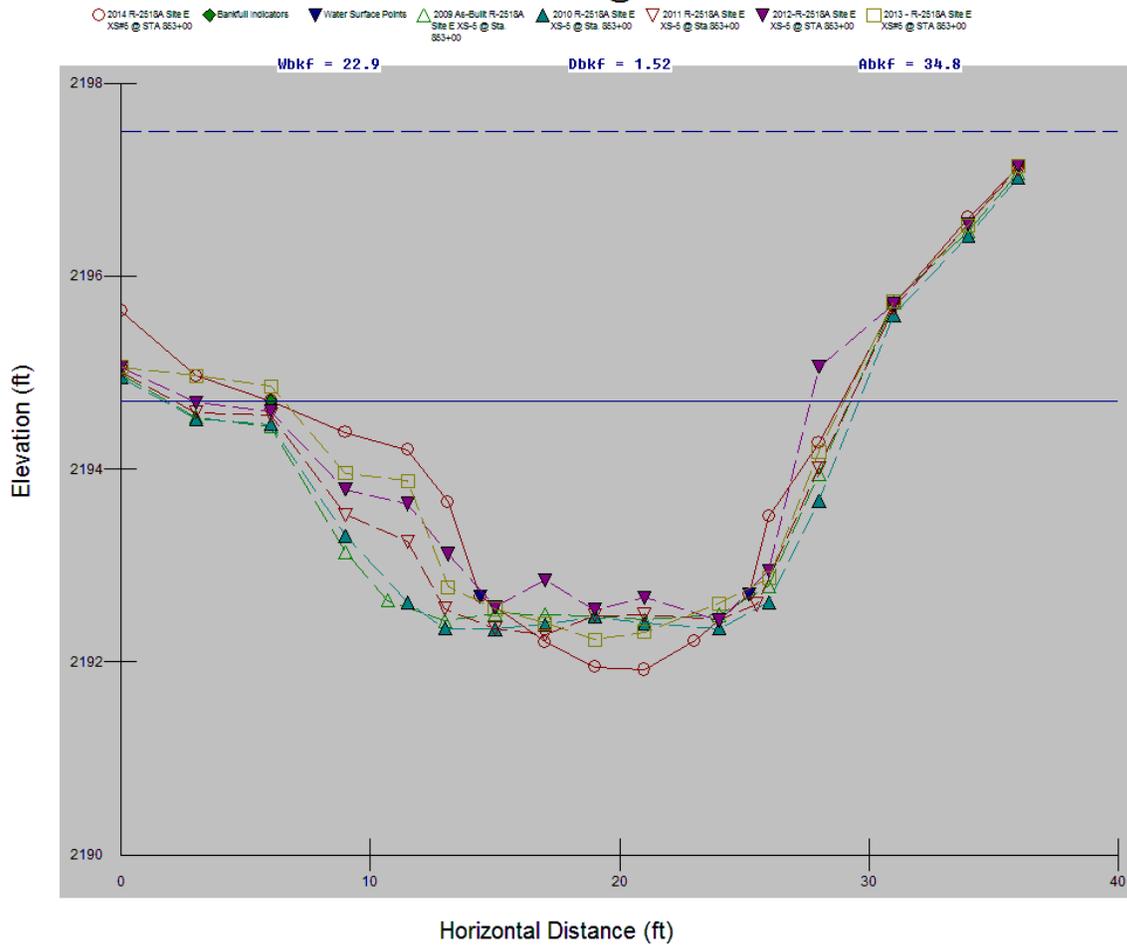
R-2518A Site E XS#5 @ STA 853+00

Site E: Cross-Section #5 (Riffle) Abbreviated Morphological Summary					
	2010	2011	2012	2013	2014
Bankfull Cross Sectional Area (ft ²)	38.49	36.94	31.55	39.91	34.85
Maximum Bankfull Depth (ft.)	2.13	2.28	2.17	2.63	2.79
Width of the Floodprone Area (ft.)	34.6	35.05	34.77	36	36
Bankfull Mean Depth (ft.)	1.66	1.61	1.46	1.71	1.52
Width/Depth Ratio	14	14.28	14.77	13.63	15.08
Entrenchment Ratio	1.49	1.52	1.61	1.54	1.57
Bankfull Width (ft.)	23.24	22.99	21.56	23.31	22.92

*The left end pin at Cross Section #5 had to be reset due to stream repairs completed in June 2014.

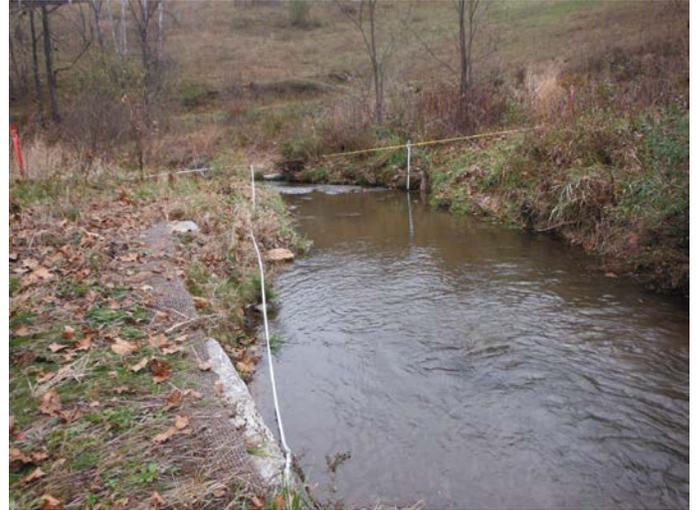
Photo Point #4 (Downstream)
Repaired left bank @ Long. Profile Sta. 829+00

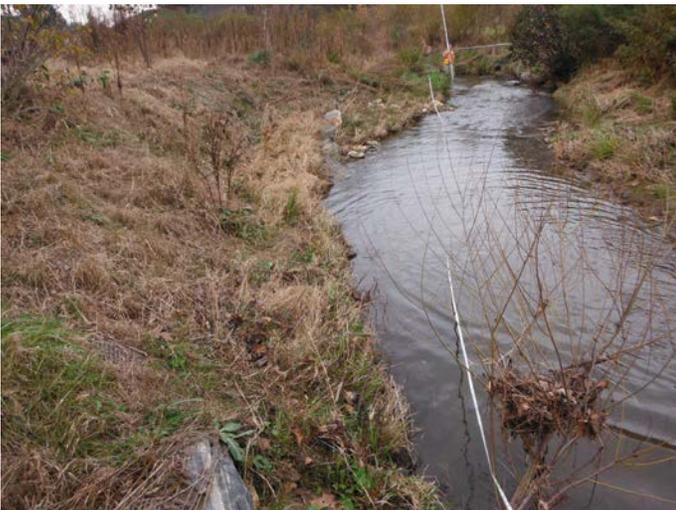
Left bank repaired @ Long. Profile Sta. 257+00
November 2014

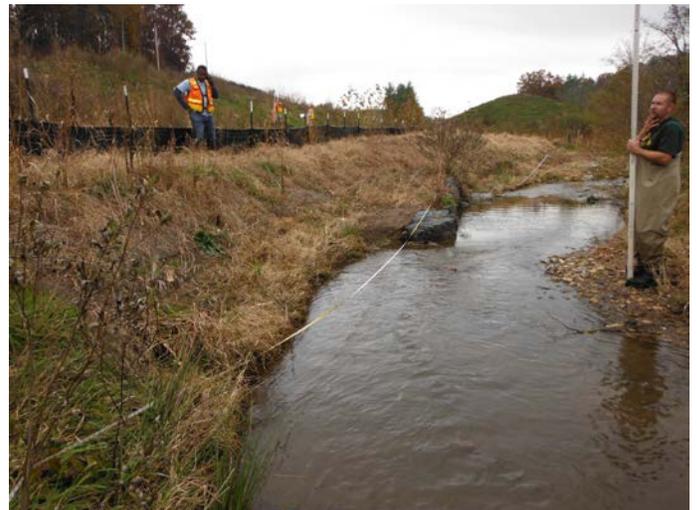
Left bank repaired @ Long. Profile Sta. 450+00

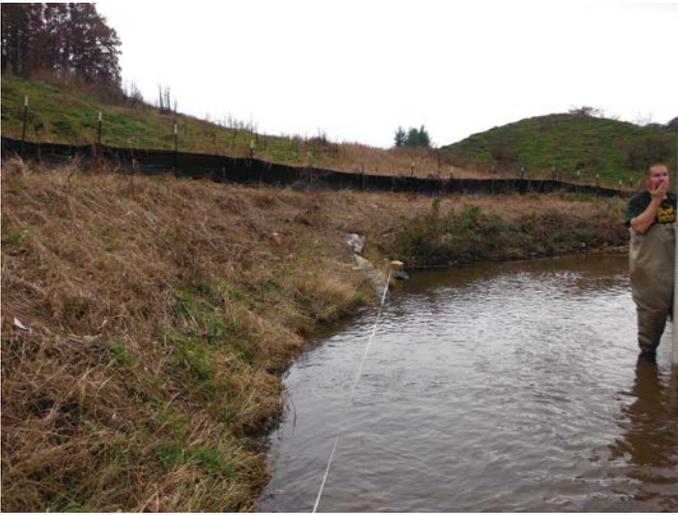
Repaired left bank @ Long. Profile Sta. 670+00

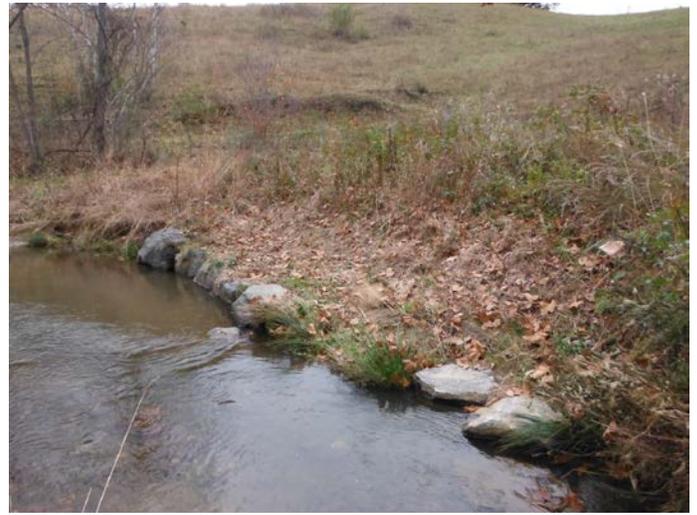
Repaired right bank @ Long. Profile Sta. 900+00

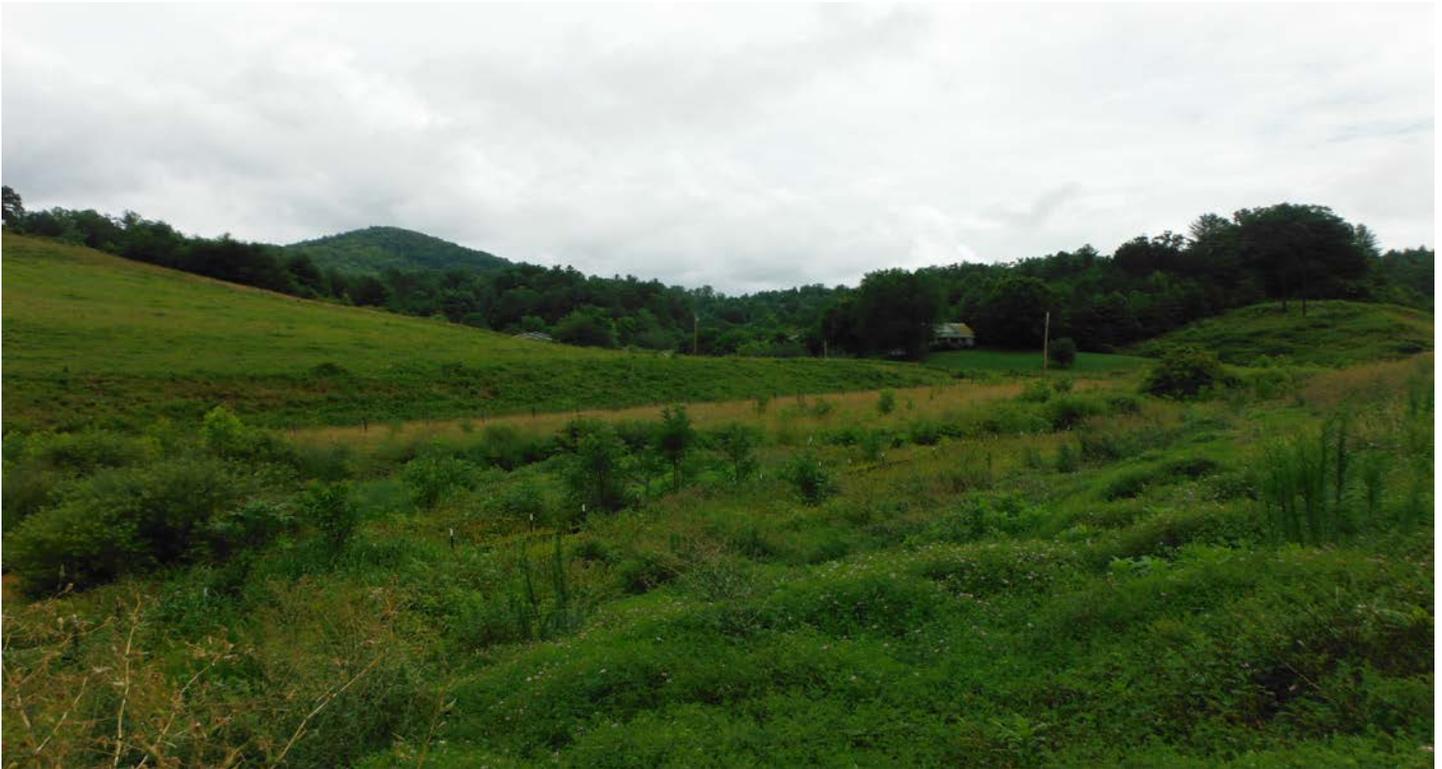
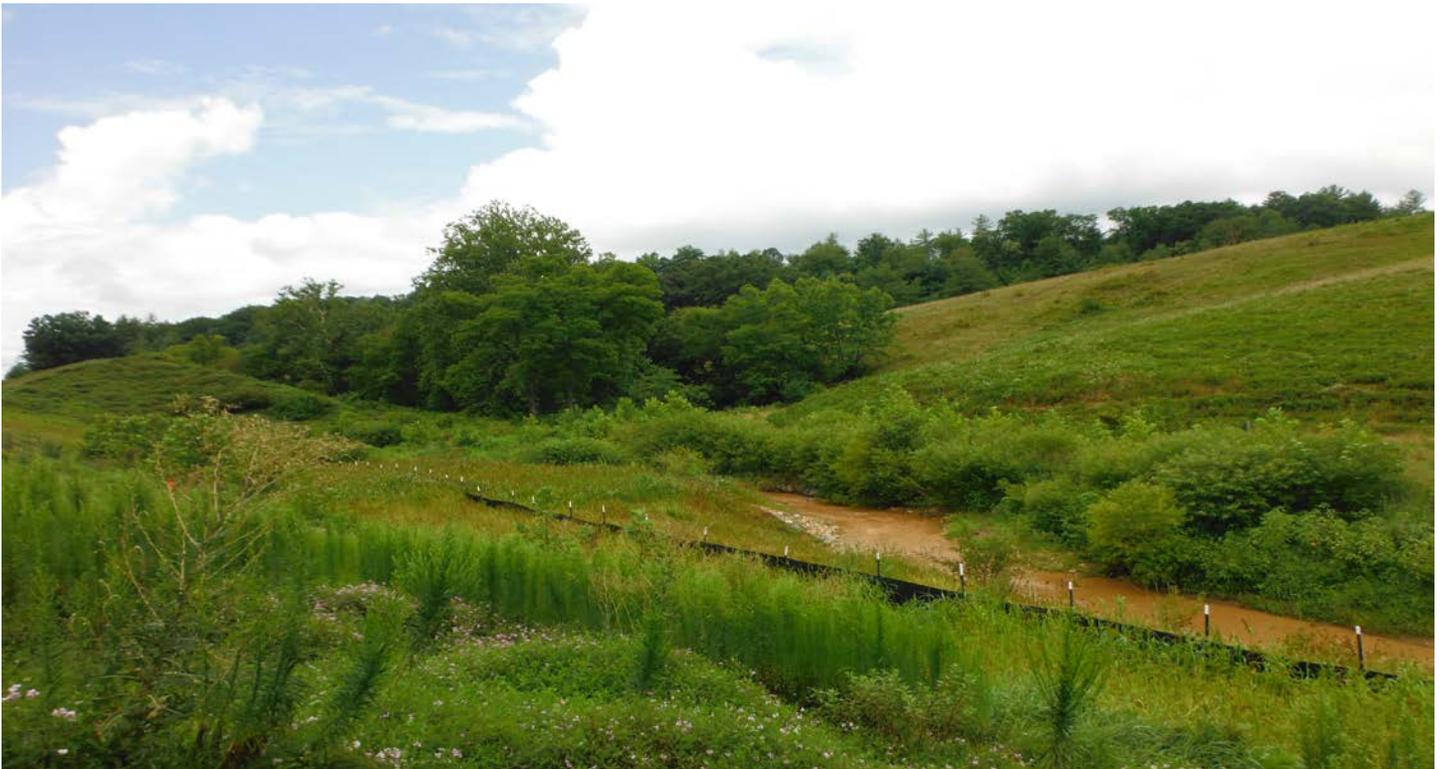
Streambank & Buffer Vegetation: The streambank reforestation was completed in March 2012. The Year 3 vegetation monitoring evaluation noted: Type I: Black Willow, Silky Dogwood, and Type II: Sycamore, Green Ash, Tulip Poplar and White Oak were surviving at the time of the monitoring evaluation. All areas disturbed by the stream repairs from June 2014 will be replanted in 2015. A few small patches of Japanese Knotweed were sprayed on May 8, 2014 and July 23, 2014 around Cross Section #5.

NCDOT will continue to monitor the planted vegetation and replant all disturbed areas from the stream repairs in 2015.
