ANNUAL REPORT FOR 2015

**Middle Fork Creek Site E Mitigation Site
Madison County
TIP No. R-2518A
COE Action ID: SAW-2007-2197-357/300
DWR #: 20071134**

Prepared By:
Natural Environment Section & Roadside Environmental Unit
North Carolina Department of Transportation
November 2015

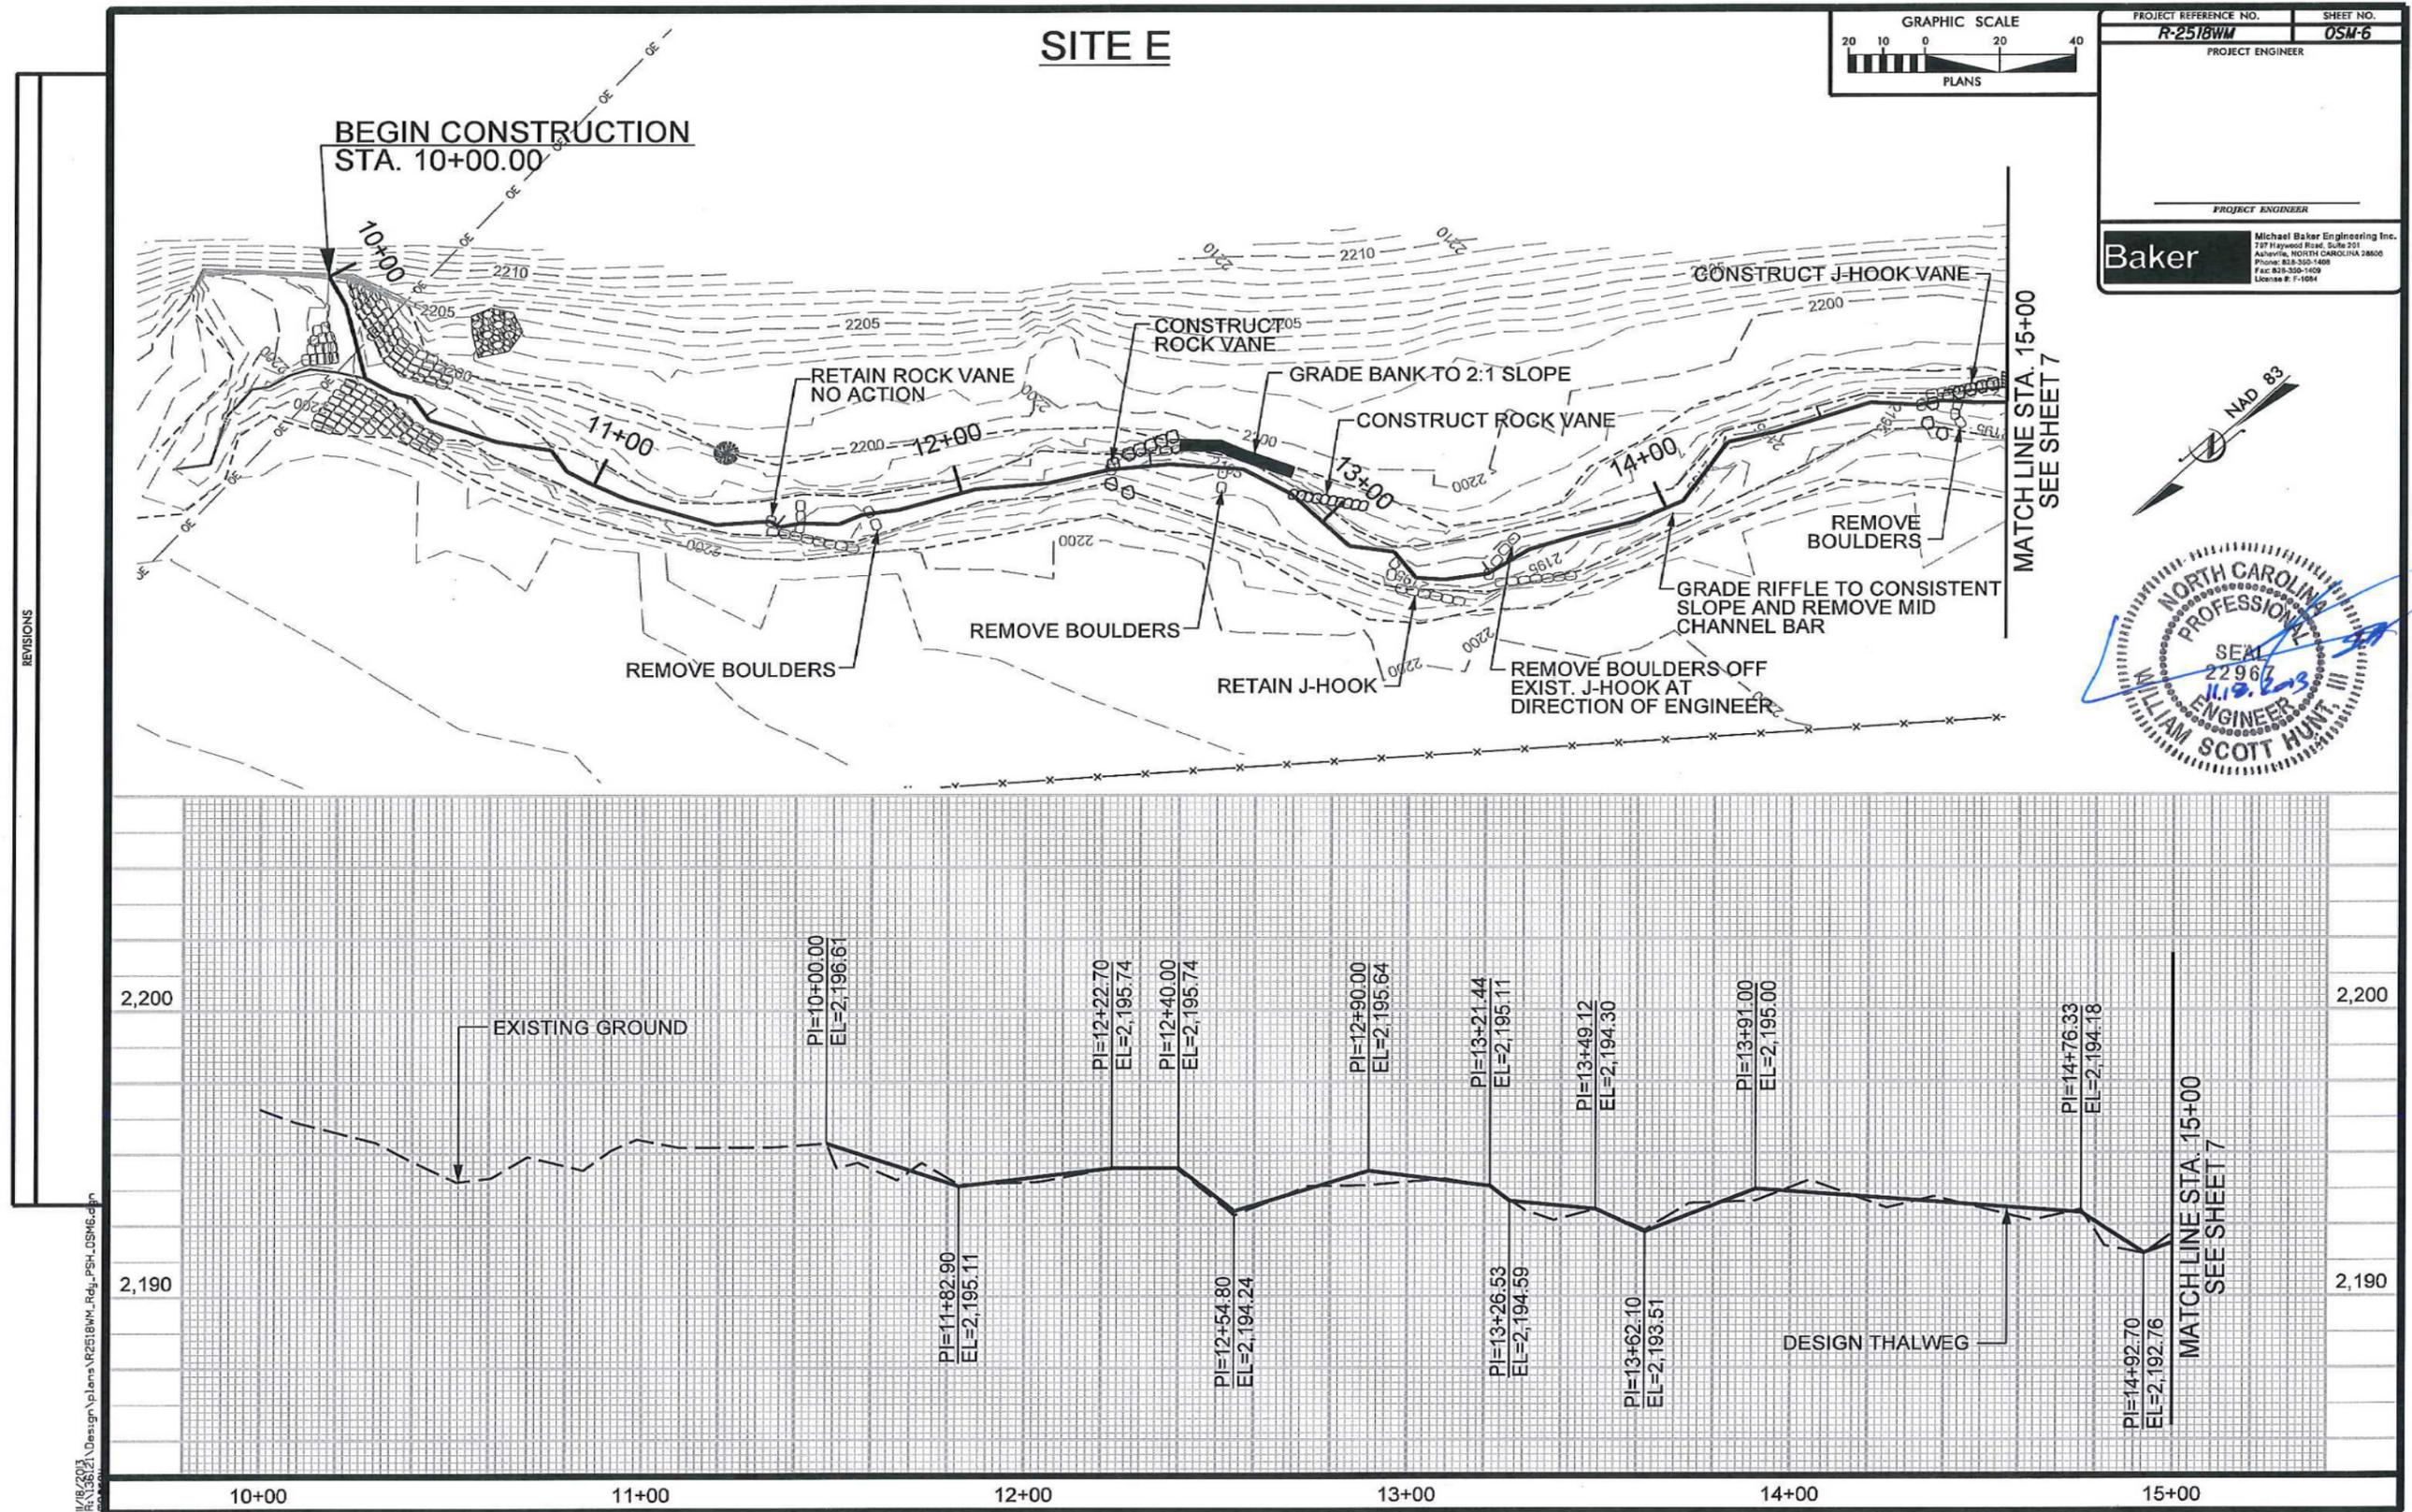
Figure 7. Site E Repair Plans

Based on the overall conclusions of monitoring at the Middle Fork Creek Site E, it has met the required monitoring protocols for the sixth formal year of monitoring on the stream and for the fourth formal year of monitoring on the planted vegetation. Stream repairs completed in June 2014 at Site E included constructing j-hooks, geolifts, rock vanes, grading work and removing some structures to stabilize the stream (see repair plans on pages 9 & 10). The streambank and buffer area were originally planted in March 2012 with live stakes and bareroot seedlings. The site was supplementally planted in March 2015 after stream repairs were completed. The planted vegetation is surviving at this time.

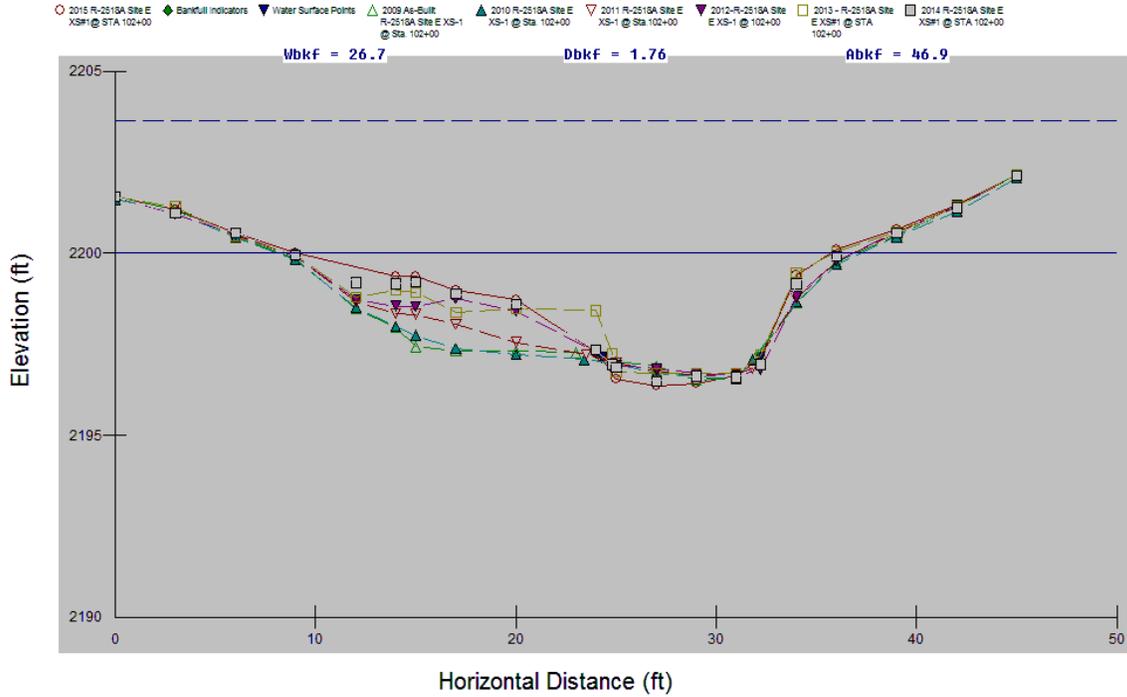
R-2518A Site E XS#1 @ STA 102+00

Site E: Cross-Section #1 (Riffle) Abbreviated Morphological Summary						
	2010	2011	2012	2013	2014	2015
Bankfull Cross Sectional Area (ft²)	59.32	56.44	50.89	46.83	47.83	46.92
Maximum Bankfull Depth (ft.)	3.26	3.28	3.28	3.26	3.47	3.64
Width of the Floodprone Area (ft.)	45	45	45	45	45	45
Bankfull Mean Depth (ft.)	2.16	2.06	1.86	1.76	1.76	1.76
Width/Depth Ratio	12.74	13.32	14.74	15.15	15.47	15.15
Entrenchment Ratio	1.64	1.64	1.64	1.69	1.65	1.69
Bankfull Width (ft.)	27.51	27.43	27.42	26.67	27.23	26.67

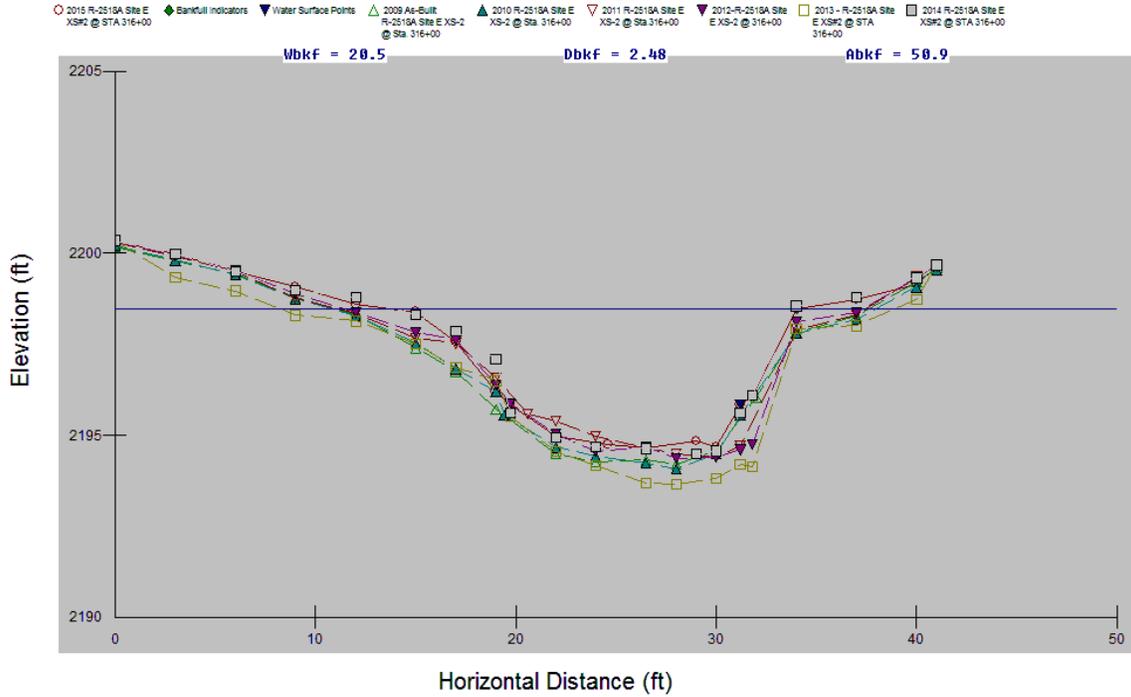
R-2518A Site E XS#2 @ STA 316+00

Site E: Cross-Section #2 (Pool) Abbreviated Morphological Summary						
	2010	2011	2012	2013	2014	2015
Bankfull Cross Sectional Area (ft²)	45.83	42.38	49.01	55.21	51.97	50.87
Maximum Bankfull Depth (ft.)	3.72	3.52	3.74	4.27	4.06	3.85
Bankfull Mean Depth (ft.)	2.28	2.11	2.38	2.63	2.54	2.48
Bankfull Width (ft.)	20.07	20.07	20.55	20.97	20.47	20.5

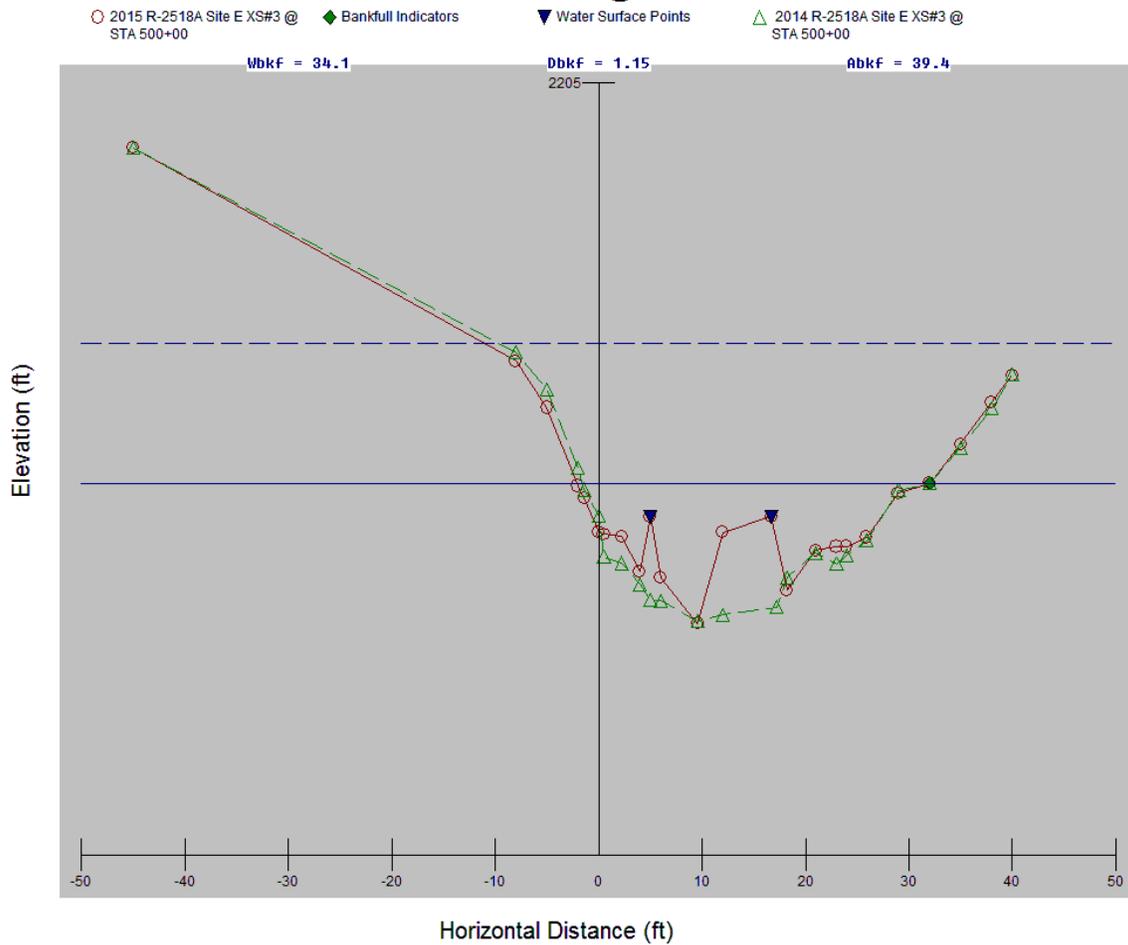
R-2518A Site E XS#3 @ STA 500+00

Site E: Cross-Section #3 (Riffle) Abbreviated Morphological Summary						
	2010	2011	2012	2013	2014	2015
Bankfull Cross Sectional Area (ft ²)	62.4	63.57	62.14	61.27	54.7	35.83
Maximum Bankfull Depth (ft.)	3.59	3.53	3.89	2.76	2.68	2.72
Width of the Floodprone Area (ft.)	40	40	40	45.8	49.3	51.12
Bankfull Mean Depth (ft.)	2.22	2.13	2.2	1.83	1.63	1.05
Width/Depth Ratio	12.64	14.03	12.86	18.32	20.6	32.48
Entrenchment Ratio	1.43	1.34	1.41	1.37	1.47	1.5
Bankfull Width (ft.)	28.06	29.89	28.3	33.52	33.57	34.1

*The left end pin at Cross Section #3 had to be reset due to stream repairs completed in June 2014, so therefore, the 2014 and 2015 were not overlaid with the previous monitoring years.

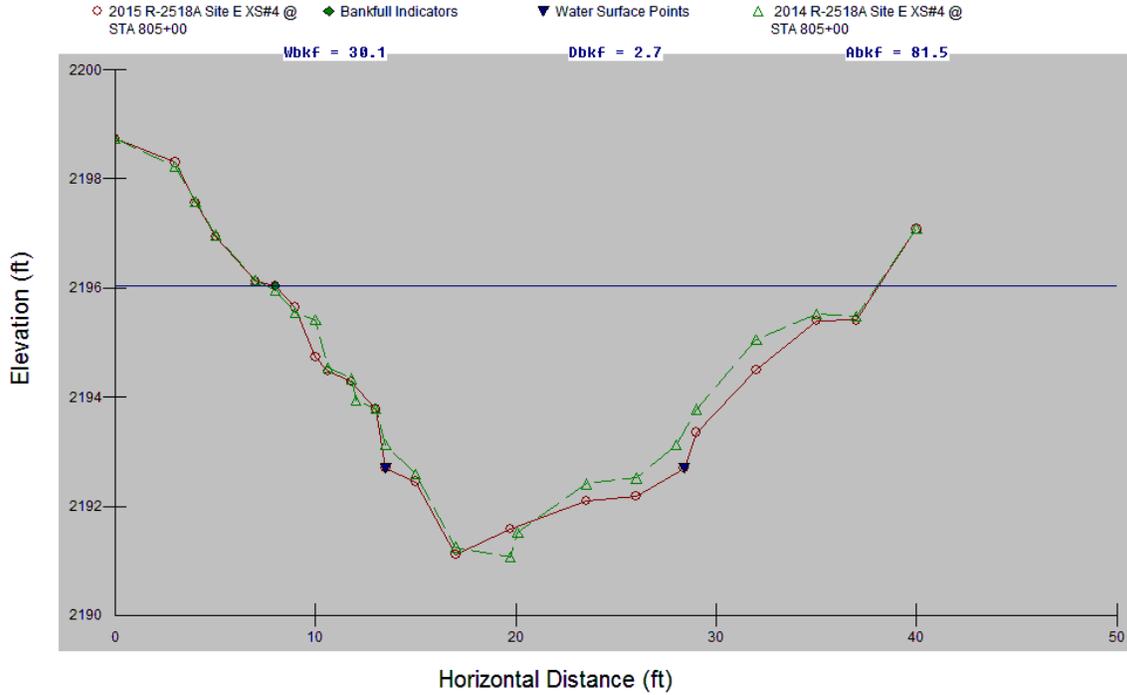
R-2518A Site E XS#4 @ STA 805+00

Site E: Cross-Section #4 (Pool) Abbreviated Morphological Summary						
	2010	2011	2012	2013	2014	2015
Bankfull Cross Sectional Area (ft ²)	69.95	70.4	62.52	46.96	73.26	81.5
Maximum Bankfull Depth (ft.)	4.24	4.53	4.58	3.5	4.89	4.92
Bankfull Mean Depth (ft.)	2.37	2.43	2.12	2.23	2.45	2.7
Bankfull Width (ft.)	29.53	28.92	29.45	21.1	29.89	30.13

*Cross Section #4 had to be reset after the stream repairs were completed in June 2014, so therefore, the 2014 and 2015 monitoring data were not overlaid with the previous monitoring years.

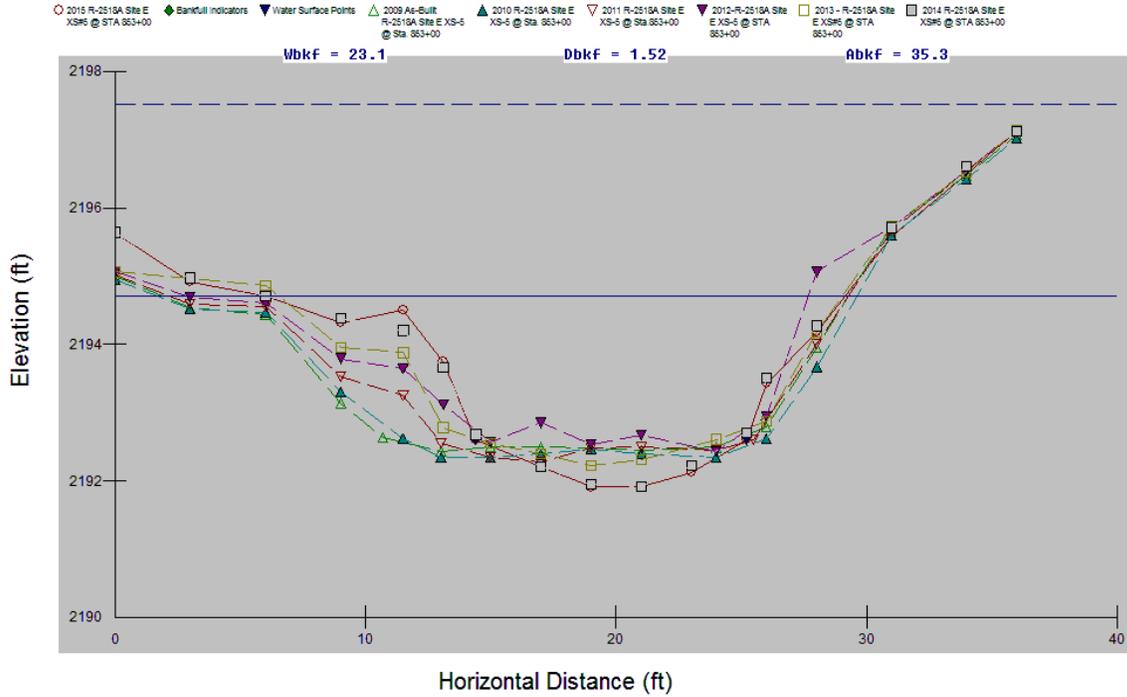
R-2518A Site E XS#5 @ STA 853+00

Streambank & Buffer Vegetation: The streambank reforestation was completed in March 2012. A supplemental planting took place in March 2015. The Year 4 vegetation monitoring evaluation noted: Type I: Black Willow, Silky Dogwood, and Type II: Sycamore, Green Ash, Tulip Poplar and White Oak were surviving at the time of the monitoring evaluation. A small area of Japanese Knotweed was sprayed in July 2015 around Cross Section #5.

Site E: Cross-Section #5 (Riffle) Abbreviated Morphological Summary						
	2010	2011	2012	2013	2014	2015
Bankfull Cross Sectional Area (ft ²)	38.49	36.94	31.55	39.91	34.85	35.27
Maximum Bankfull Depth (ft.)	2.13	2.28	2.17	2.63	2.79	2.8
Width of the Floodprone Area (ft.)	34.6	35.05	34.77	36	36	36
Bankfull Mean Depth (ft.)	1.66	1.61	1.46	1.71	1.52	1.52
Width/Depth Ratio	14	14.28	14.77	13.63	15.08	15.22
Entrenchment Ratio	1.49	1.52	1.61	1.54	1.57	1.56
Bankfull Width (ft.)	23.24	22.99	21.56	23.31	22.92	23.14

*The left end pin at Cross Section #5 had to be reset due to stream repairs completed in June 2014.
