# ANNUAL REPORT FOR 2012

**Middle Fork Creek Site I Mitigation Site  
Madison County  
TIP No. R-2518A  
COE Action ID: SAW-2007-2197-357/300  
DWQ #: 20071134**

Prepared By:  
Natural Environment Section & Roadside Environmental Unit  
North Carolina Department of Transportation  
December 2012

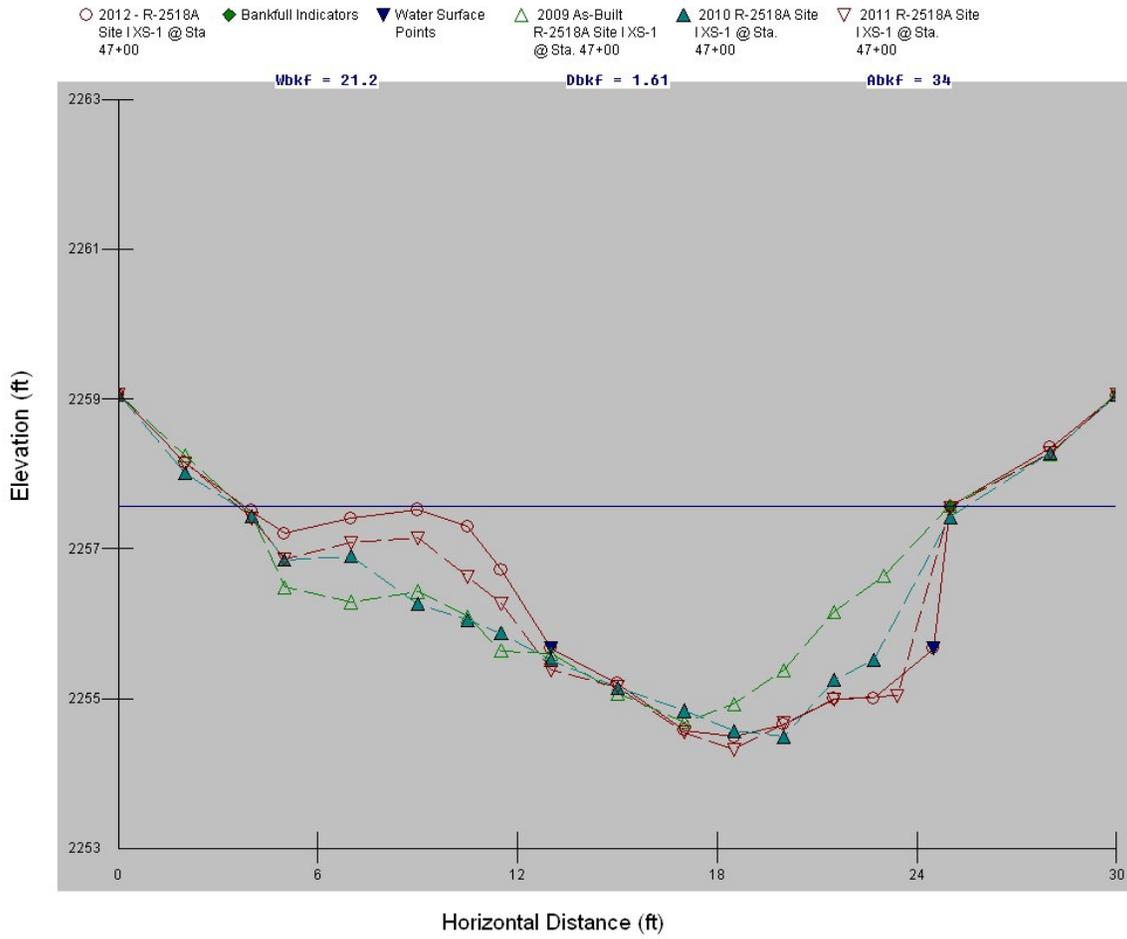
### R-2518A Site I XS-1 @ Sta 47+00

Based on comparisons of the As-Built to the monitoring data, all of the cross sections appear stable with little or no active bank erosion, except for, Cross Section #1. Cross Section #1 has experienced some bank erosion on the right bank. Graphs of the cross sections are presented in Appendix A. Future survey data will vary depending on actual location of rod placement and alignment; however, this information should remain similar in appearance. The longitudinal profile showed that the channel bed was stable for the 2012 monitoring evaluation. There was some left bank erosion noted downstream of PP#1 and PP#2 and upstream of PP#3. NCDOT plans to live stake these eroded banks by March 2013 to help stabilize these areas. Pebble counts were not required per the permit conditions and therefore were not completed.

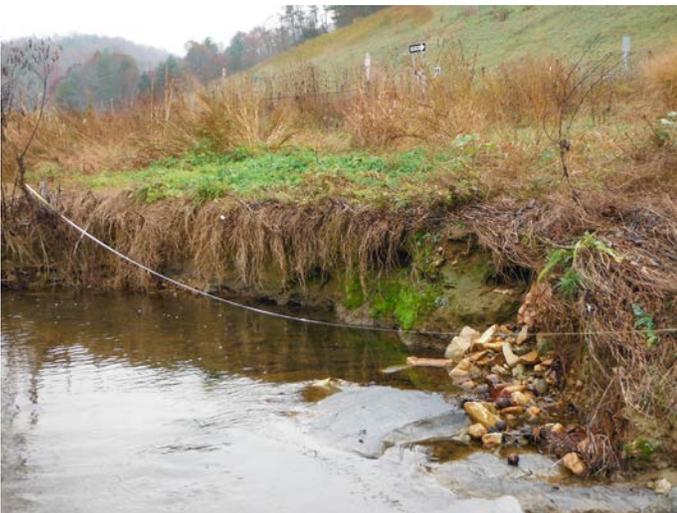
Left Bank Erosion Downstream of Photo Point#1  
November 2012

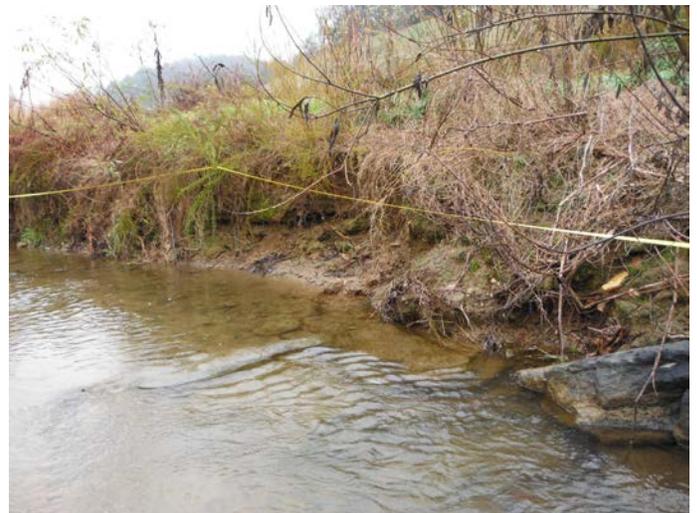
Left Bank Erosion Downstream of Photo Point #2

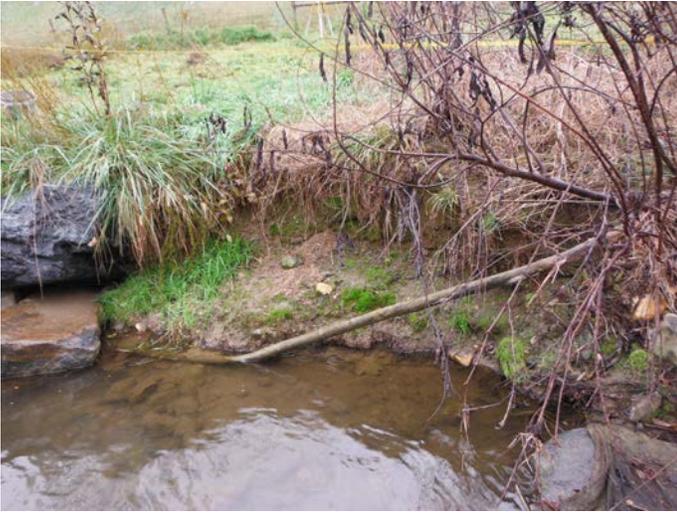
Left Bank Erosion Upstream of Photo Point #3

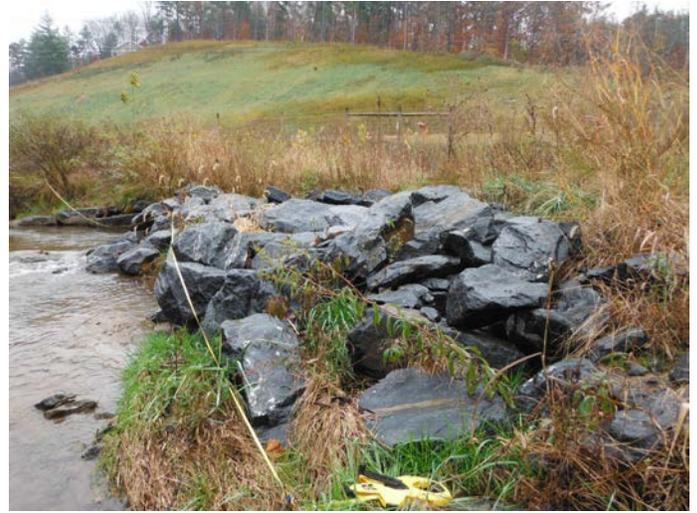
Left Bank Repaired from Sta. 11+79 to 11+95 Lt.

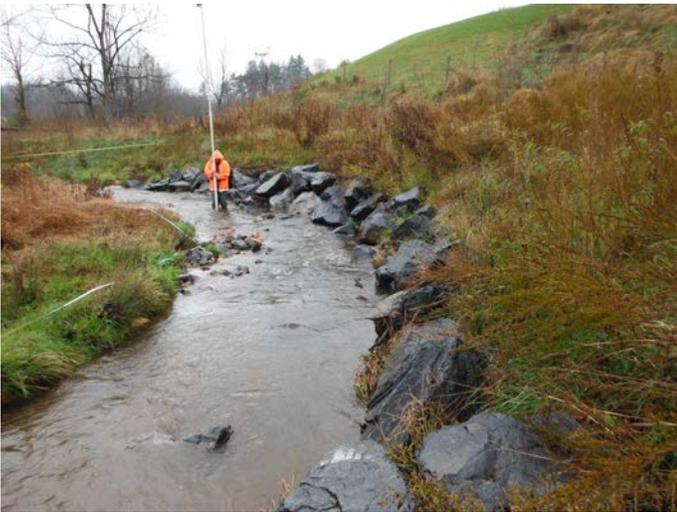
Left Bank Repaired from Sta. 11+95 to 12+05 Rt.  
November 2012

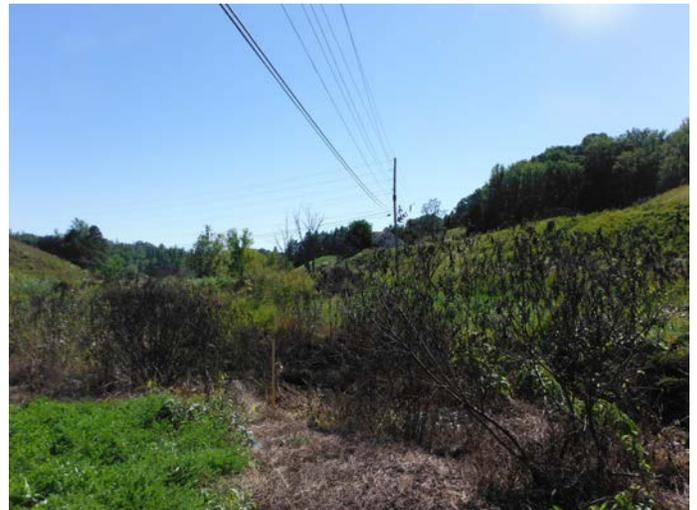
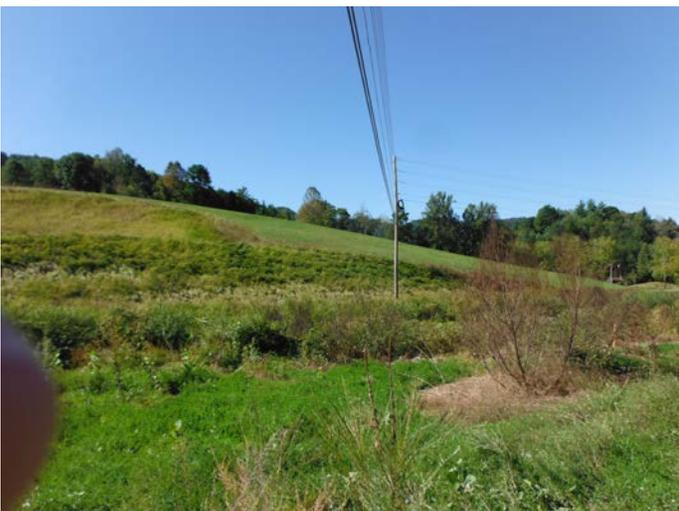
**Streambank & Buffer Vegetation:** The streambank reforestation was completed in March 2012. The Year 1 vegetation monitoring evaluation noted: Type I: Black Willow and Type II: Sycamore, Green Ash, Tulip Poplar, and White Oak were surviving at the time of the monitoring evaluation. It was noted during the monitoring evaluation that the power line easement has been sprayed with an herbicide application.

Powerline Easement Sprayed

Powerline Easement Sprayed  
September 2012
