ANNUAL REPORT FOR 2013

**Middle Fork Creek Site I Mitigation Site
Madison County
TIP No. R-2518A
COE Action ID: SAW-2007-2197-357/300
DWR #: 20071134**

Prepared By:
Natural Environment Section & Roadside Environmental Unit
North Carolina Department of Transportation
November 2013

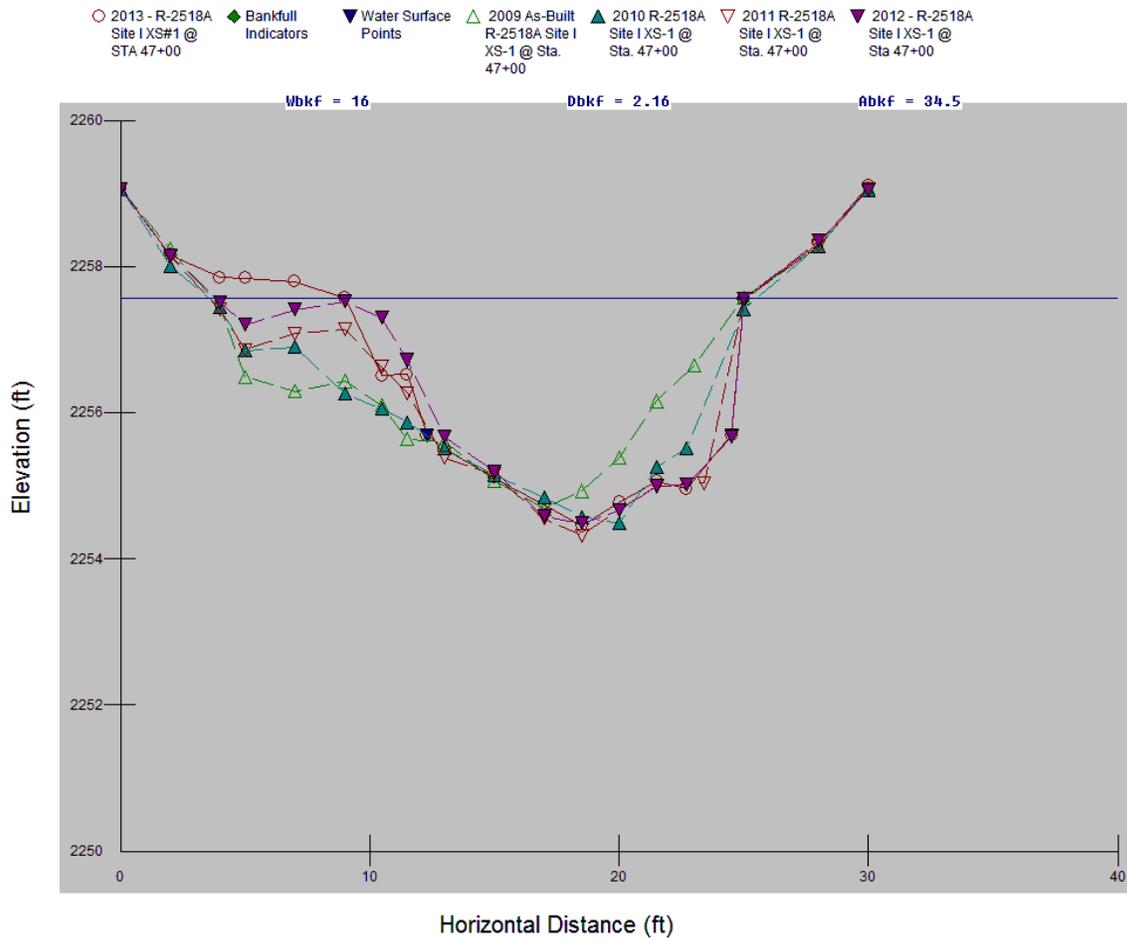
R-2518A Site I XS#1 @ STA 47+00

Based on comparisons of the As-Built to the monitoring data, all of the cross sections appear stable with little or no active bank erosion, except for, some right bank erosion at Cross Section #1. Graphs of the cross sections are presented in Appendix A. Future survey data will vary depending on actual location of rod placement and alignment; however, this information should remain similar in appearance. The longitudinal profile showed that the channel bed was stable for the 2013 monitoring evaluation but there was some left bank erosion noted downstream of PP#1, downstream of PP#2, and downstream of PP#4. Pebble counts were not required per the permit conditions and therefore were not completed. Two bankfull events were documented at Site I during the 2013 monitoring year.

Site I: Cross-Section #1 (Pool) Abbreviated Morphological Summary					
	2010	2011	2012	2013	2014
Bankfull Cross Sectional Area (ft ²)	34.89	42.04	33.97	34.54	
Maximum Bankfull Depth (ft.)	2.93	2.89	3.07	3.11	
Bankfull Mean Depth (ft.)	1.66	1.67	1.61	2.16	
Bankfull Width (ft.)	20.97	25.14	21.16	15.99

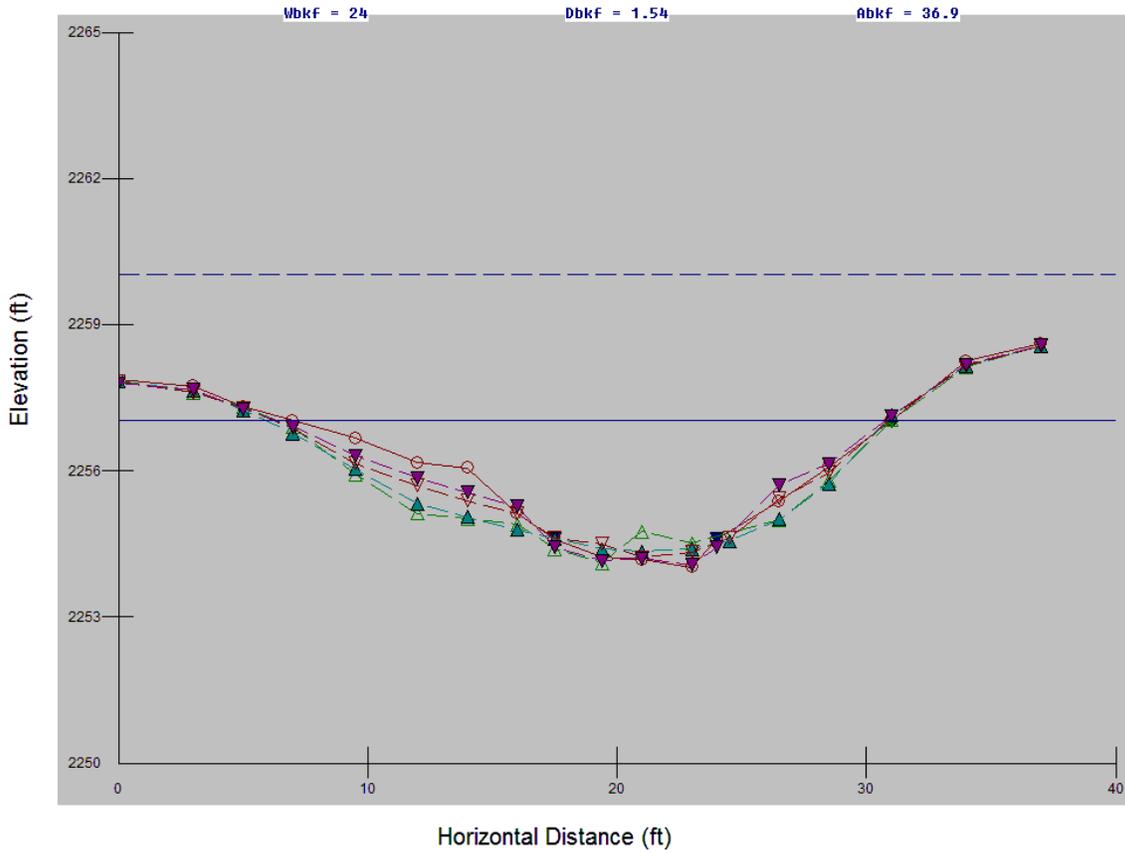
R-2518A Site I XS#2 @ STA 185+05

Site I: Cross-Section #2 (Riffle) Abbreviated Morphological Summary					
	2010	2011	2012	2013	2014
Bankfull Cross Sectional Area (ft ²)	46.76	42.04	41.31	36.86	
Maximum Bankfull Depth (ft.)	2.8	2.89	1.64	3.01	
Width of the Floodprone Area (ft.)	37	37	37	37	
Bankfull Mean Depth (ft.)	1.83	1.67	1.64	1.54	
Width/Depth Ratio	13.96	15.05	15.35	15.58	
Entrenchment Ratio	1.45	1.47	1.47	1.54	
Bankfull Width (ft.)	25.54	25.14	25.17	24

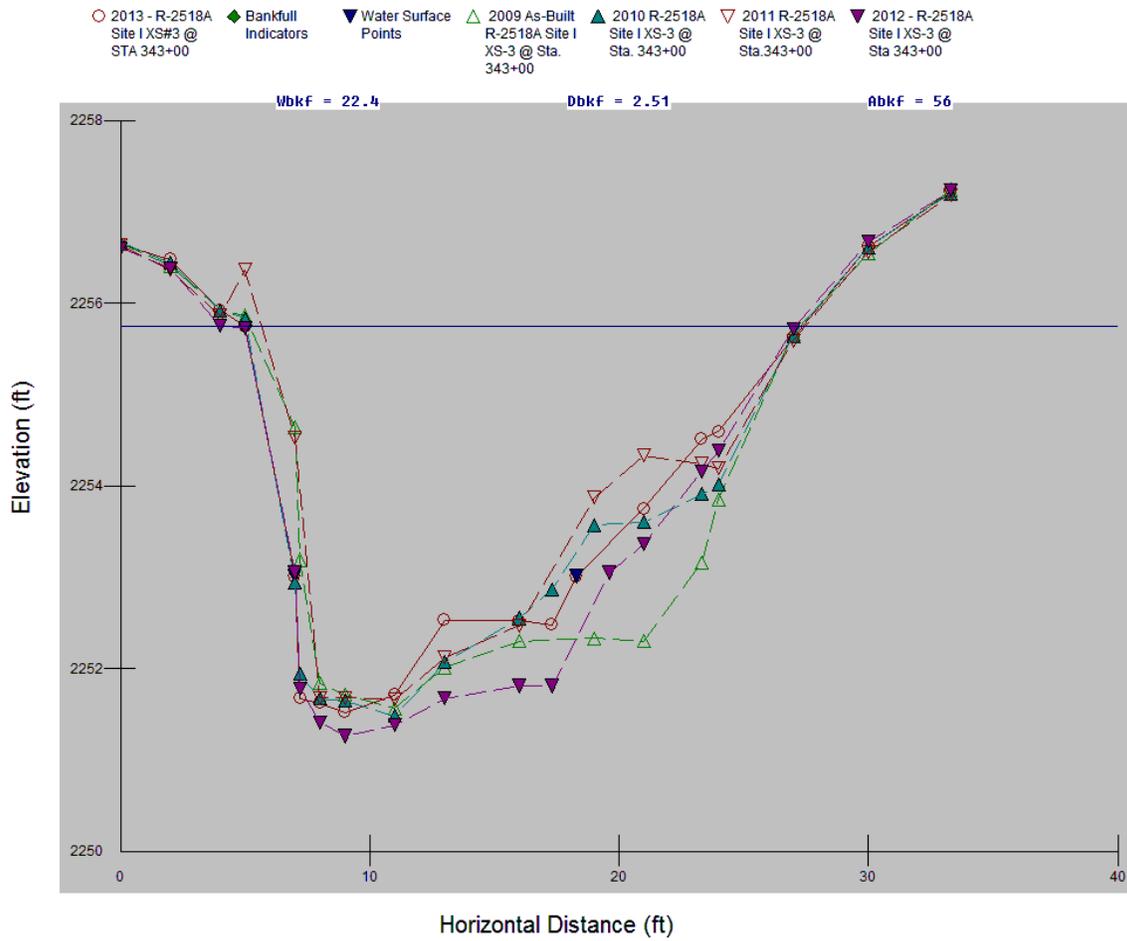
R-2518A Site I XS#3 @ STA 343+00

Site I: Cross-Section #3 (Pool) Abbreviated Morphological Summary					
	2010	2011	2012	2013	2014
Bankfull Cross Sectional Area (ft ²)	60.29	65.99	64.06	56.03	
Maximum Bankfull Depth (ft.)	4.35	4.7	4.47	4.22	
Bankfull Mean Depth (ft.)	2.67	2.71	2.91	2.51	
Bankfull Width (ft.)	22.59	24.38	22.03	22.36

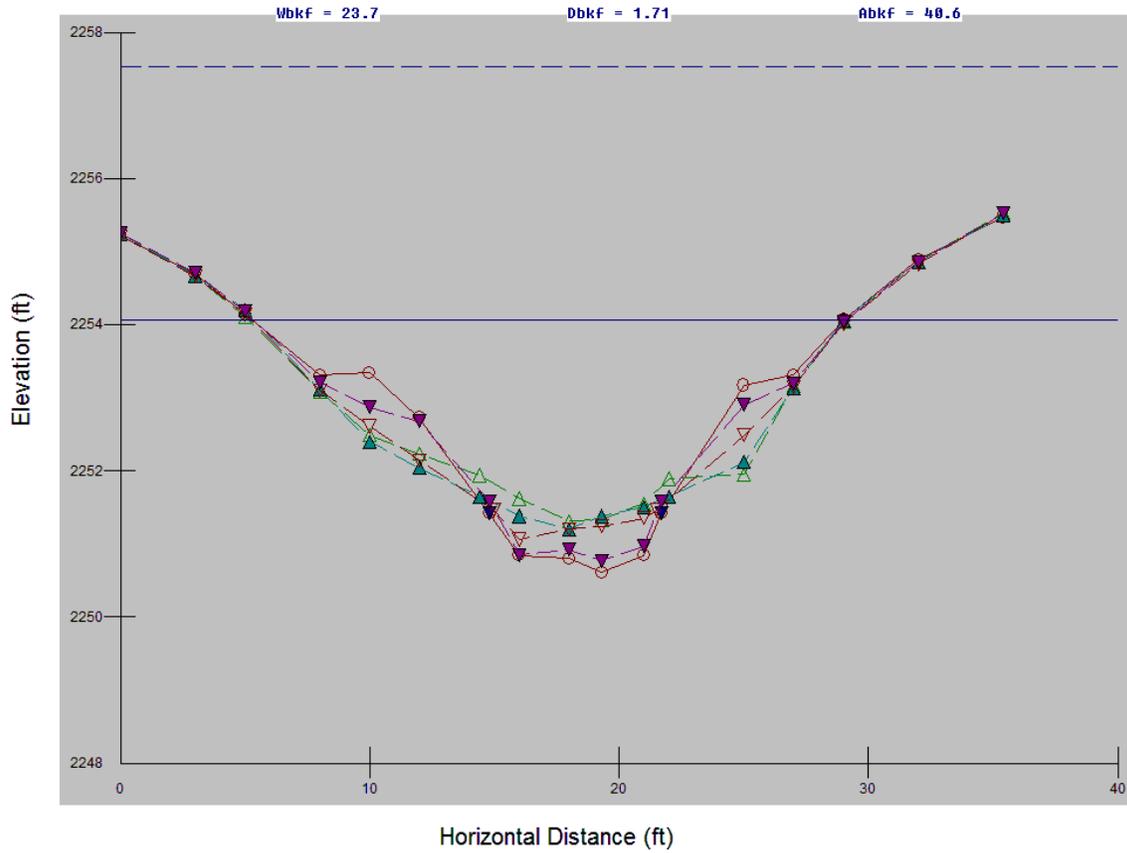
R-2518A Site I XS#4 @ STA 483+00

Site I: Cross-Section #4 (Riffle) Abbreviated Morphological Summary					
	2010	2011	2012	2013	2014
Bankfull Cross Sectional Area (ft ²)	43.32	41.82	40.88	40.61	
Maximum Bankfull Depth (ft.)	2.86	2.95	3.27	3.46	
Width of the Floodprone Area (ft.)	35.4	35.4	35.4	35.4	
Bankfull Mean Depth (ft.)	1.83	1.77	1.73	1.71	
Width/Depth Ratio	12.9	13.35	13.62	13.89	
Entrenchment Ratio	1.5	1.5	1.5	1.49	
Bankfull Width (ft.)	23.61	23.63	23.57	23.75

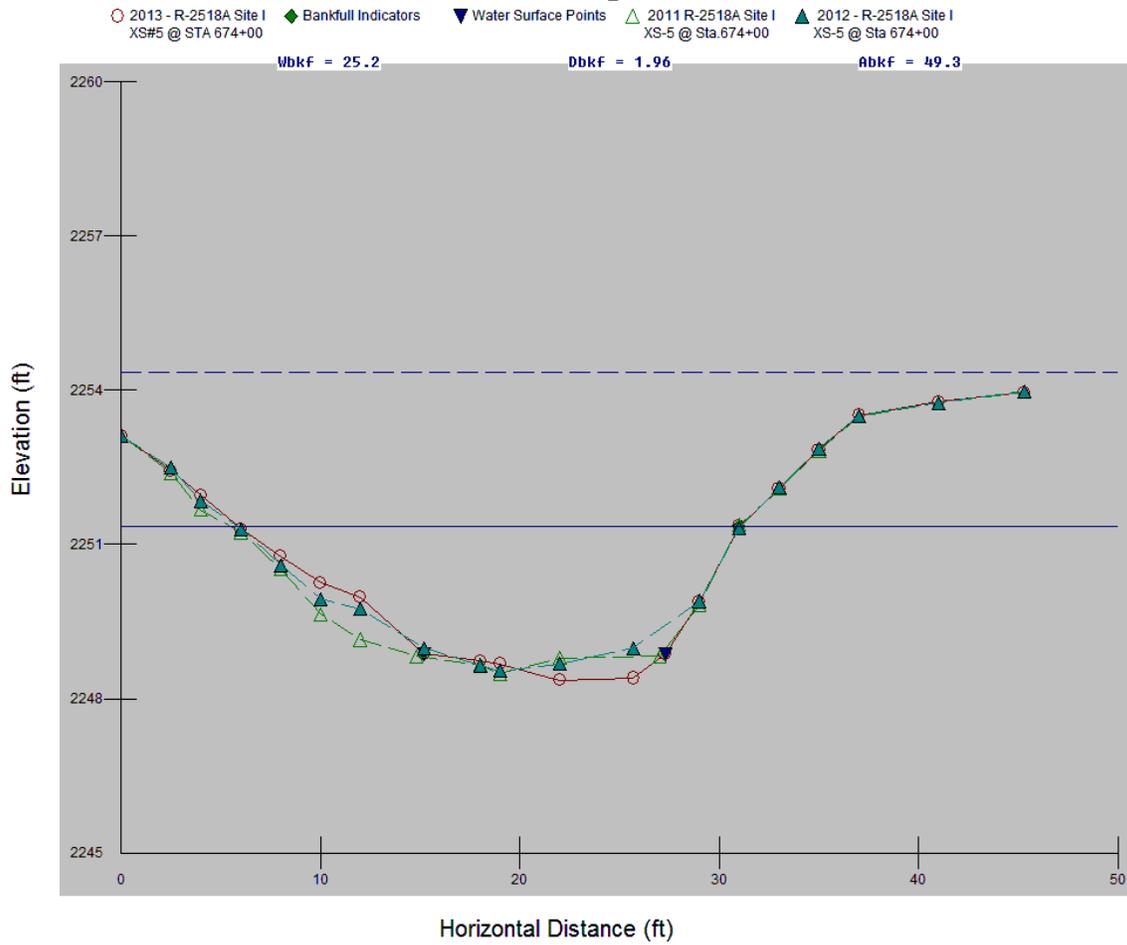
R-2518A Site I XS#5 @ STA 674+00

Site I: Cross-Section #5 (Riffle) Abbreviated Morphological Summary				
	2011	2012	2013	2014
Bankfull Cross Sectional Area (ft ²)	52.26	46.77	49.35	
Maximum Bankfull Depth (ft.)	2.89	2.78	2.99	
Width of the Floodprone Area (ft.)	45.3	45.3	45.3	
Bankfull Mean Depth (ft.)	2.04	1.87	1.96	
Width/Depth Ratio	12.57	13.41	12.83	
Entrenchment Ratio	1.77	1.81	1.8	
Bankfull Width (ft.)	25.64	25.07	25.15

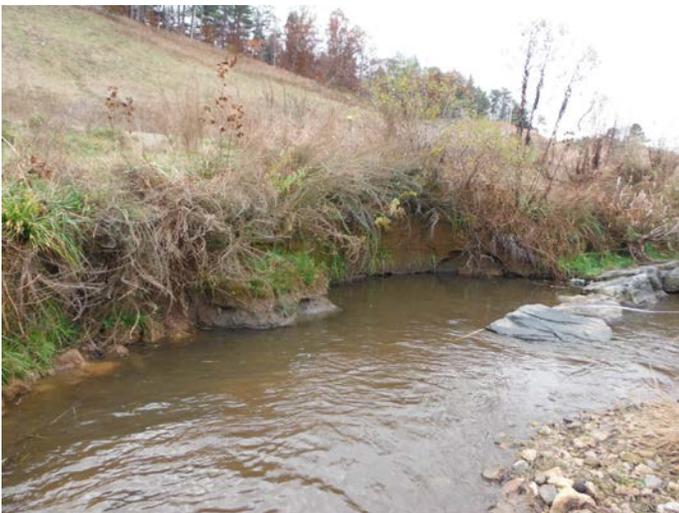
Left Bank Erosion Downstream of Photo Point#1
November 2013

The UT to Middle Fork Creek Site I Mitigation Site has not met the required monitoring protocols for the fourth formal year of monitoring on the stream but has met the required monitoring protocols for the second formal year of monitoring on the planted vegetation. NCDOT plans to repair the eroded banks by the Spring of 2014 and any disturbed areas from the repair work will be replanted. NCDOT will continue monitoring the Middle Fork Creek Site I Mitigation Site in 2014.

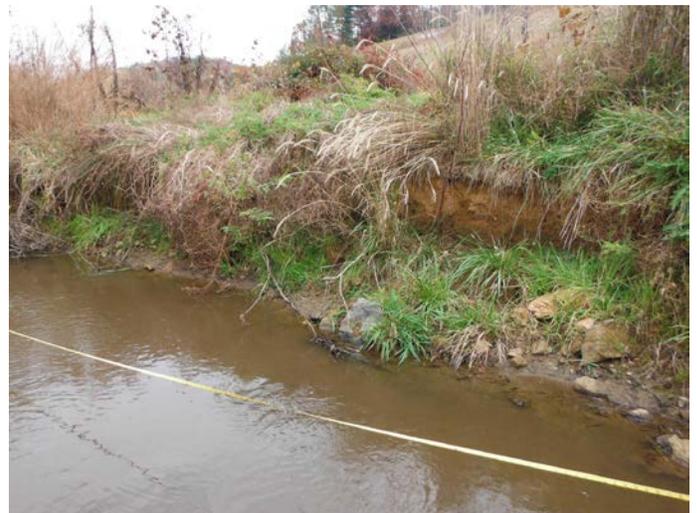
Left Bank Erosion Downstream of Photo Point #2

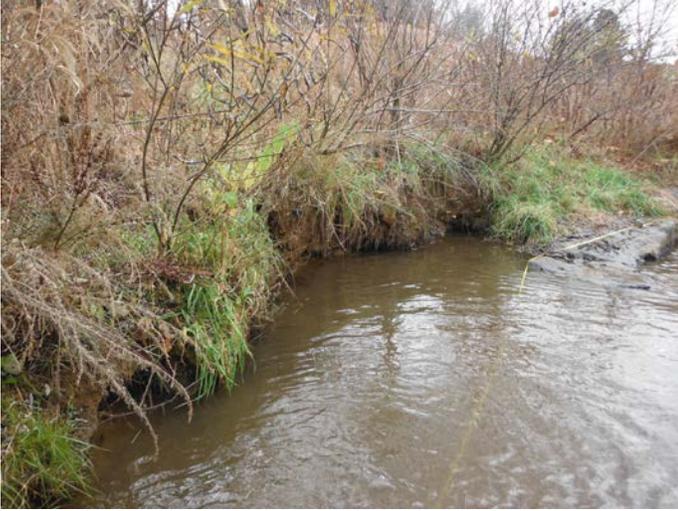
Left Bank Erosion downstream of PP#4
