# ANNUAL REPORT FOR 2014

**Turkey Branch Site J Mitigation Site  
Madison County  
TIP No. R-2518A  
COE Action ID: SAW-2007-2197-357/300  
DWR #: 20071134**

Prepared By:  
Natural Environment Section & Roadside Environmental Unit  
North Carolina Department of Transportation  
December 2014

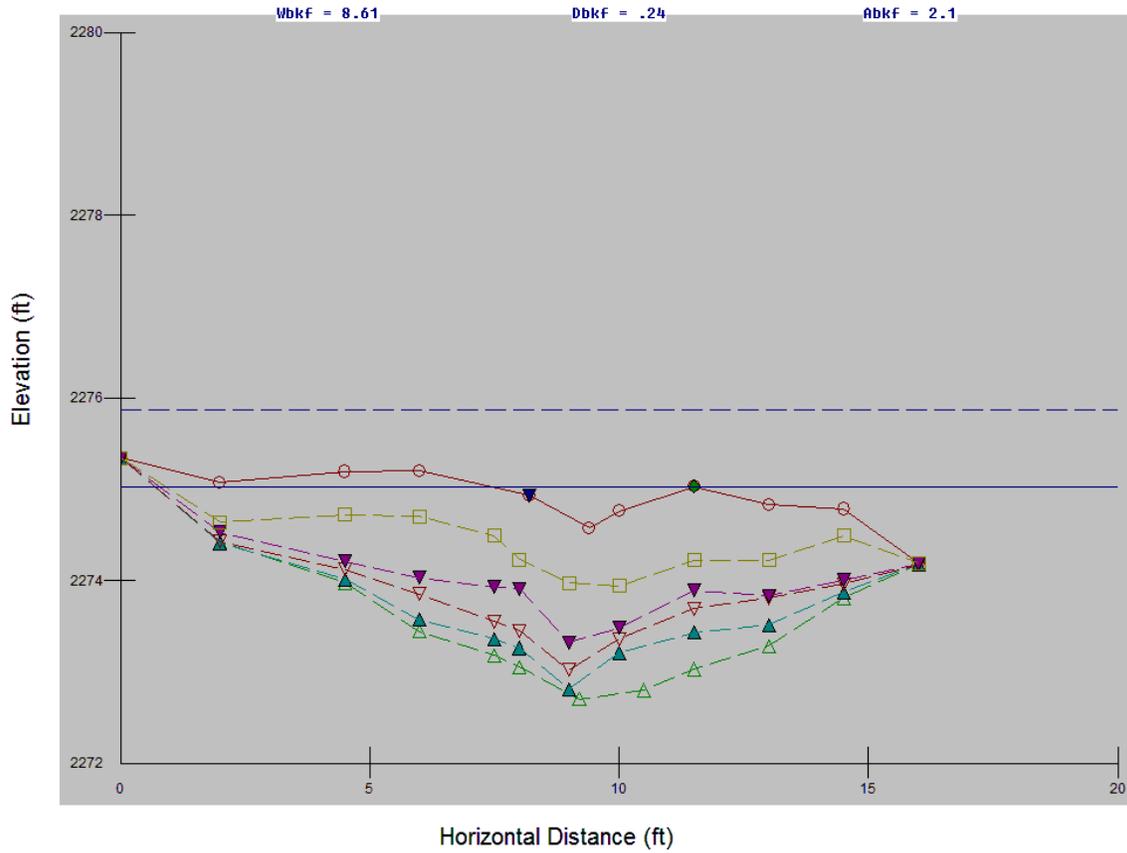
### R-2518A Site J XS#1 @ STA 53+07

Site J: Cross-Section #1 (Riffle) Abbreviated Morphological Summary					
	2010	2011	2012	2013	2014
Bankfull Cross Sectional Area (ft <sup>2</sup> )	5.84	1.35	1.07	0.6	0.8
Maximum Bankfull Depth (ft.)	1.2	0.67	0.57	0.28	0.84
Width of the Floodprone Area (ft.)	15.72	13.44	13.45	8.57	16
Bankfull Mean Depth (ft.)	0.55	0.29	0.31	0.17	0.19
Width/Depth Ratio	19.42	16.21	11.19	21.24	21.63
Entrenchment Ratio	1.47	2.86	3.88	2.37	3.89
Bankfull Width (ft.)	10.68	4.7	3.47	3.61	4.11

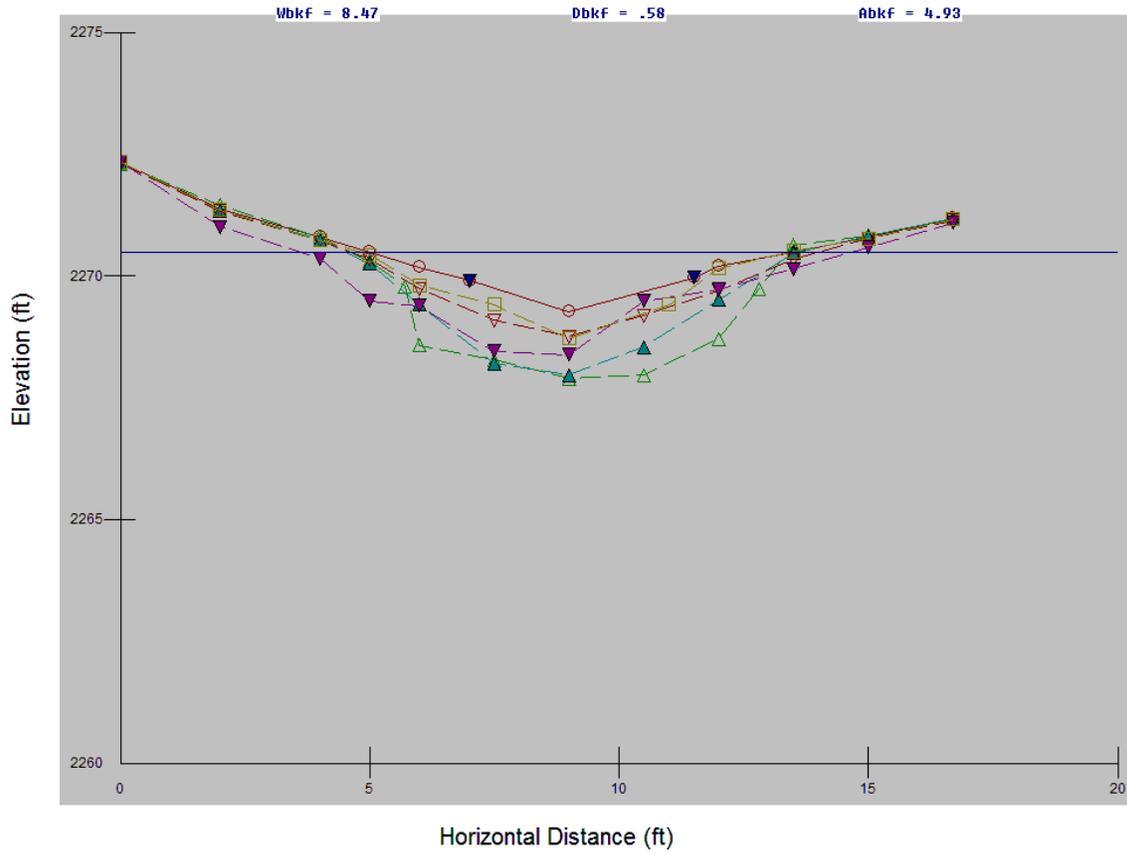
### R-2518A Site J XS#2 @ STA 297+00

Site J: Cross-Section #2 (Pool) Abbreviated Morphological Summary					
	2010	2011	2012	2013	2014
Bankfull Cross Sectional Area (ft <sup>2</sup> )	12.96	7.63	8.29	7.77	4.93
Maximum Bankfull Depth (ft.)	2.51	1.57	1.76	1.79	1.21
Bankfull Mean Depth (ft.)	1.45	0.9	0.9	0.89	0.58
Bankfull Width (ft.)	8.95	8.48	9.25	8.77	8.47

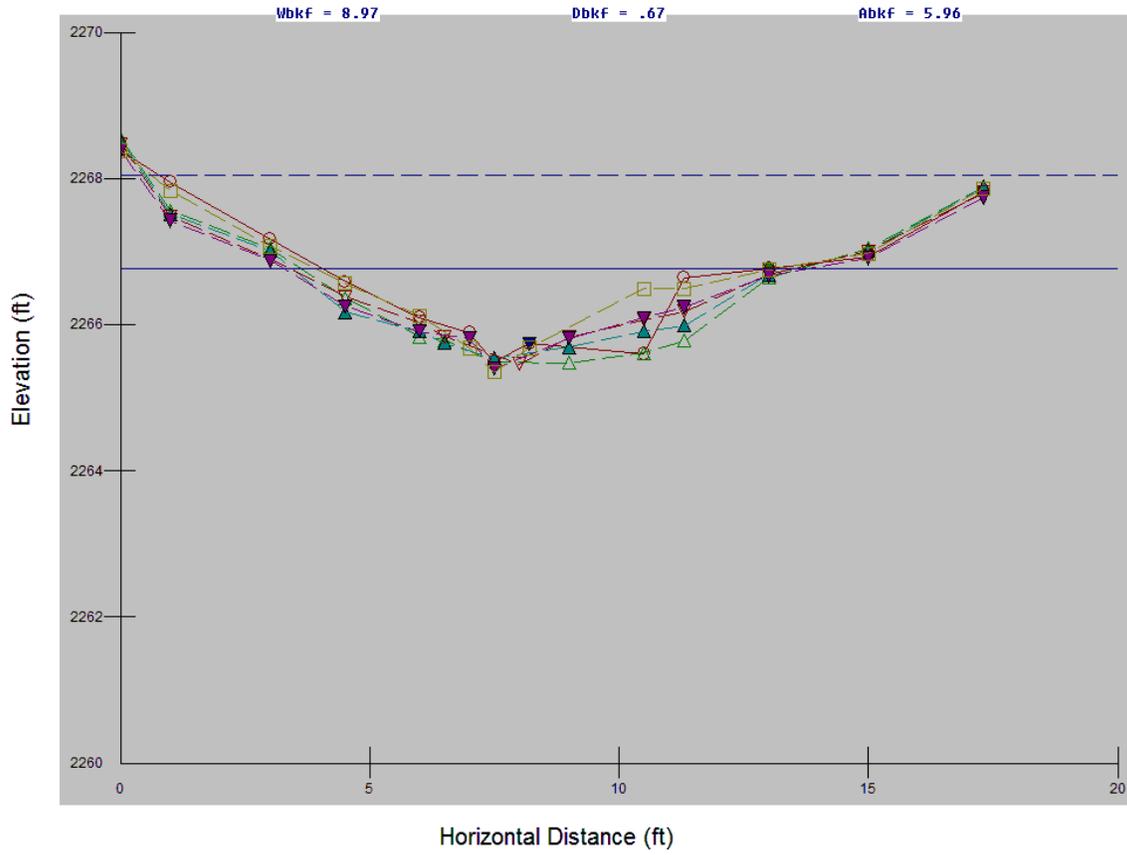
### R-2518A Site J XS#3 @ STA 567+00

Site J: Cross-Section #3 (Riffle) Abbreviated Morphological Summary					
	2010	2011	2012	2013	2014
Bankfull Cross Sectional Area (ft <sup>2</sup> )	6.74	5.84	5.89	4.96	5.96
Maximum Bankfull Depth (ft.)	1.14	1.23	1.27	1.4	1.28
Width of the Floodprone Area (ft.)	16.42	16.74	16.84	16.88	16.53
Bankfull Mean Depth (ft.)	0.72	0.62	0.62	0.55	0.67
Width/Depth Ratio	13.07	15.18	15.35	16.47	13.39
Entrenchment Ratio	1.75	1.78	1.77	1.86	1.84
Bankfull Width (ft.)	9.41	9.41	9.52	9.06	8.97

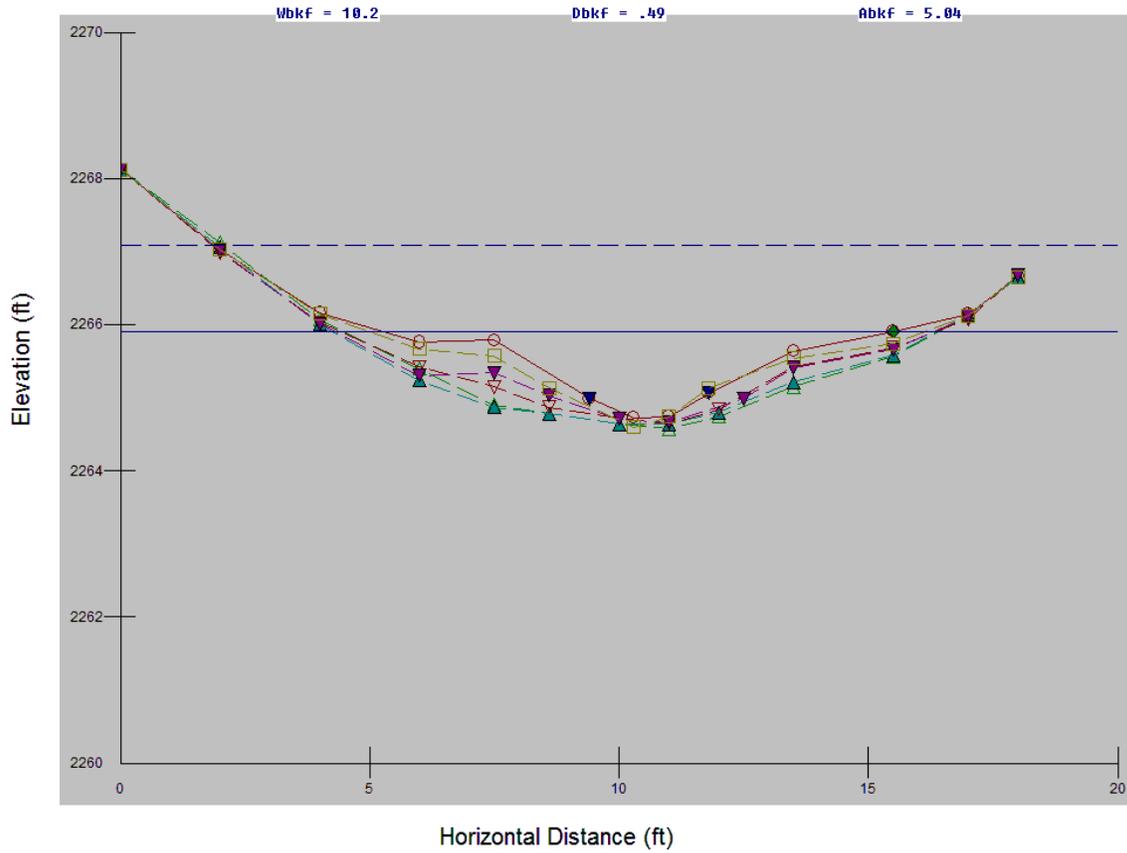
### R-2518A Site J XS#4 @ STA 737+00

Site J: Cross-Section #4 (Riffle) Abbreviated Morphological Summary					
	2010	2011	2012	2013	2014
Bankfull Cross Sectional Area (ft <sup>2</sup> )	6.02	3.37	5.26	4.39	5.04
Maximum Bankfull Depth (ft.)	0.94	0.77	1	1.14	1.18
Width of the Floodprone Area (ft.)	14.74	13.52	15.28	15.66	16.11
Bankfull Mean Depth (ft.)	0.58	0.45	0.5	0.45	0.49
Width/Depth Ratio	17.91	16.67	21.02	21.76	20.92
Entrenchment Ratio	1.42	1.8	1.45	1.6	1.57
Bankfull Width (ft.)	10.39	7.5	10.51	9.79	10.25

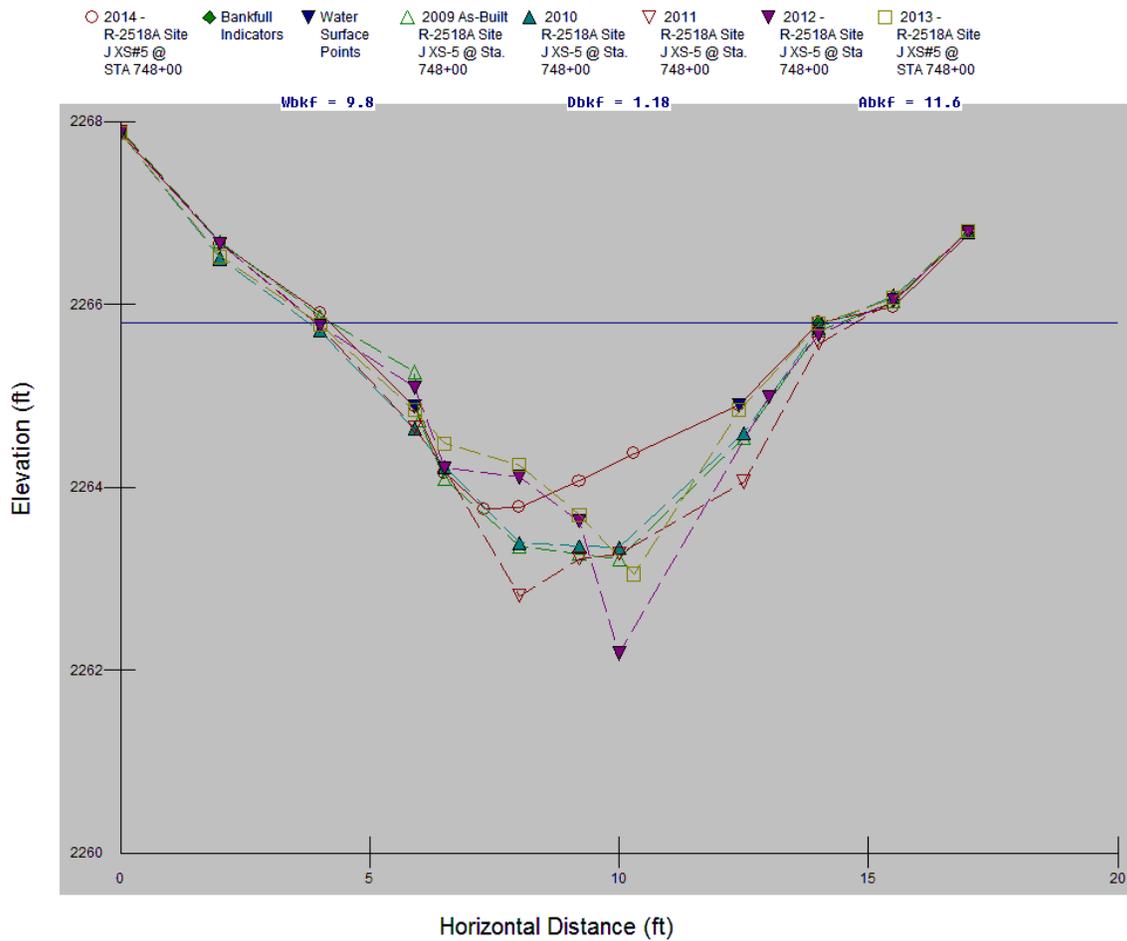
### R-2518A Site J XS#5 @ STA 748+00

Site J: Cross-Section #5 (Pool) Abbreviated Morphological Summary					
	2010	2011	2012	2013	2014
Bankfull Cross Sectional Area (ft <sup>2</sup> )	14.82	15.33	14.33	13.21	11.6
Maximum Bankfull Depth (ft.)	2.4	2.76	3.49	2.74	2.04
Bankfull Mean Depth (ft.)	1.47	1.58	1.47	1.32	1.18
Bankfull Width (ft.)	10.08	9.67	9.72	10.03	9.8

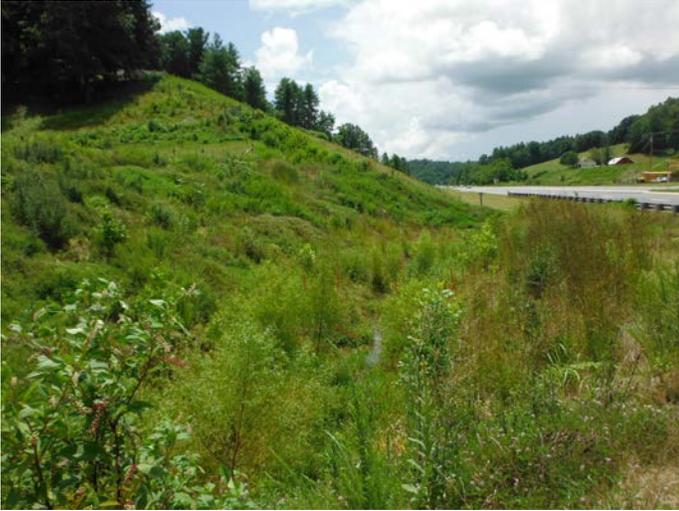
**Streambank & Buffer Vegetation:** The streambank reforestation was completed in March 2012. The Year 3 vegetation monitoring evaluation noted: Type I: Black Willow, Silky Dogwood and Type II: Sycamore, Green Ash, Tulip Poplar and White Oak were surviving at the time of the monitoring evaluation. The powerline easement was noted during the 2014 monitoring evaluation as having been sprayed.

Vegetation Overview Photo (Looking Downstream)

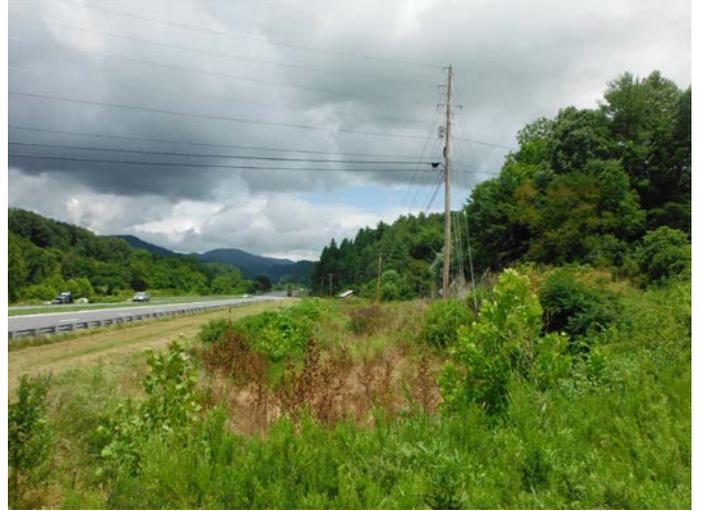
Vegetation Overview Photo (Looking Upstream)

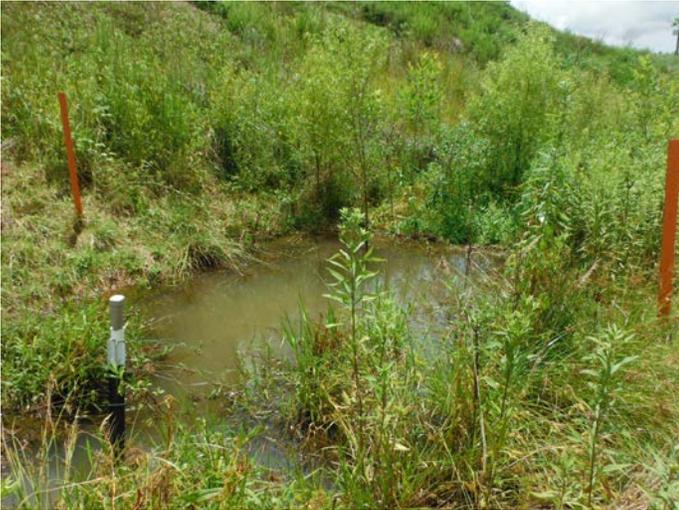
Beaver dam downstream of Cross Section #5
