ANNUAL REPORT FOR 2014

Bald Creek Site #1 Mitigation Site
Yancey County
TIP No. R-2518B
COE Action ID: SAW-2007-2197-357/300
DWR #: 20071134

Prepared By:
Natural Environment Section & Roadside Environmental Unit
North Carolina Department of Transportation
December 2014

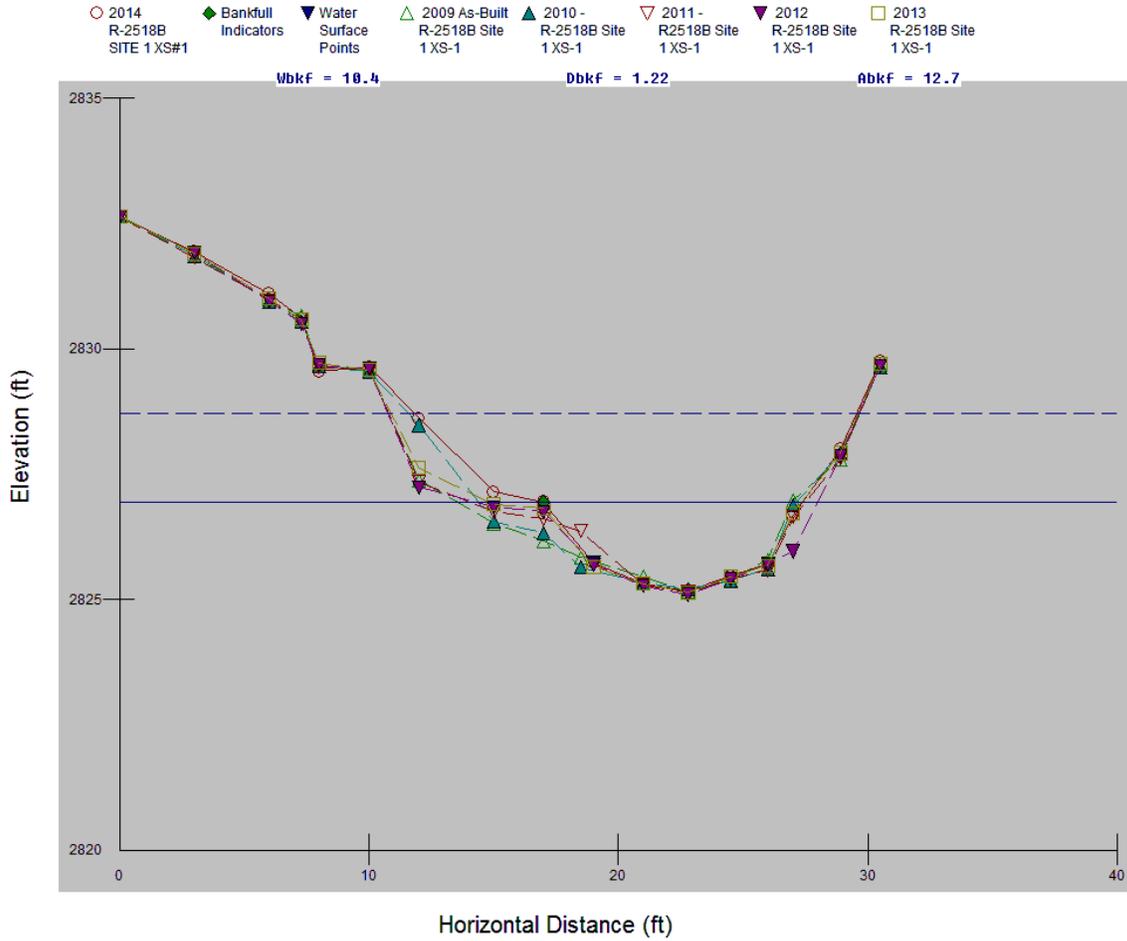
R-2518B SITE 1 XS#1

Site #1: Cross-Section #1 (Riffle) Abbreviated Morphological Summary					
	2010	2011	2012	2013	2014
Bankfull Cross Sectional Area (ft²)	14.15	9.39	11.96	11.83	12.7
Maximum Bankfull Depth (ft.)	1.67	1.49	1.65	1.68	1.78
Width of the Floodprone Area (ft.)	17.62	17.88	18.36	18.32	17.77
Bankfull Mean Depth (ft.)	1.13	0.9	1.11	1.17	1.22
Width/Depth Ratio	11.07	11.59	9.72	8.67	8.5
Entrenchment Ratio	1.41	1.71	1.7	1.81	1.71
Bankfull Width (ft.)	12.51	10.43	10.79	10.14	10.37

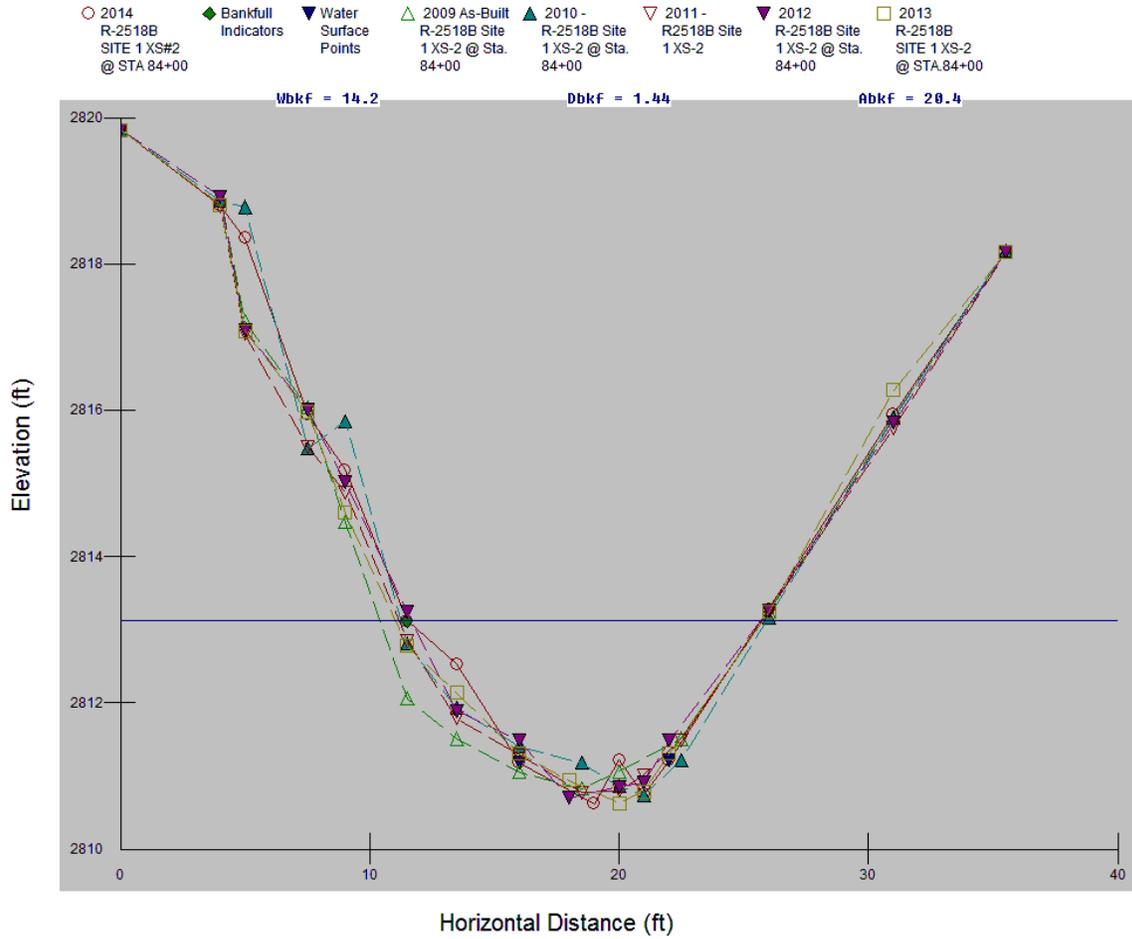
R-2518B SITE 1 XS#2 @ STA 84+00

Site #1: Cross-Section #2 (Pool) Abbreviated Morphological Summary					
	2010	2011	2012	2013	2014
Bankfull Cross Sectional Area (ft²)	17.28	18.19	22.35	16.62	20.41
Maximum Bankfull Depth (ft.)	2.07	2.08	2.54	2.15	2.5
Bankfull Mean Depth (ft.)	1.25	1.33	1.55	1.23	1.44
Bankfull Width (ft.)	13.86	13.7	14.46	13.55	14.19

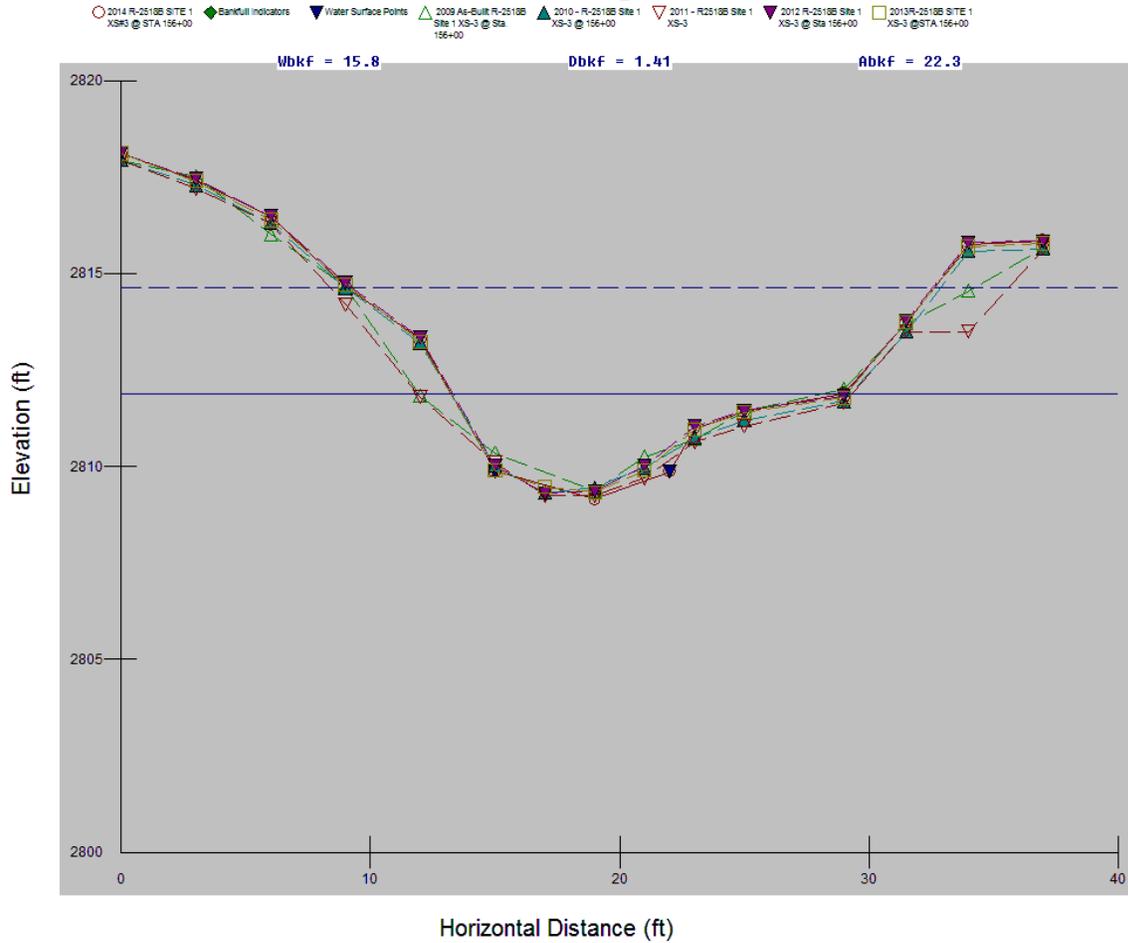
R-2518B SITE 1 XS#3 @ STA 156+00

Site #1: Cross-Section #3 (Riffle) Abbreviated Morphological Summary					
	2010	2011	2012	2013	2014
Bankfull Cross Sectional Area (ft ²)	19.03	20.99	19.61	19.46	22.3
Maximum Bankfull Depth (ft.)	2.37	2.4	2.53	2.44	2.74
Width of the Floodprone Area (ft.)	21.98	25.58	22.36	22.09	23.58
Bankfull Mean Depth (ft.)	1.22	1.25	1.25	1.24	1.41
Width/Depth Ratio	12.77	13.39	12.5	12.65	11.18
Entrenchment Ratio	1.41	1.53	1.43	1.41	1.5
Bankfull Width (ft.)	15.58	16.74	15.63	15.69	15.77

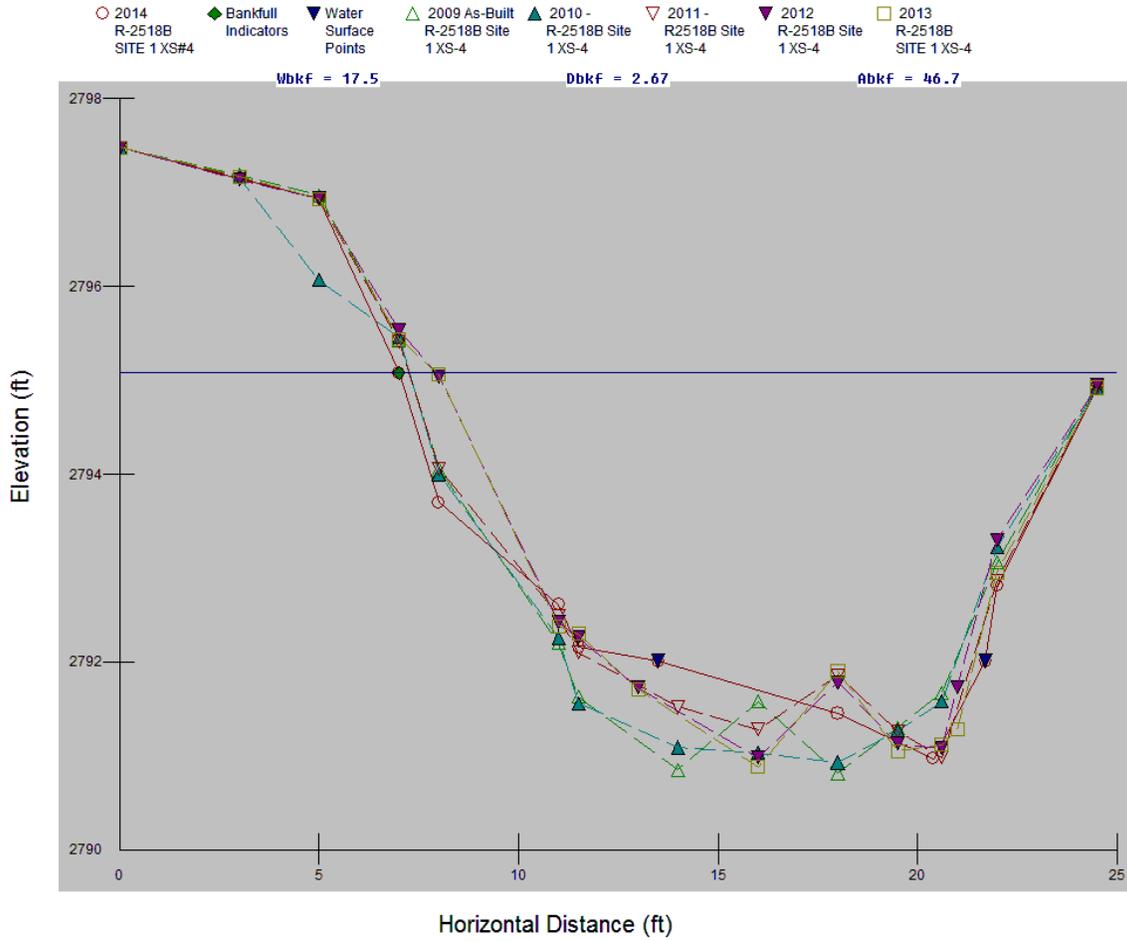
R-2518B SITE 1 XS#4

Site #1: Cross-Section #4 (Pool) Abbreviated Morphological Summary					
	2010	2011	2012	2013	2014
Bankfull Cross Sectional Area (ft²)	32.13	30.18	44.19	45.65	46.67
Maximum Bankfull Depth (ft.)	3.07	3.08	4.06	4.18	4.11
Bankfull Mean Depth (ft.)	2.12	1.92	2.68	2.77	2.67
Bankfull Width (ft.)	15.15	15.73	16.5	16.5	17.5

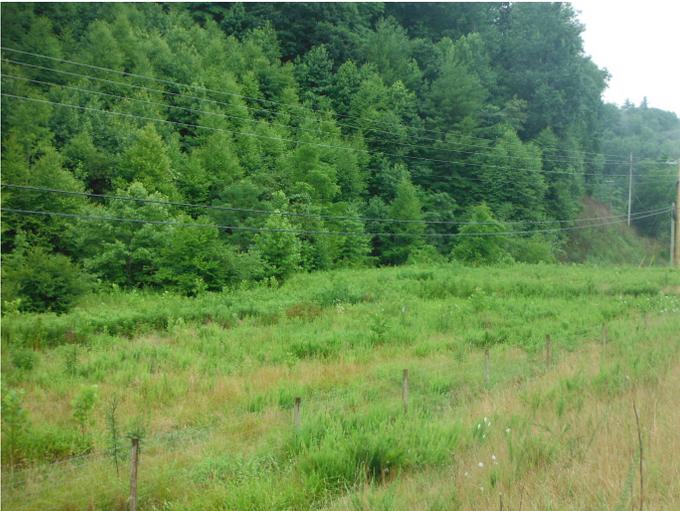
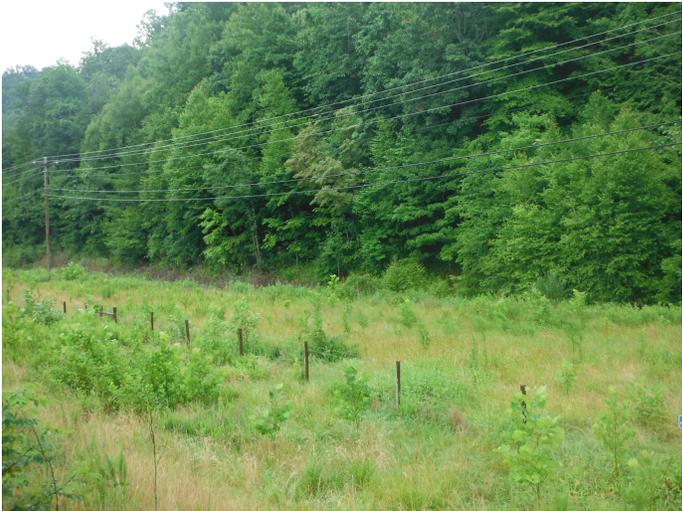
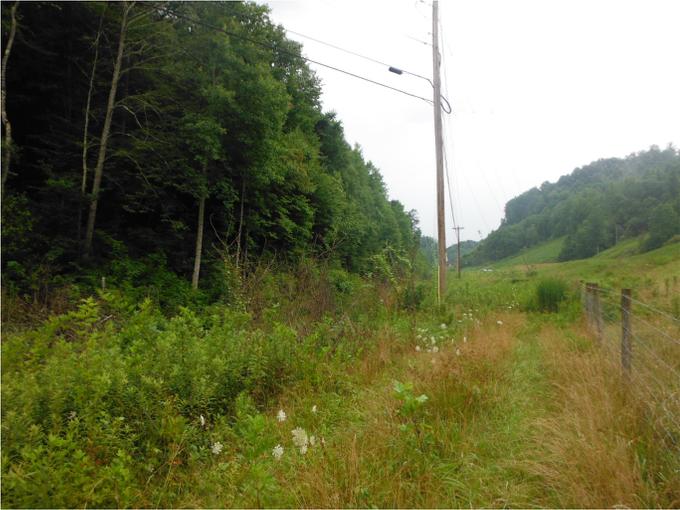
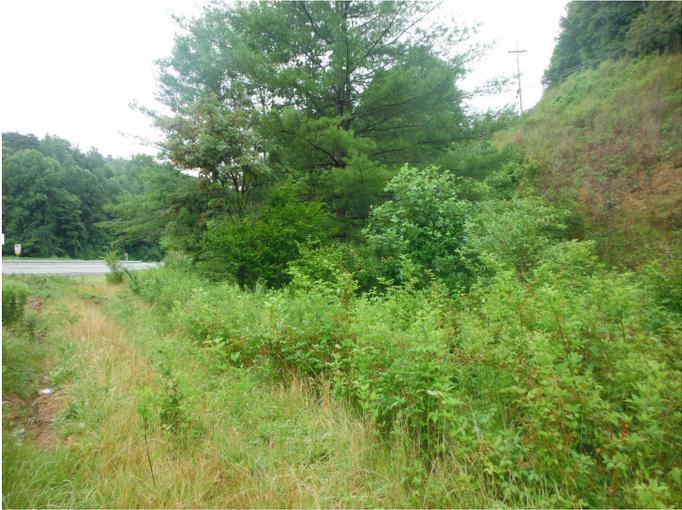
Streambank & Buffer Vegetation: The streambank reforestation was completed in March 2012. The Year 3 vegetation monitoring evaluation noted: Type II: Sycamore, Green Ash, Tulip Poplar and White Oak were surviving at the time of the monitoring evaluation. It was noted during the monitoring evaluation that the vegetation along the streambank and buffer within the power line easement had been cut and sprayed with an herbicide application.
