ANNUAL REPORT FOR 2013

Bald Creek Site #4 Mitigation Site
Yancey County
TIP No. R-2518B
COE Action ID: SAW-2007-2197-357/300
DWR #: 20071134

Prepared By:
Natural Environment Section & Roadside Environmental Unit
North Carolina Department of Transportation
December 2013

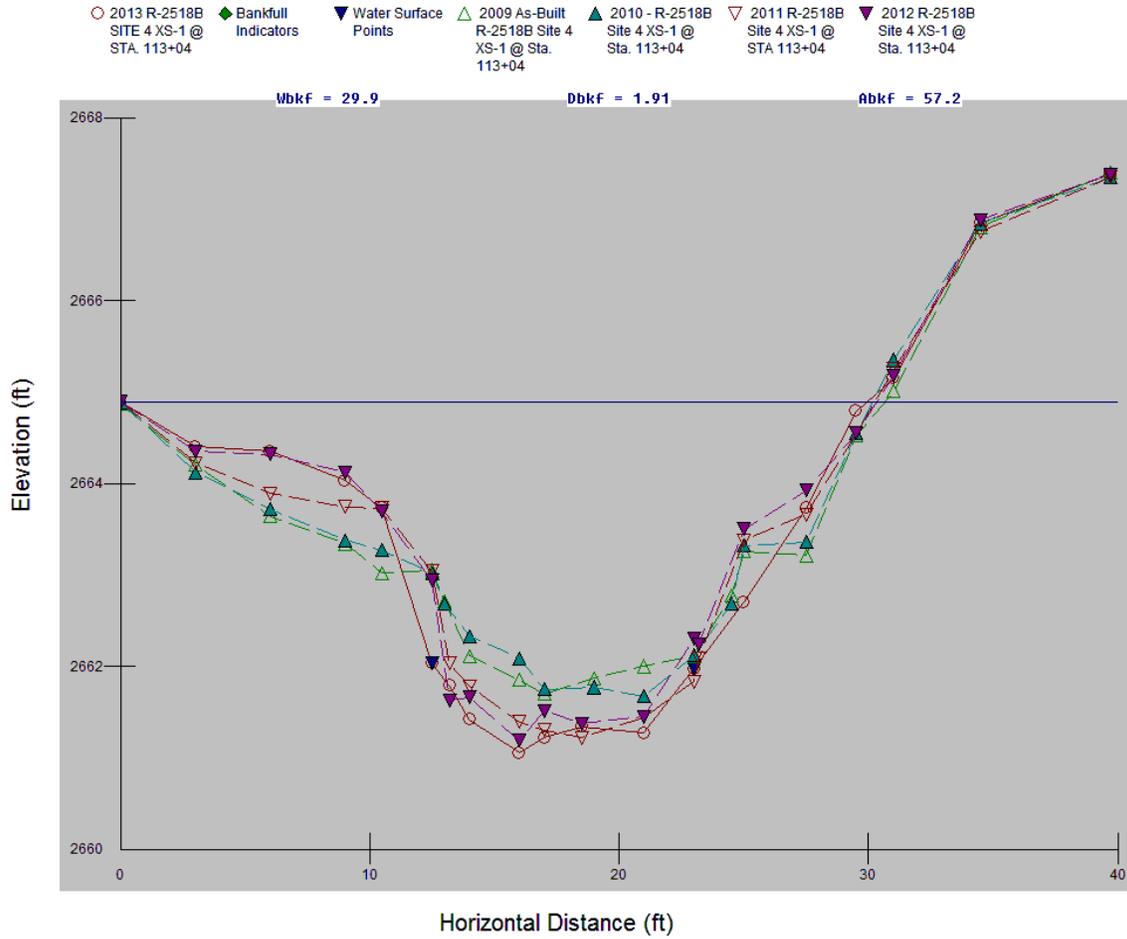
R-2518B SITE 4 XS-1 @ STA. 113+04

Based on comparisons of the As-Built data to monitoring data, all of the cross sections appear stable with little or no active bank erosion. Graphs of the cross sections are presented in Appendix A. Future survey data will vary depending on actual location of rod placement and alignment; however, this information should remain similar in appearance. The longitudinal profile showed that the channel was stable for the 2013 monitoring evaluation. Pebble counts were not required per the permit conditions and therefore were not completed. Multiple bankfull events were documented at Site 4 during the 2013 monitoring year.

Site #4: Cross-Section #1 (Pool) Abbreviated Morphological Summary*					
	2010	2011	2012	2013	2014
Bankfull Cross Sectional Area (ft ²)	54.78	56.12	52.46	57.19	
Maximum Bankfull Depth (ft.)	3.22	3.67	3.7	3.84	
Bankfull Mean Depth (ft.)	1.82	1.86	1.73	1.91	
Bankfull Width (ft.)	30.14	30.23	30.31	29.92

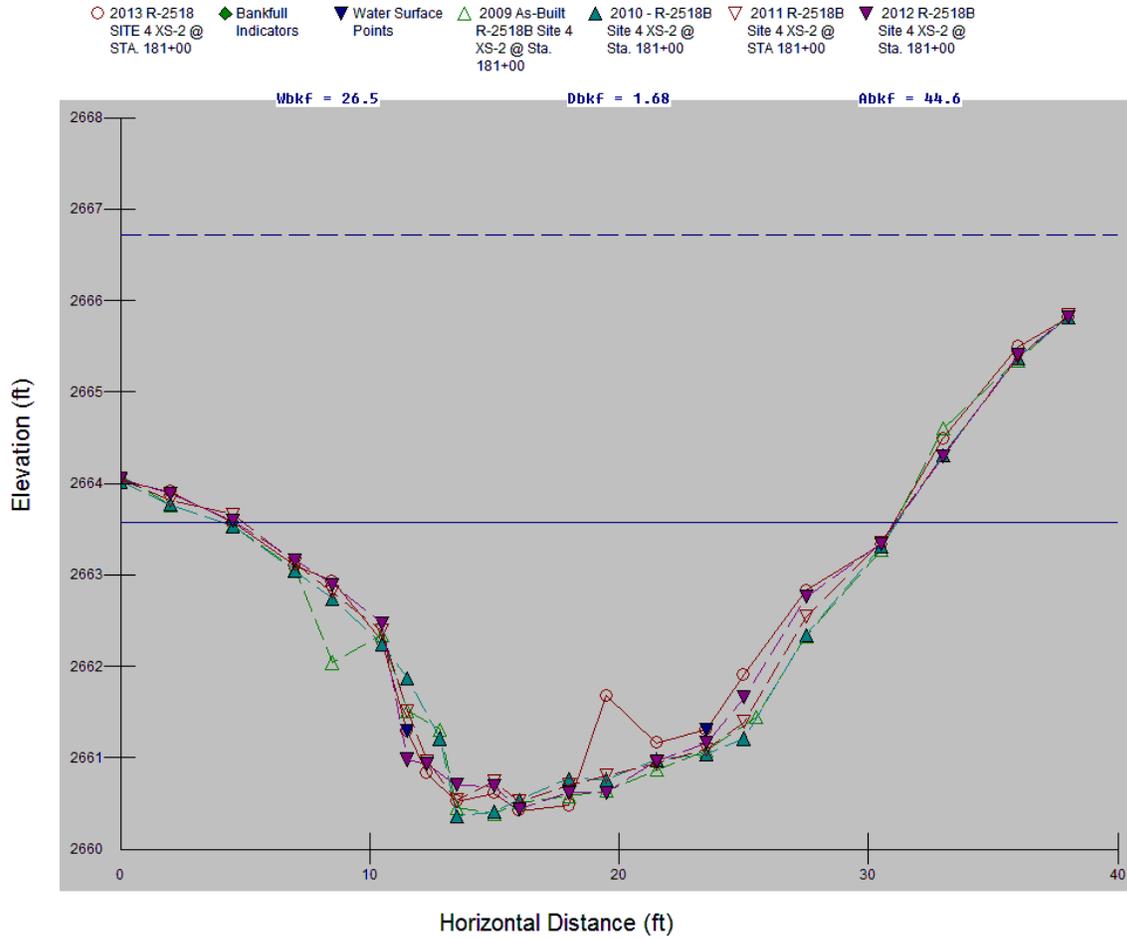
R-2518 SITE 4 XS-2 @ STA. 181+00

Site #4: Cross-Section #2 (Riffle) Abbreviated Morphological Summary					
	2010	2011	2012	2013	2014
Bankfull Cross Sectional Area (ft ²)	47.84	50.03	47.53	44.6	
Maximum Bankfull Depth (ft.)	3.17	3.14	3.15	3.15	
Width of the Floodprone Area (ft.)	38	38	38	36	
Bankfull Mean Depth (ft.)	1.8	1.87	1.78	1.68	
Width/Depth Ratio	14.75	14.34	14.98	15.79	
Entrenchment Ratio	1.43	1.42	1.43	1.36	
Bankfull Width (ft.)	26.55	26.82	26.66	26.52

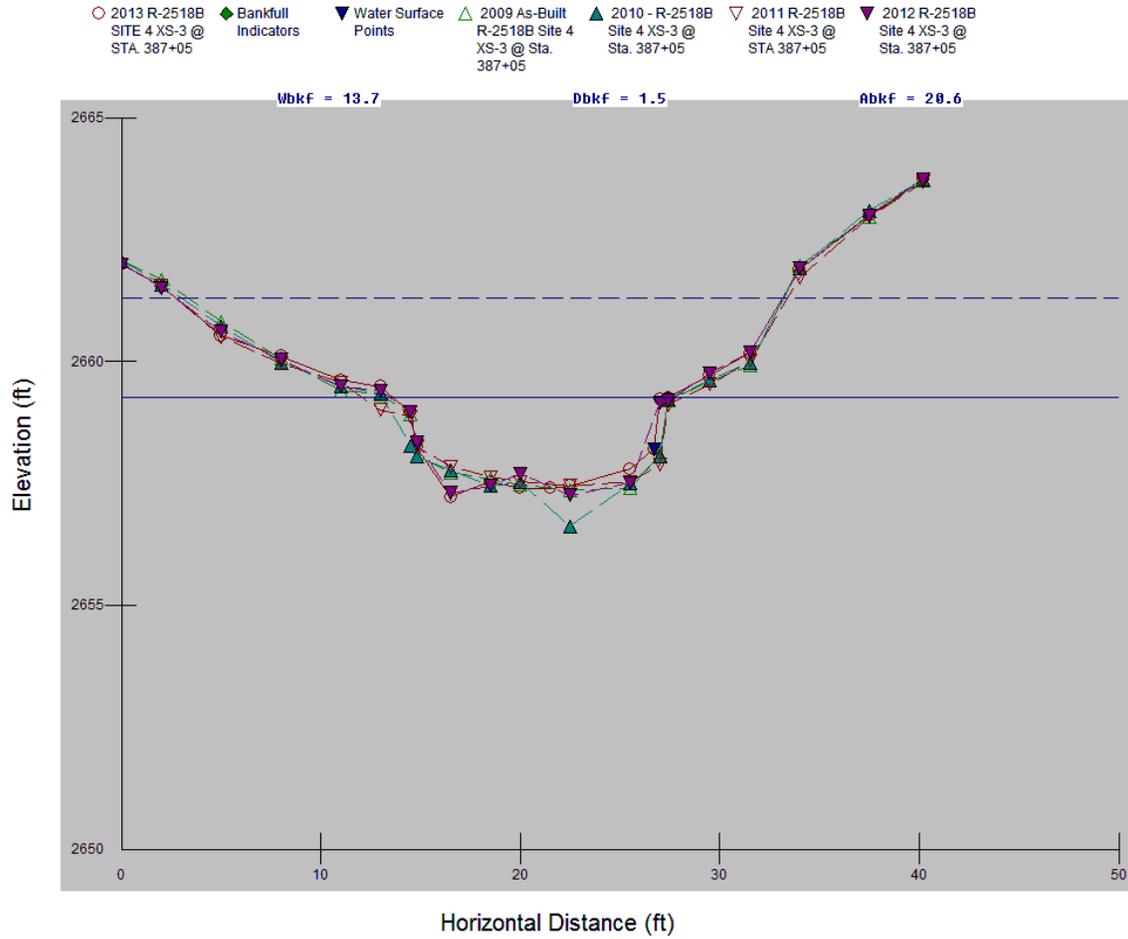
R-2518B SITE 4 XS-3 @ STA. 387+05

Site #4: Cross-Section #3 (Riffle) Abbreviated Morphological Summary					
	2010	2011	2012	2013	2014
Bankfull Cross Sectional Area (ft ²)	23.26	18.56	19.61	20.6	
Maximum Bankfull Depth (ft.)	2.6	1.66	1.93	2.04	
Width of the Floodprone Area (ft.)	32.87	28.38	29.56	30.43	
Bankfull Mean Depth (ft.)	1.63	1.26	1.43	1.5	
Width/Depth Ratio	8.73	11.74	9.57	9.17	
Entrenchment Ratio	2.31	1.92	2.16	2.21	
Bankfull Width (ft.)	14.23	14.79	13.68	13.75

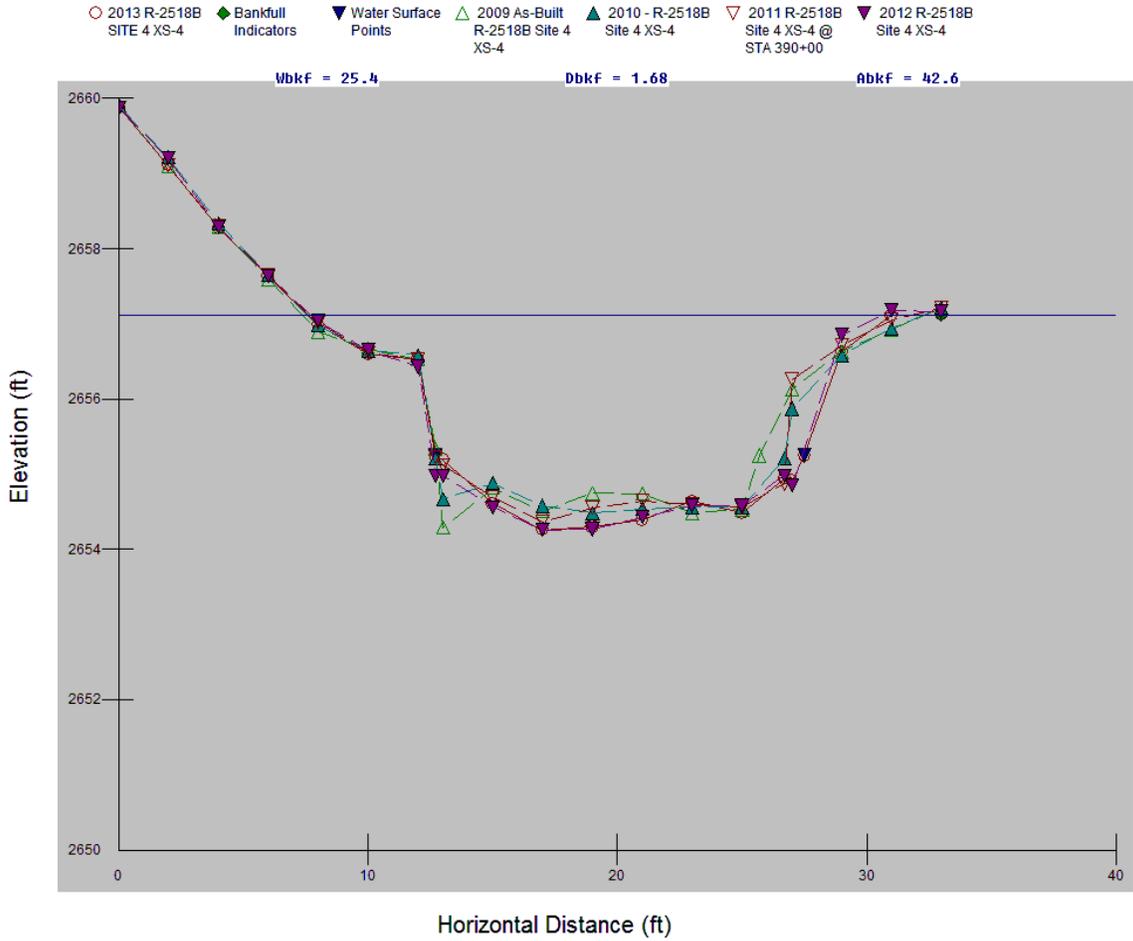
R-2518B SITE 4 XS-4

Site #4: Cross-Section #4 (Pool) Abbreviated Morphological Summary*					
	2010	2011	2012	2013	2014
Bankfull Cross Sectional Area (ft ²)	42.48	41.78	43.36	42.64	
Maximum Bankfull Depth (ft.)	2.73	2.84	2.9	2.86	
Bankfull Mean Depth (ft.)	1.65	1.63	1.86	1.68	
Bankfull Width (ft.)	25.69	25.6	23.29	25.41

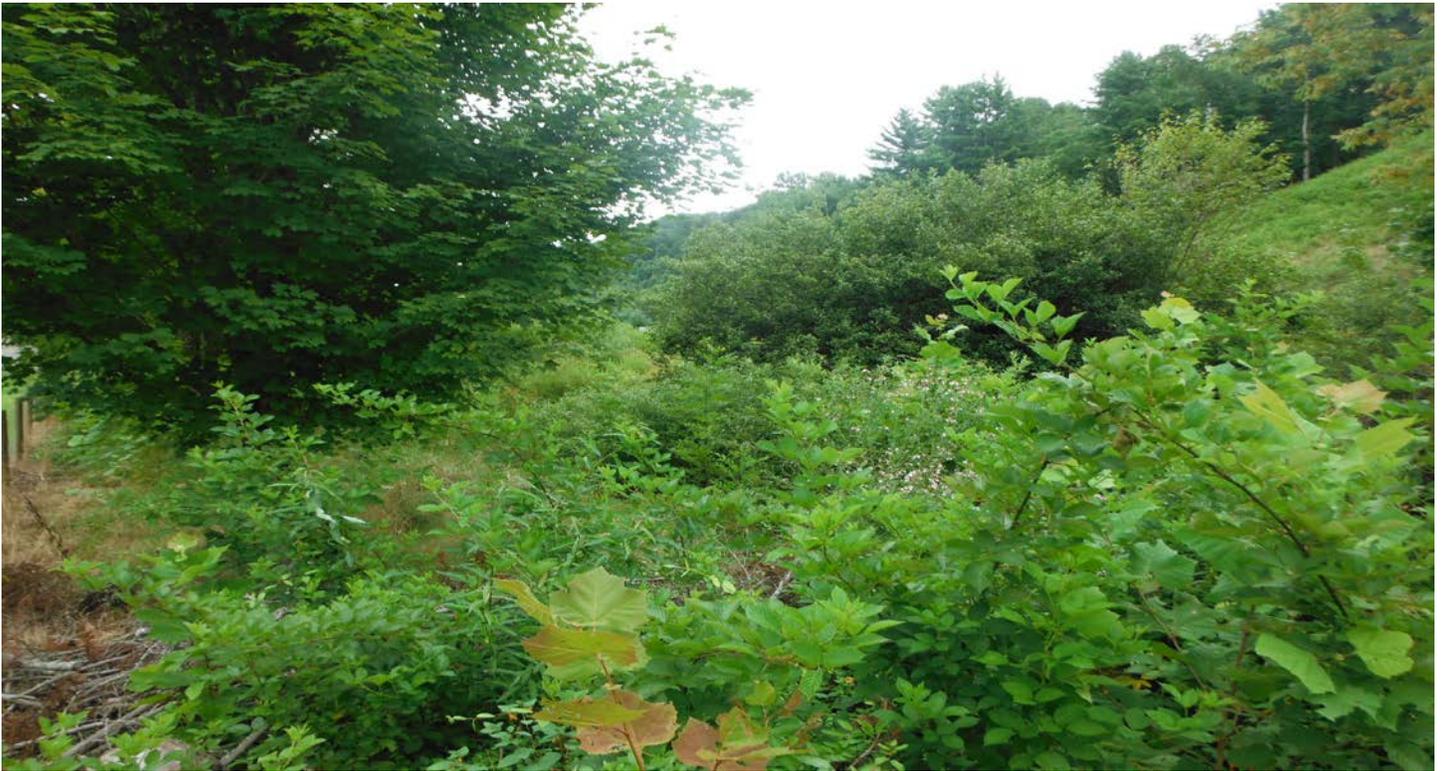
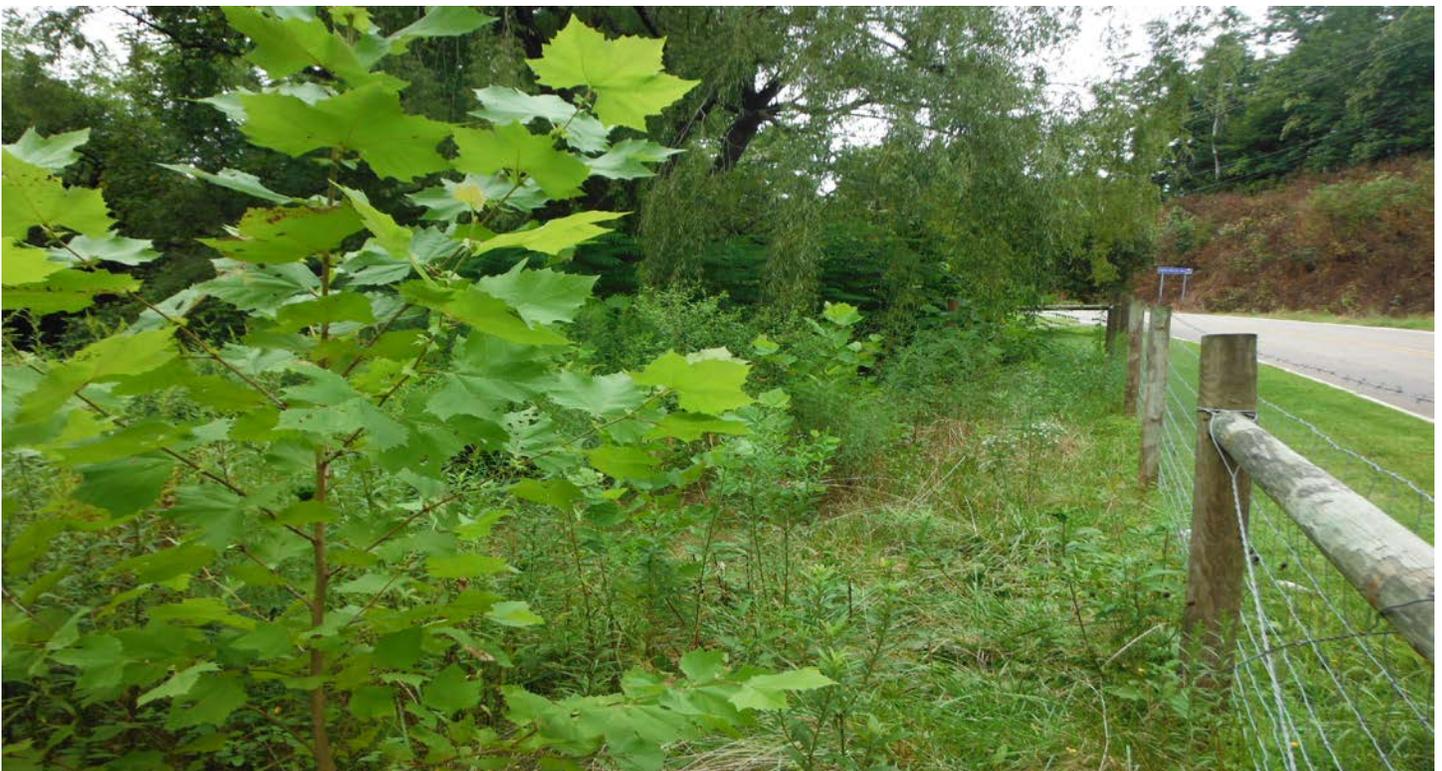
Vegetation Overview Photo

Streambank & Buffer Vegetation: The streambank reforestation was completed in March 2012. The Year 2 vegetation monitoring evaluation noted: Type I: Black Willow, Silky Dogwood and Type II: Sycamore, Green Ash, Tulip Poplar, and White Oak were surviving at the time of the monitoring evaluation.
