ANNUAL REPORT FOR 2015

Bald Creek Site #4 Mitigation Site
Yancey County
TIP No. R-2518B
COE Action ID: SAW-2007-2197-357/300
DWR #: 20071134

Prepared By:
Natural Environment Section & Roadside Environmental Unit
North Carolina Department of Transportation
November 2015

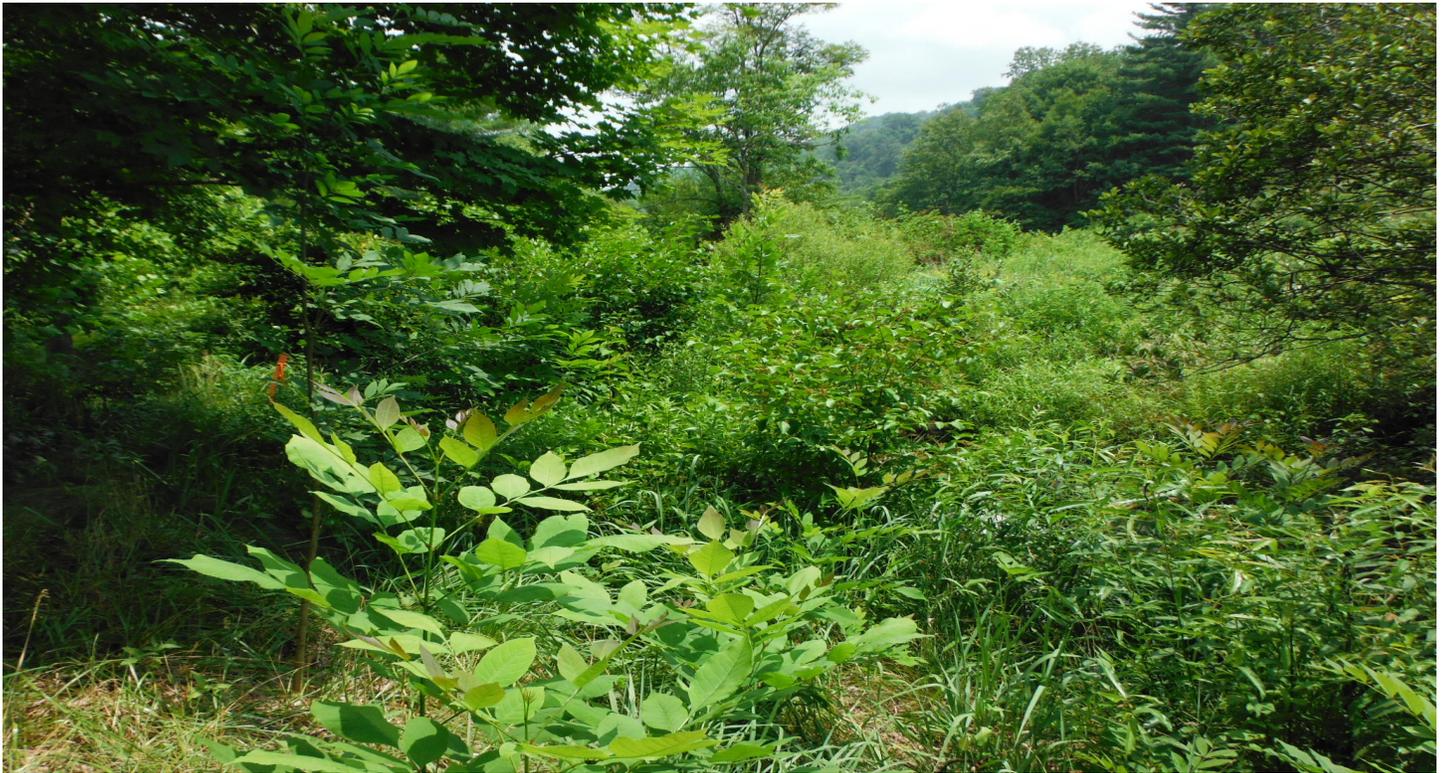
Vegetation Overview Photo

Streambank & Buffer Vegetation: The streambank reforestation was completed in March 2012. The Year 4 vegetation monitoring evaluation noted: Type I: Black Willow, Silky Dogwood and Type II: Sycamore, Green Ash, Tulip Poplar, and White Oak were surviving at the time of the monitoring evaluation.
