ANNUAL REPORT FOR 2012

Bald Creek Site #8 Mitigation Site
Yancey County
TIP No. R-2518B
COE Action ID: SAW-2007-2197-357/300
DWQ #: 20071134

Prepared By:
Natural Environment Section & Roadside Environmental Unit
North Carolina Department of Transportation
December 2012

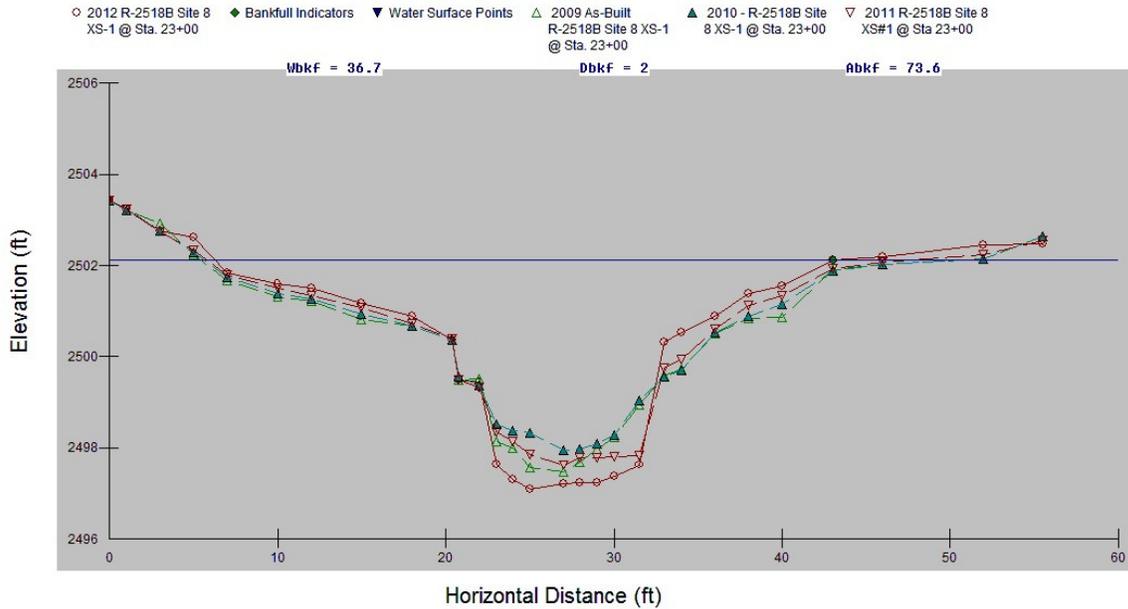
R-2518B Site 8 XS-1 @ Sta. 23+00

Site #8: Cross-Section #1 (Pool) Abbreviated Morphological Summary*					
	2010	2011	2012	2013	2014
Bankfull Cross Sectional Area (ft²)	63.37	66.88	73.56		
Maximum Bankfull Depth (ft.)	3.93	4.31	5.03		
Bankfull Mean Depth (ft.)	1.73	1.83	2		
Bankfull Width (ft.)	36.56	36.53	36.71

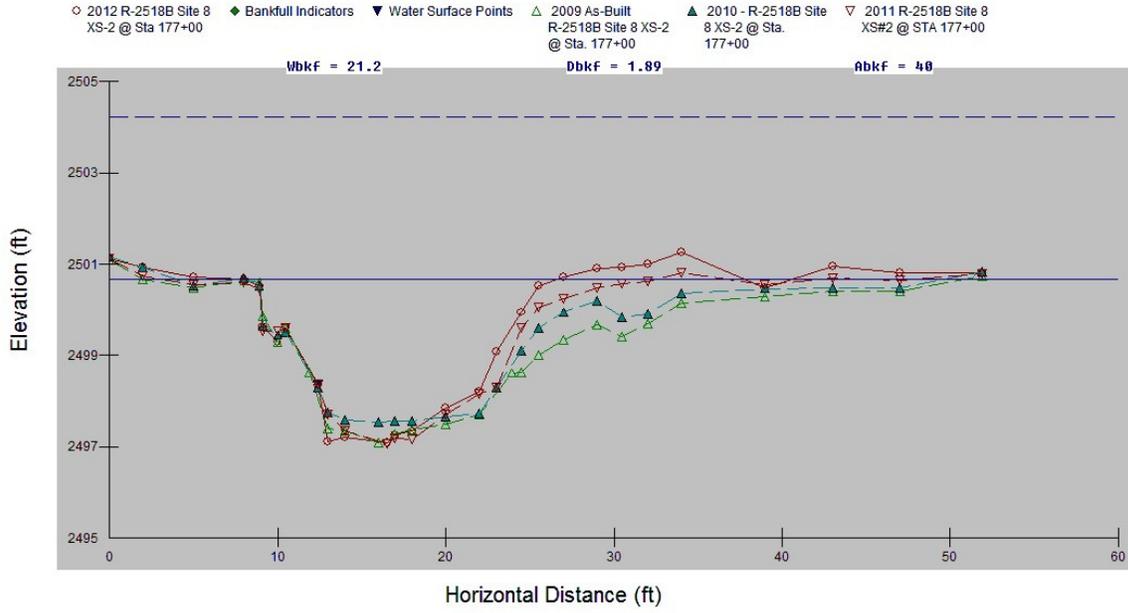
R-2518B Site 8 XS-2 @ Sta 177+00

Site #8: Cross-Section #2 (Riffle) Abbreviated Morphological Summary					
	2010	2011	2012	2013	2014
Bankfull Cross Sectional Area (ft. ²)	39.07	41.53	40.05		
Maximum Bankfull Depth (ft.)	2.81	3.54	3.57		
Width of the Floodprone Area (ft.)	51.9	51.9	51.9		
Bankfull Mean Depth (ft.)	1.56	1.79	1.89		
Width/Depth Ratio	16.06	12.99	11.2		
Entrenchment Ratio	2.07	2.23	2.45		
Bankfull Width (ft.)	25.06	23.25	21.16

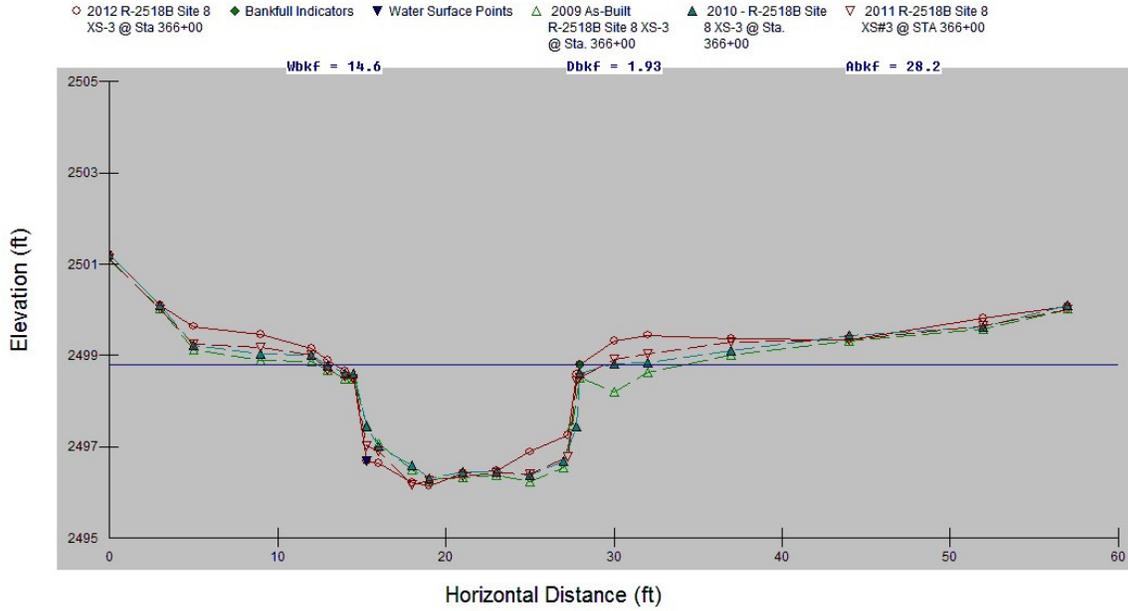
R-2518B Site 8 XS-3 @ Sta 366+00

Site #8: Cross-Section #3 (Pool) Abbreviated Morphological Summary*					
	2010	2011	2012	2013	2014
Bankfull Cross Sectional Area (ft²)	25.73	25.79	28.22		
Maximum Bankfull Depth (ft.)	2.28	2.36	2.64		
Bankfull Mean Depth (ft.)	1.91	1.86	1.93		
Bankfull Width (ft.)	13.5	13.9	14.58

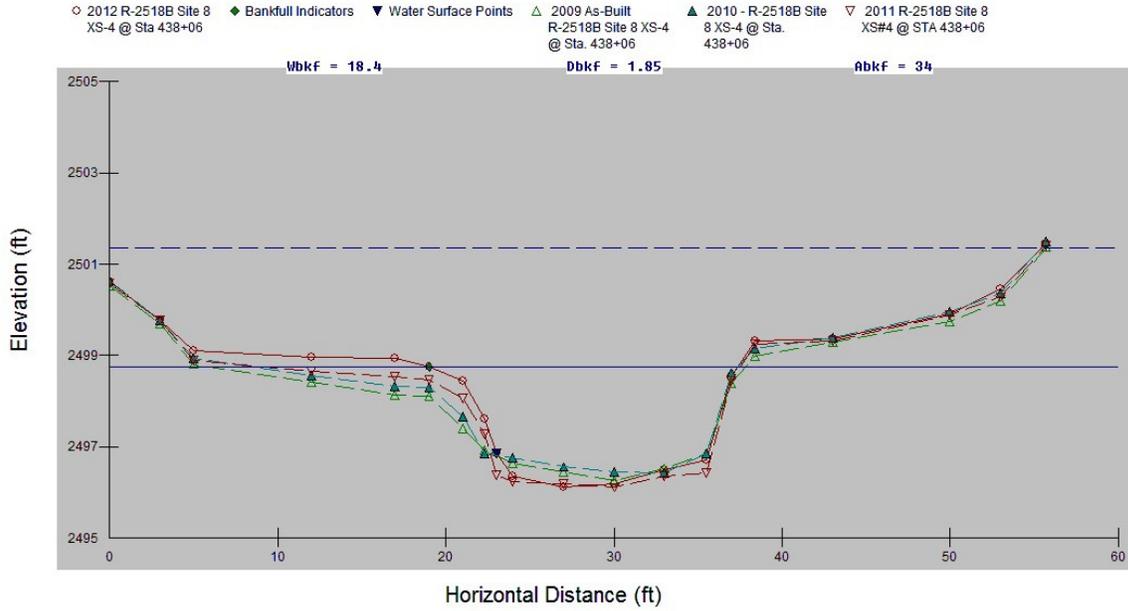
R-2518B Site 8 XS-4 @ Sta 438+06

Site #8: Cross-Section #4 (Riffle) Abbreviated Morphological Summary					
	2010	2011	2012	2013	2014
Bankfull Cross Sectional Area (ft ²)	25.58	31.87	33.97		
Maximum Bankfull Depth (ft.)	1.88	2.36	2.62		
Width of the Floodprone Area (ft.)	50.11	54.31	55.48		
Bankfull Mean Depth (ft.)	1.44	1.77	1.85		
Width/Depth Ratio	12.32	10.19	9.94		
Entrenchment Ratio	2.83	3.01	3.02		
Bankfull Width (ft.)	17.74	18.04	18.38

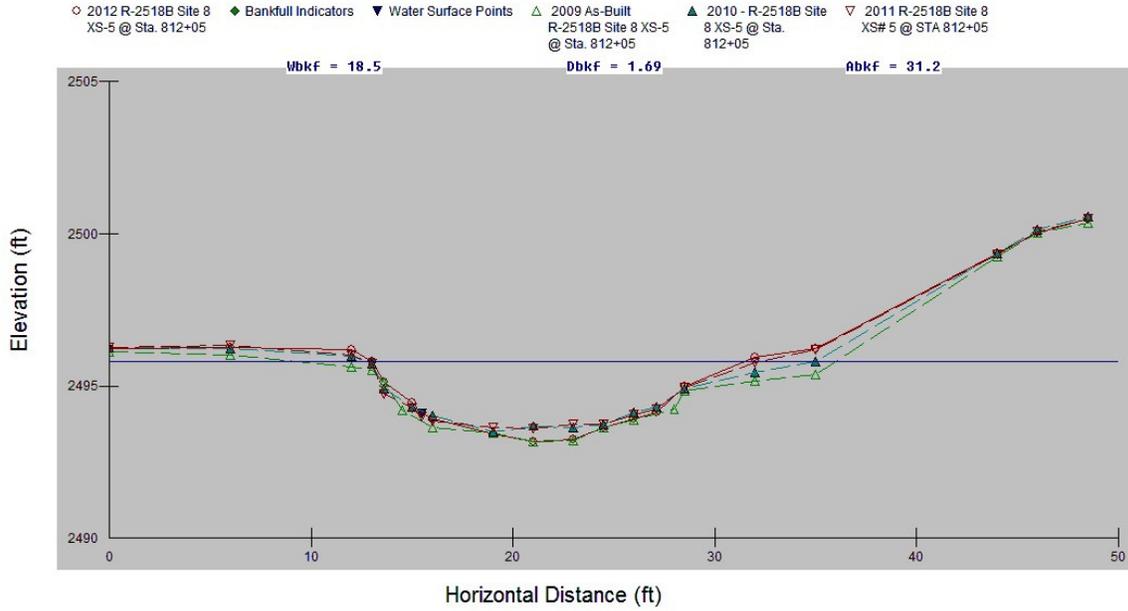
R-2518B Site 8 XS-5 @ Sta. 812+05

Site #8: Cross-Section #5 (Pool) Abbreviated Morphological Summary*					
	2010	2011	2012	2013	2014
Bankfull Cross Sectional Area (ft²)	29.34	28.13	31.18		
Maximum Bankfull Depth (ft.)	2.25	2.11	2.62		
Bankfull Mean Depth (ft.)	1.36	1.49	1.69		
Bankfull Width (ft.)	21.57	18.82	18.48

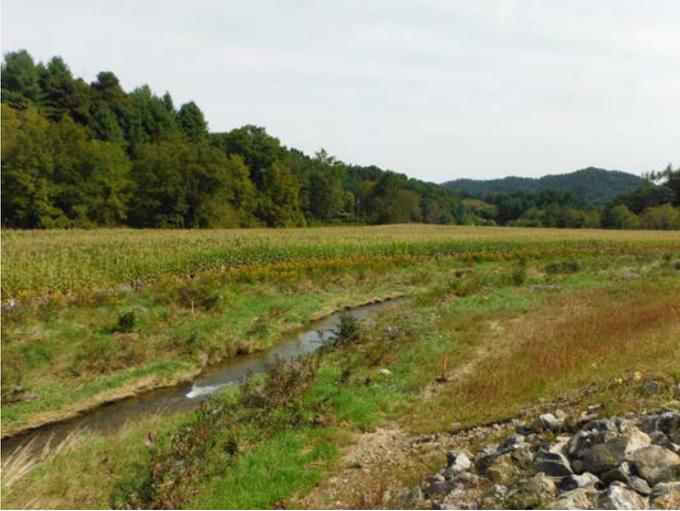
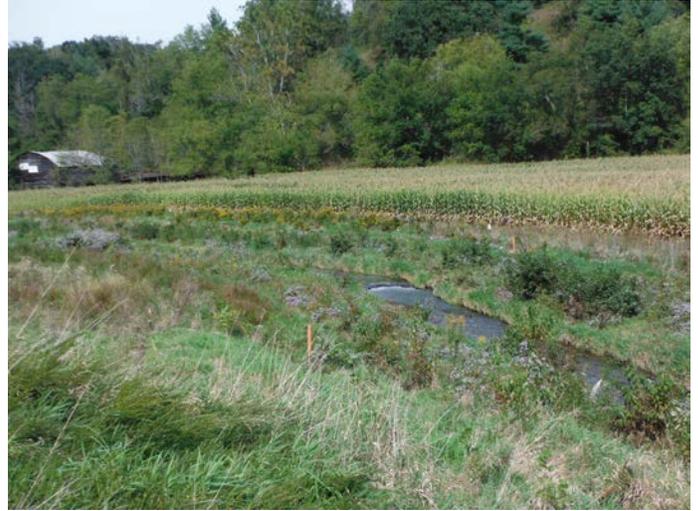
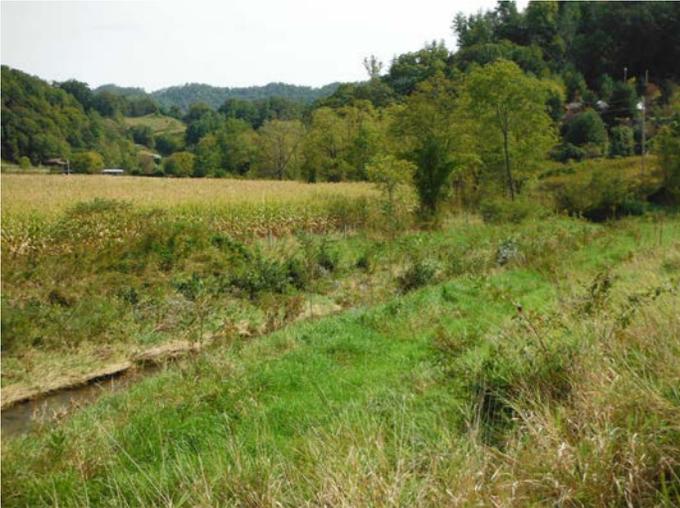
Vegetation Overview Photo

Streambank & Buffer Vegetation: The streambank reforestation was completed in March 2012. The Year 1 vegetation monitoring evaluation noted: Type I: Black Willow, Silky Dogwood and Type II: Sycamore, Green Ash, Tulip Poplar and White Oak were surviving at the time of the monitoring evaluation. There was missing planted vegetation from Sta. 10+00 to 11+00 along the right buffer where temporary erosion control devices had been removed.

NCDOT plans to complete a supplemental planting by March 2013 on the right buffer where temporary erosion control devices were removed. NCDOT will continue to monitor the planted vegetation in 2013.
