ANNUAL REPORT FOR 2015

Phipps Creek Site #11 Mitigation Site
Yancey County
TIP No. R-2518B
COE Action ID: SAW-2007-2197-357/300
DWR #: 20071134

Prepared By:
Natural Environment Section & Roadside Environmental Unit
North Carolina Department of Transportation
November 2015

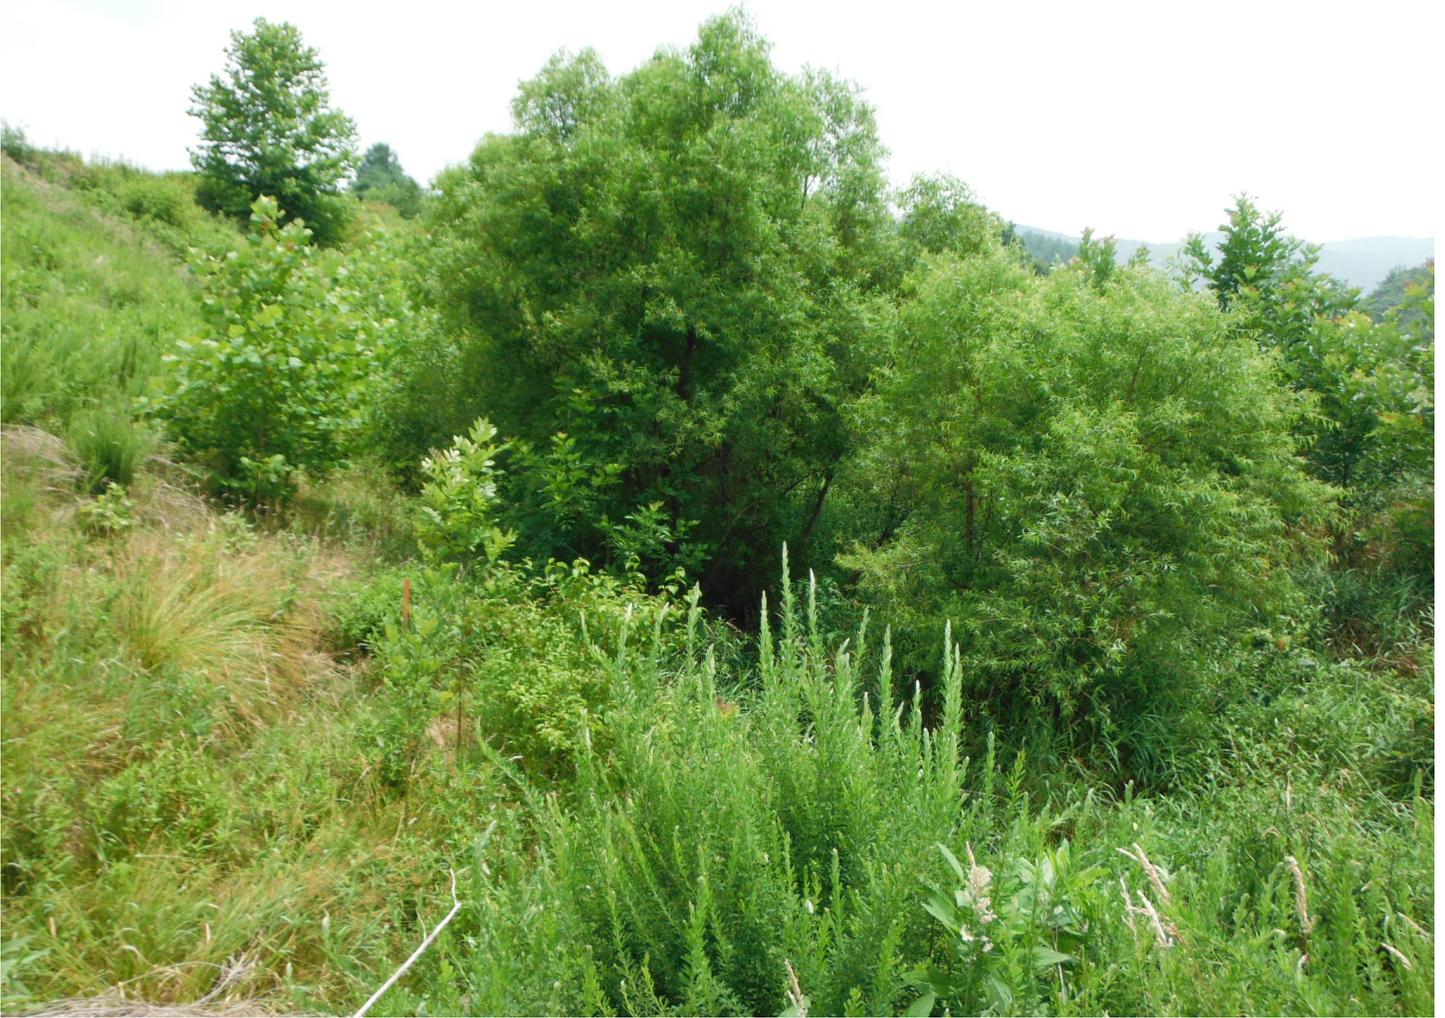
Vegetation Overview Photo

Streambank & Buffer Vegetation: The streambank reforestation was completed in March 2012. The Year 4 vegetation monitoring evaluation noted: Type I: Black Willow, Silky Dogwood and Type II: Sycamore, Green Ash, Tulip Poplar and White Oak were surviving at the time of the monitoring evaluation.
