ANNUAL REPORT FOR 2014

Phipps Creek Site #11 Mitigation Site
Yancey County
TIP No. R-2518B
COE Action ID: SAW-2007-2197-357/300
DWR #: 20071134

Prepared By:
Natural Environment Section & Roadside Environmental Unit
North Carolina Department of Transportation
December 2014

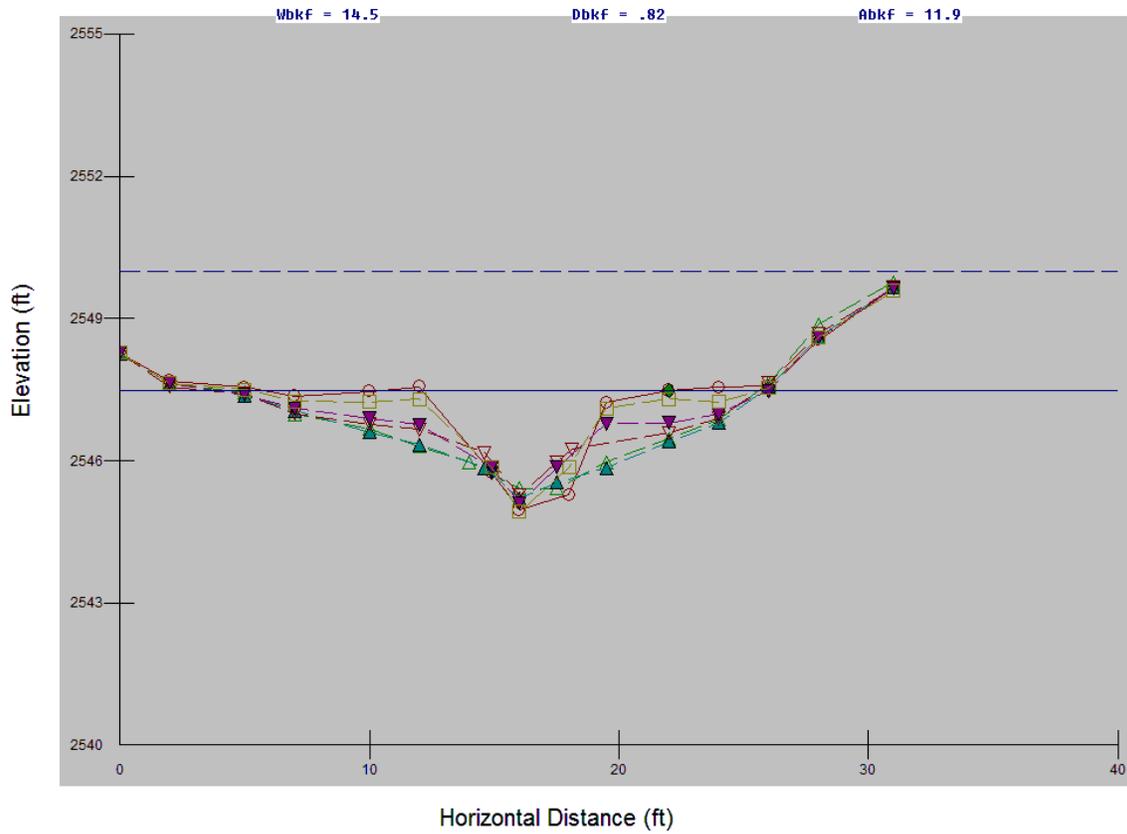
R-2518B SITE 11 XS#1 @ STA 153+05

Based on comparisons of the As-Built to the monitoring data, all of the cross sections appear stable with little or no active bank erosion. Graphs of the cross sections are presented in Appendix A. Future survey data will vary depending on actual location of rod placement and alignment; however, this information should remain similar in appearance.

Site #11: Cross-Section #1 (Riffle) Abbreviated Morphological Summary					
	2010	2011	2012	2013	2014
Bankfull Cross Sectional Area (ft. ²)	5.66	4.14	5.85	9.49	11.61
Maximum Bankfull Depth (ft.)	1.19	1.32	1.7	2.38	2.52
Width of the Floodprone Area (ft.)	23.7	25.52	27.84	31	31
Bankfull Mean Depth (ft.)	0.54	0.43	0.55	0.95	1.18
Width/Depth Ratio	19.37	22.42	19.31	10.53	8.36
Entrenchment Ratio	2.27	2.65	2.62	3.1	3.14
Bankfull Width (ft.)	10.46	9.64	10.62	10	9.87

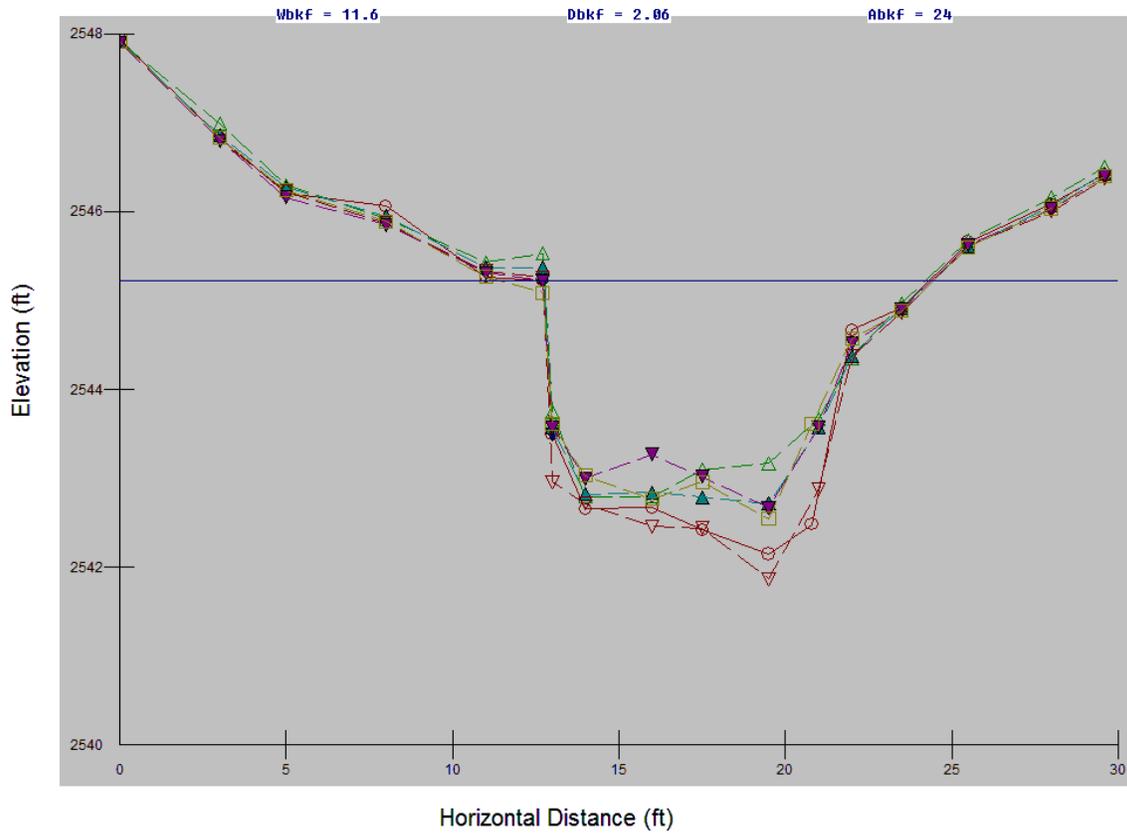
R-2518B SITE 11 XS#2 @ STA 221+05

Site #11: Cross-Section #2 (Pool) Abbreviated Morphological Summary*					
	2010	2011	2012	2013	2014
Bankfull Cross Sectional Area (ft.²)	22.69	26.91	19.43	18.79	24.01
Maximum Bankfull Depth (ft.)	2.65	3.39	2.55	2.54	3.08
Bankfull Mean Depth (ft.)	1.87	2.27	1.66	1.65	2.06
Bankfull Width (ft.)	12.1	11.84	11.68	11.36	11.64

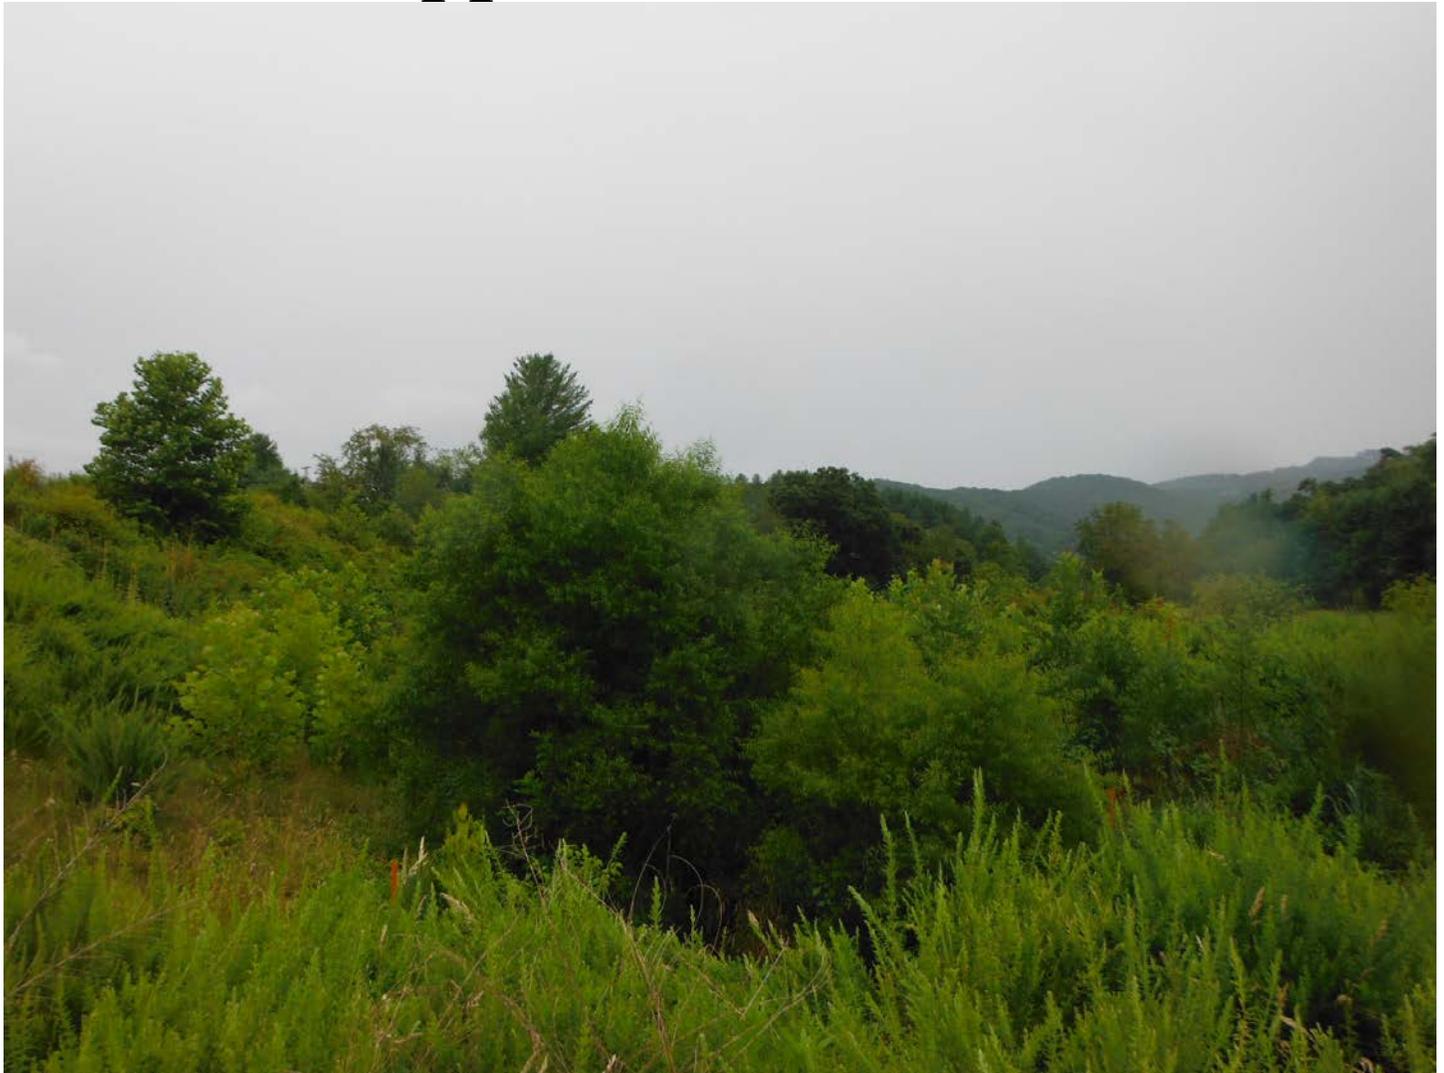
Vegetation Overview Photo

Streambank & Buffer Vegetation: The streambank reforestation was completed in March 2012. The Year 3 vegetation monitoring evaluation noted: Type I: Black Willow, Silky Dogwood and Type II: Sycamore, Green Ash, Tulip Poplar and White Oak were surviving at the time of the monitoring evaluation.
