ANNUAL REPORT FOR 2014

**UT to Bald Creek (Hydro Site) Permit Site #7
Mitigation Site
Yancey County
TIP No. R-2518B
COE Action ID: SAW-2007-2197-357/300
DWR #: 20071134**

Prepared By:
Natural Environment Section & Roadside Environmental Unit
North Carolina Department of Transportation
December 2014

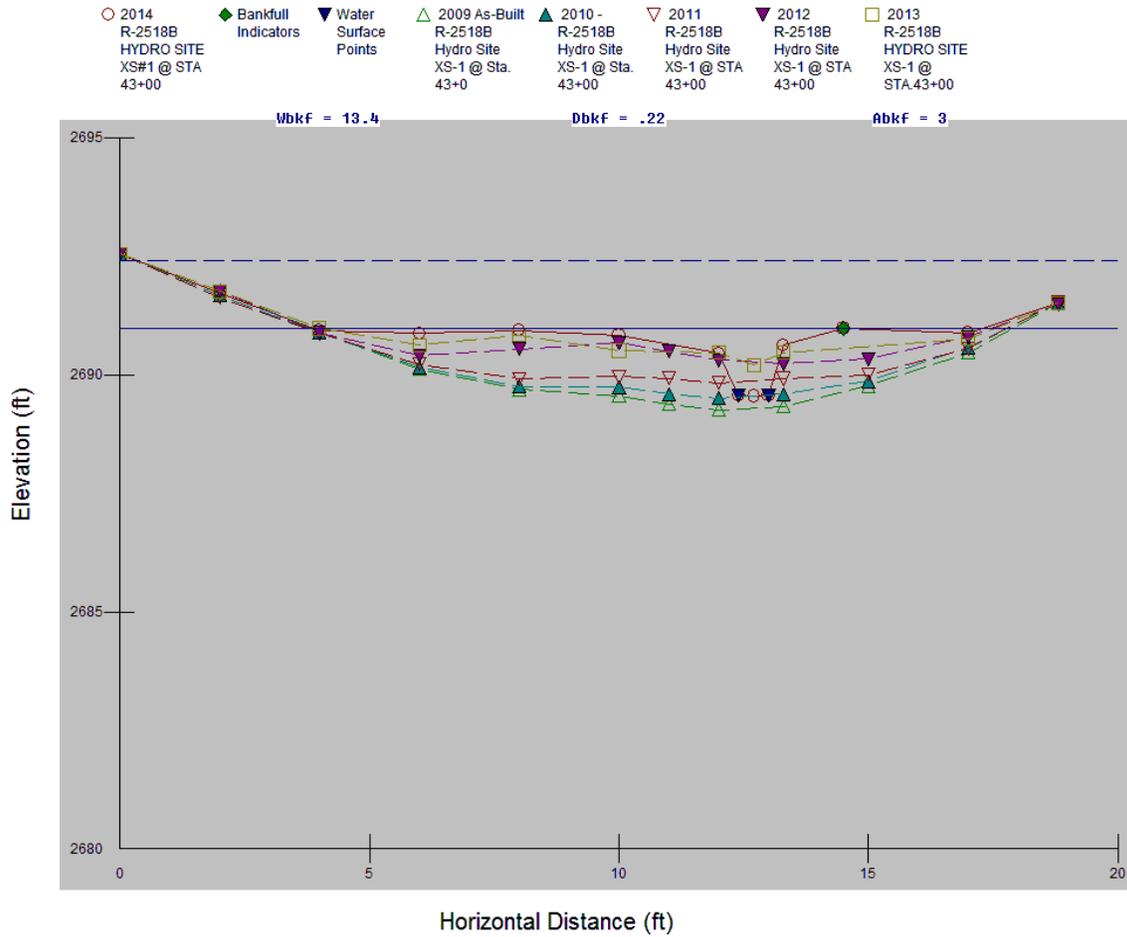
R-2518B HYDRO SITE XS#1 @ STA 43+00

Hydro Site: Cross-Section #1 (Riffle) Abbreviated Morphological Summary					
	2010	2011	2012	2013	2014
Bankfull Cross Sectional Area (ft ²)	8.62	6.07	4.03	1.81	2.88
Maximum Bankfull Depth (ft.)	1.07	0.72	0.57	0.55	1.43
Width of the Floodprone Area (ft)	16.72	15.35	15.6	15.17	18.47
Bankfull Mean Depth (ft.)	0.71	0.51	0.32	0.21	0.27
Width/Depth Ratio	17.11	23.53	39.59	40.57	39.37
Entrenchment Ratio	1.38	1.28	1.23	1.78	1.74
Bankfull Width (ft.)	12.15	12	12.67	8.52	10.63

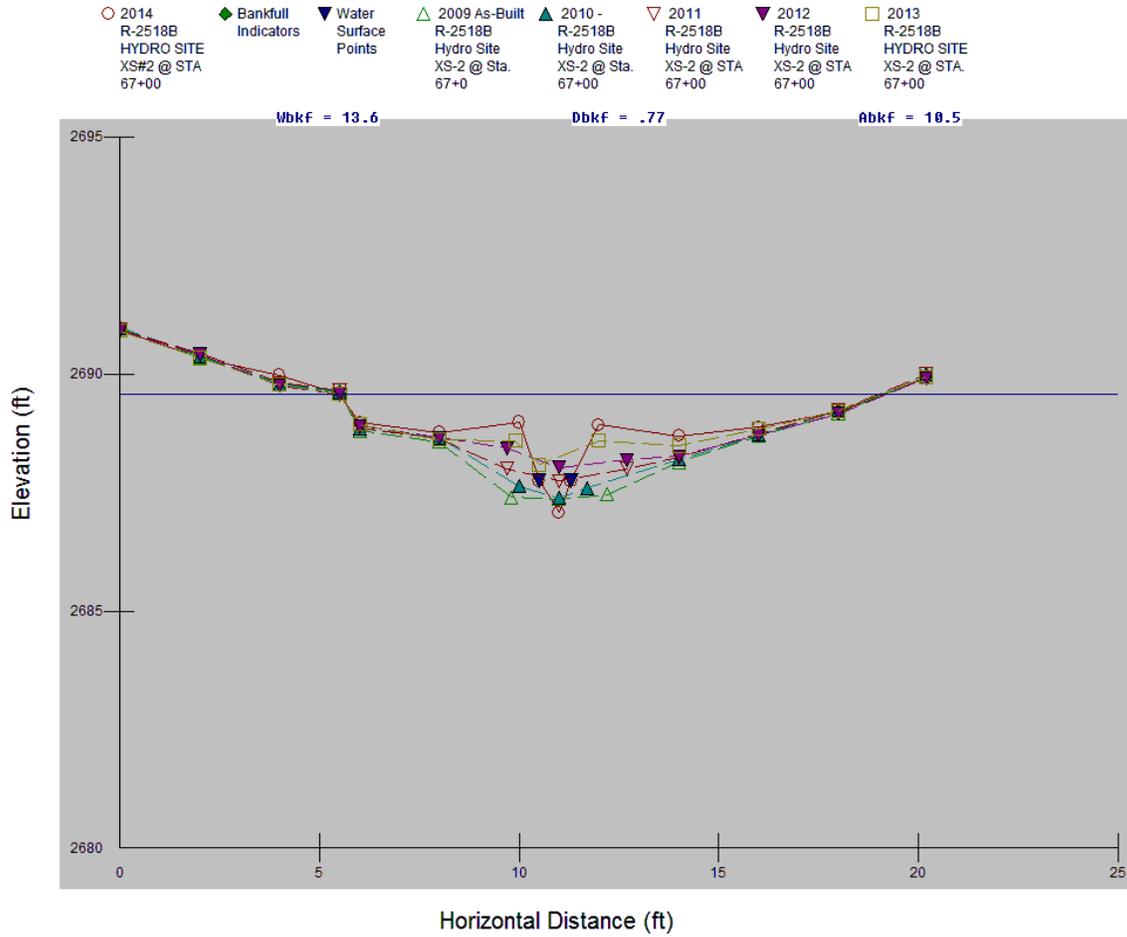
R-2518B HYDRO SITE XS#2 @ STA 67+00

Hydro Site: Cross-Section #2 (Pool) Abbreviated Morphological Summary*					
	2010	2011	2012	2013	2014
Bankfull Cross Sectional Area (ft²)	16.25	15.46	13.3	11.42	10.47
Maximum Bankfull Depth (ft.)	2.23	1.91	1.55	1.49	2.49
Bankfull Mean Depth (ft.)	1.19	1.13	0.97	0.84	0.77
Bankfull Width (ft.)	13.6	13.7	13.73	13.6	13.63

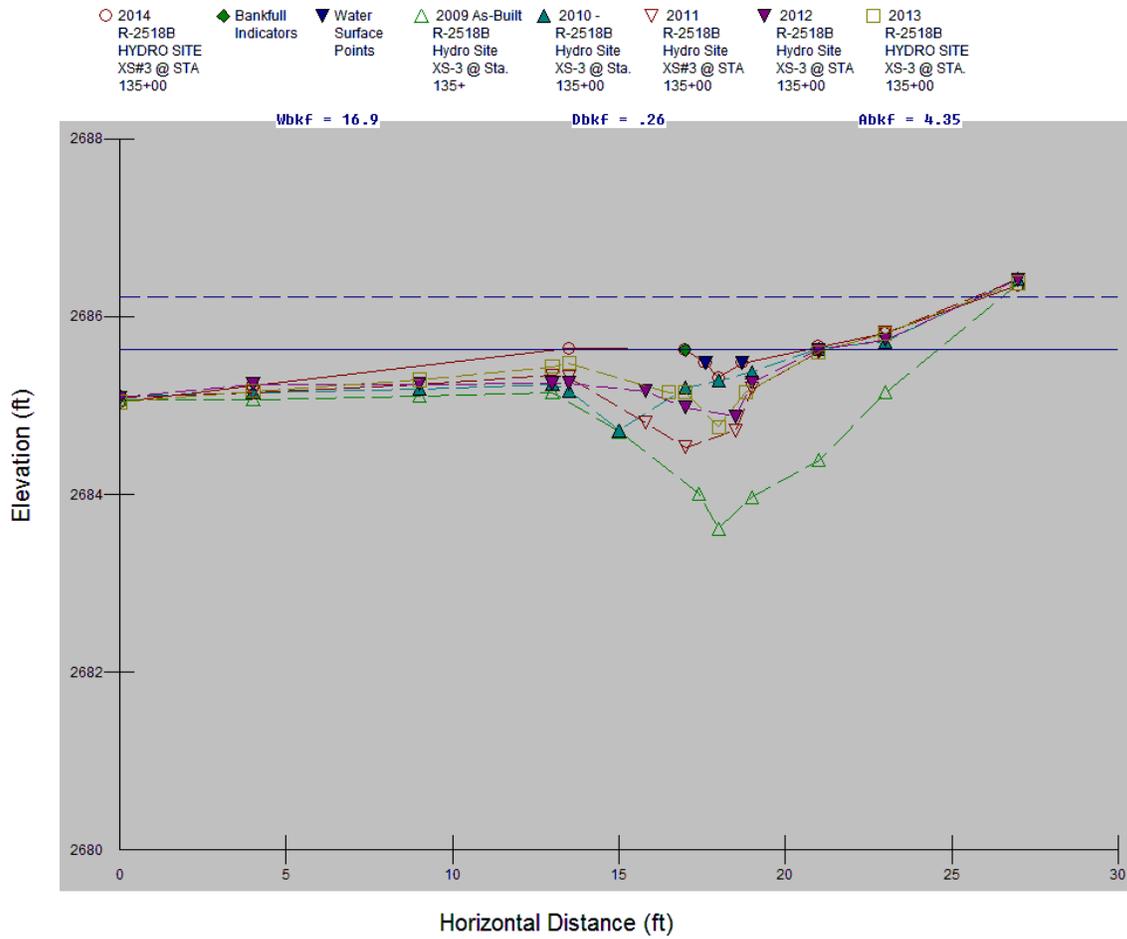
R-2518B HYDRO SITE XS#3 @ STA 135+00

Hydro Site: Cross-Section #3 (Riffle) Abbreviated Morphological Summary					
	2010	2011	2012	2013	2014
Bankfull Cross Sectional Area (ft²)	1.03	2.76	0.89	1.87	0.45
Maximum Bankfull Depth (ft.)	0.52	0.81	0.37	0.72	0.59
Width of the Floodprone Area (ft.)	23.23	25.2	20.95	25.74	26.04
Bankfull Mean Depth (ft.)	0.23	0.41	0.16	0.27	0.12
Width/Depth Ratio	19.57	16.41	34.31	25.59	30.17
Entrenchment Ratio	5.16	3.74	3.82	3.72	7.2
Bankfull Width (ft.)	4.5	6.73	5.49	6.91	3.62

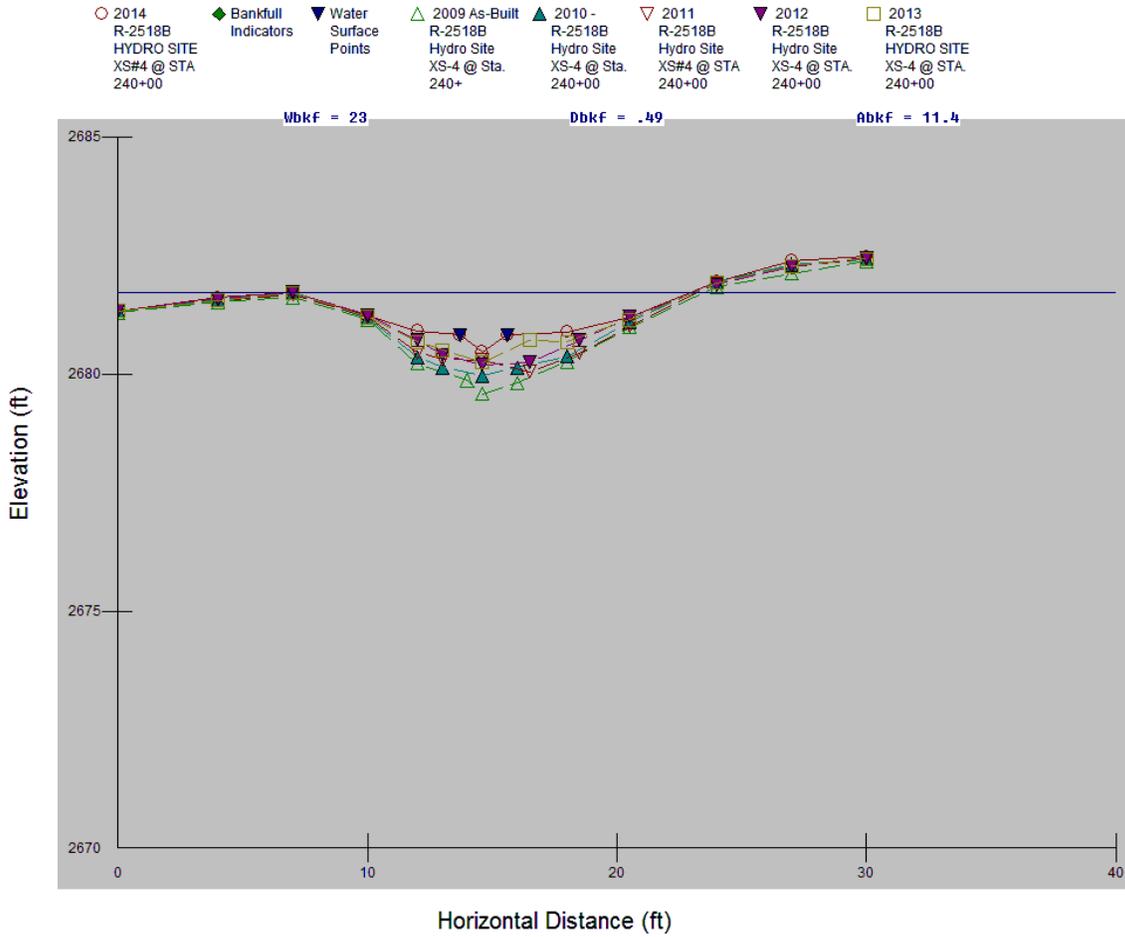
R-2518B HYDRO SITE XS#4 @ STA 240+00

Hydro Site: Cross-Section #4 (Pool) Abbreviated Morphological Summary*					
	2010	2011	2012	2013	2014
Bankfull Cross Sectional Area (ft ²)	15.15	14.32	13.19	12.1	10.13
Maximum Bankfull Depth (ft.)	1.74	1.62	1.52	1.46	1.27
Bankfull Mean Depth (ft.)	0.94	0.89	0.82	0.75	0.63
Bankfull Width (ft.)	16.04	16.07	16.16	16.05	15.99

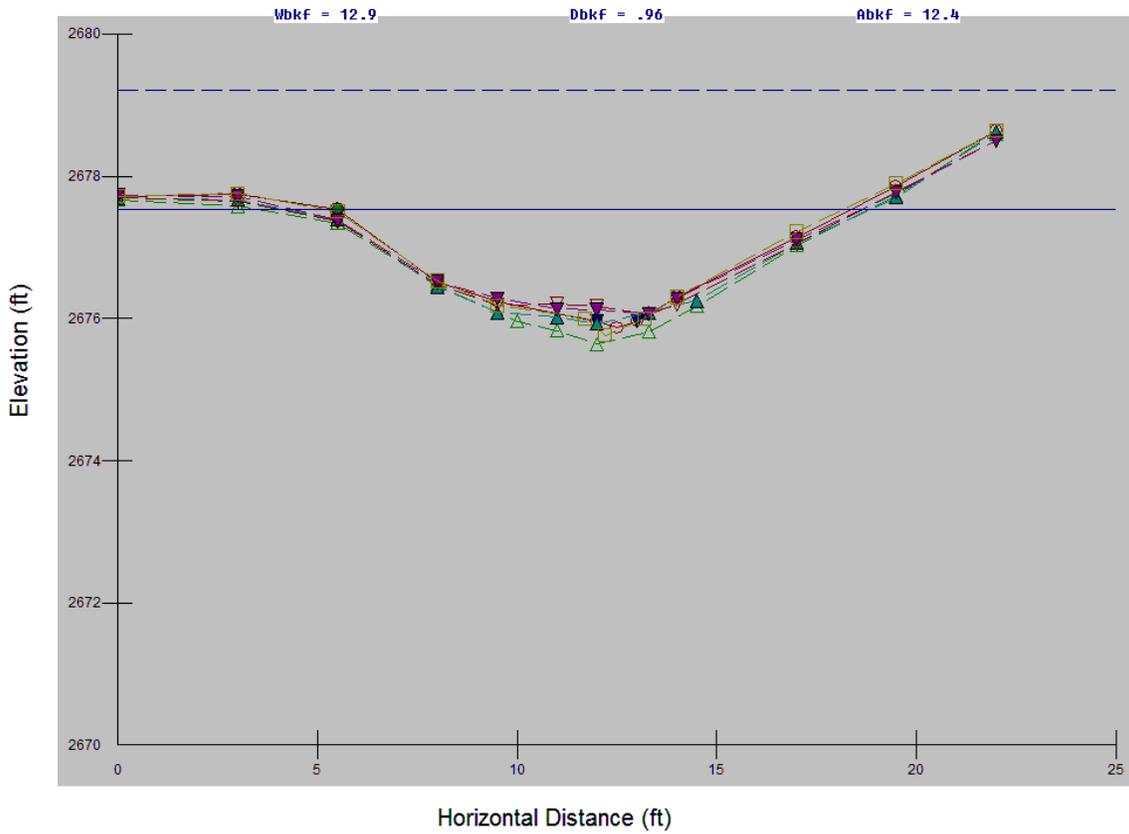
R-2518B HYDRO SITE XS#5 @ STA 335+00

Hydro Site: Cross-Section #5 (Riffle) Abbreviated Morphological Summary					
	2010	2011	2012	2013	2014
Bankfull Cross Sectional Area (ft ²)	11.63	10.38	10.27	11.91	12.41
Maximum Bankfull Depth (ft.)	1.46	1.3	1.31	1.74	1.67
Width of the Floodprone Area (ft.)	22	22	22	22	22
Bankfull Mean Depth (ft.)	0.91	0.83	0.82	0.95	0.96
Width/Depth Ratio	14.05	15.13	15.27	13.19	13.43
Entrenchment Ratio	1.72	1.75	1.76	1.76	1.71
Bankfull Width (ft.)	12.79	12.56	12.52	12.53	12.89

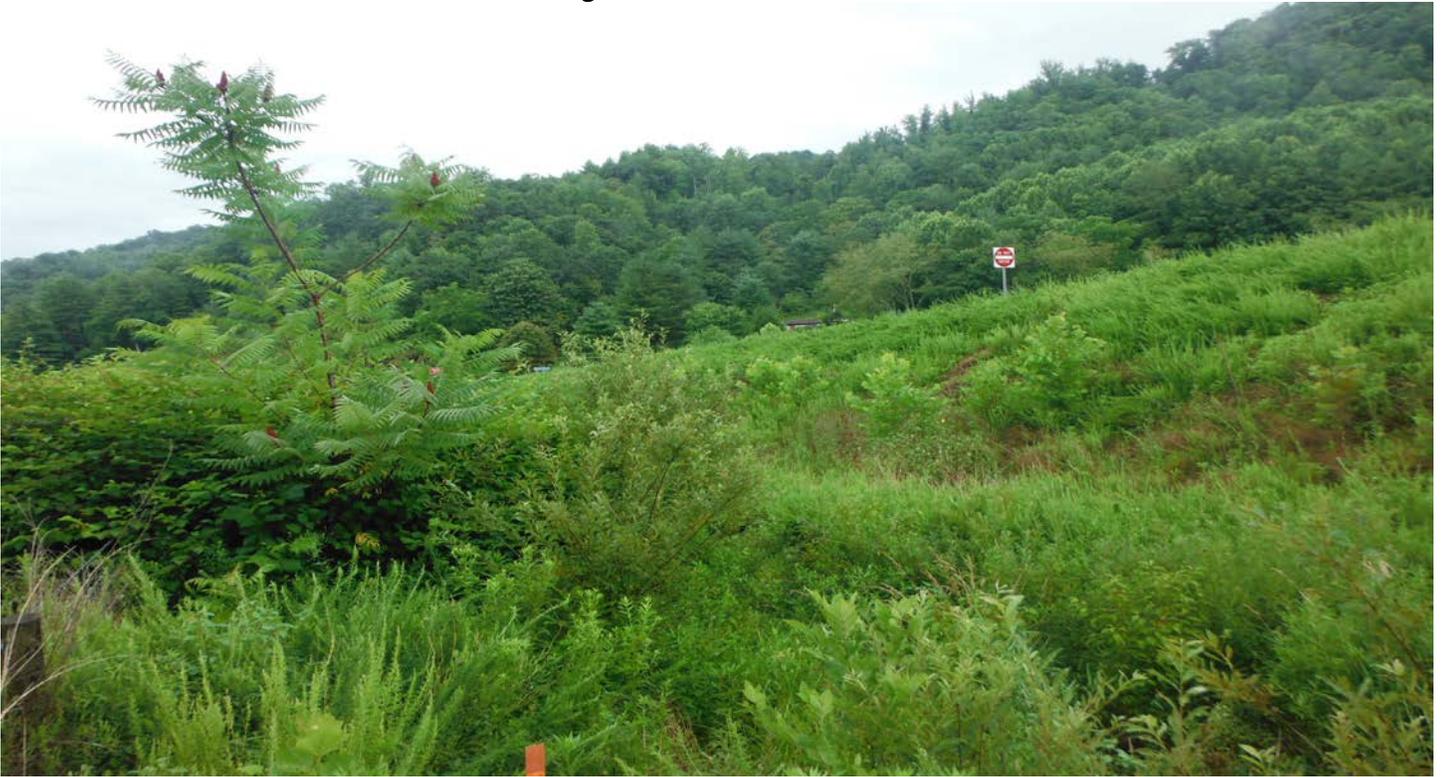
Vegetation Overview Photo

Streambank & Buffer Vegetation: The streambank reforestation was completed in March 2012. The Year 3 vegetation monitoring evaluation noted: Type I: Black Willow, Silky Dogwood and Type II: Sycamore and Green Ash were surviving at the time of monitoring evaluation. A patch of Japanese Knotweed was sprayed with an herbicide application on July 23, 2014.

NCDOT will continue to monitor the planted vegetation and spraying the Japanese Knotweed as needed in 2015.
