ANNUAL REPORT FOR 2013

**UT to Cane River Site #12 Mitigation Site
Yancey County
TIP No. R-2518B
COE Action ID: SAW-2007-2197-357/300
DWR #: 20071134**

Prepared By:
Natural Environment Section & Roadside Environmental Unit
North Carolina Department of Transportation
December 2013

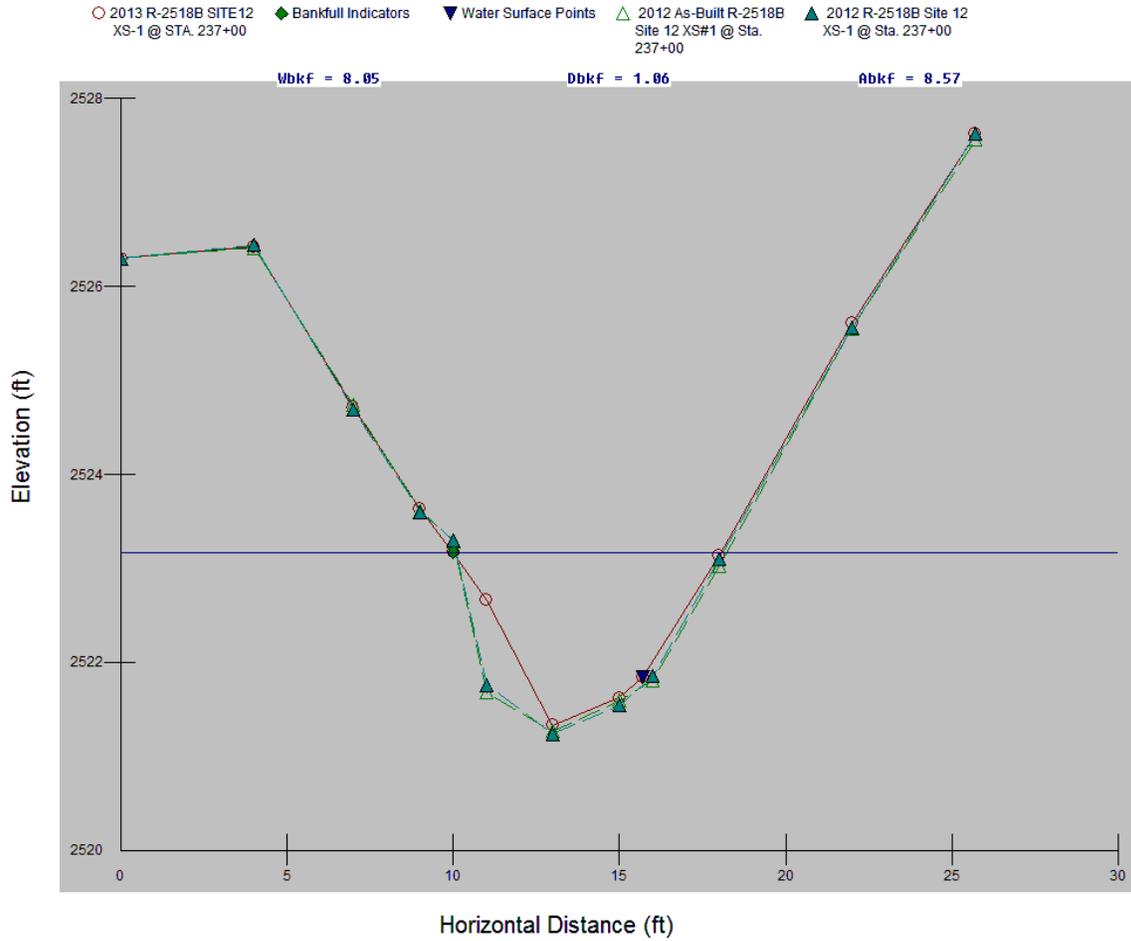
R-2518B SITE12 XS-1 @ STA. 237+00

Based on comparisons of the As-Built to the monitoring data, all of the cross sections appear stable with little or no active bank erosion. Graphs of the cross sections are presented in Appendix A. Future survey data will vary depending on actual location of rod placement and alignment; however, this information should remain similar in appearance.

Site #12: Cross-Section #1 (Pool) Abbreviated Morphological Summary					
	2012	2013	2014	2015	2016
Bankfull Cross Sectional Area (ft ²)	11.48	8.57			
Maximum Bankfull Depth (ft.)	2.06	1.84			
Bankfull Mean Depth (ft.)	1.38	1.06			
Bankfull Width (ft.)	8.33	8.05

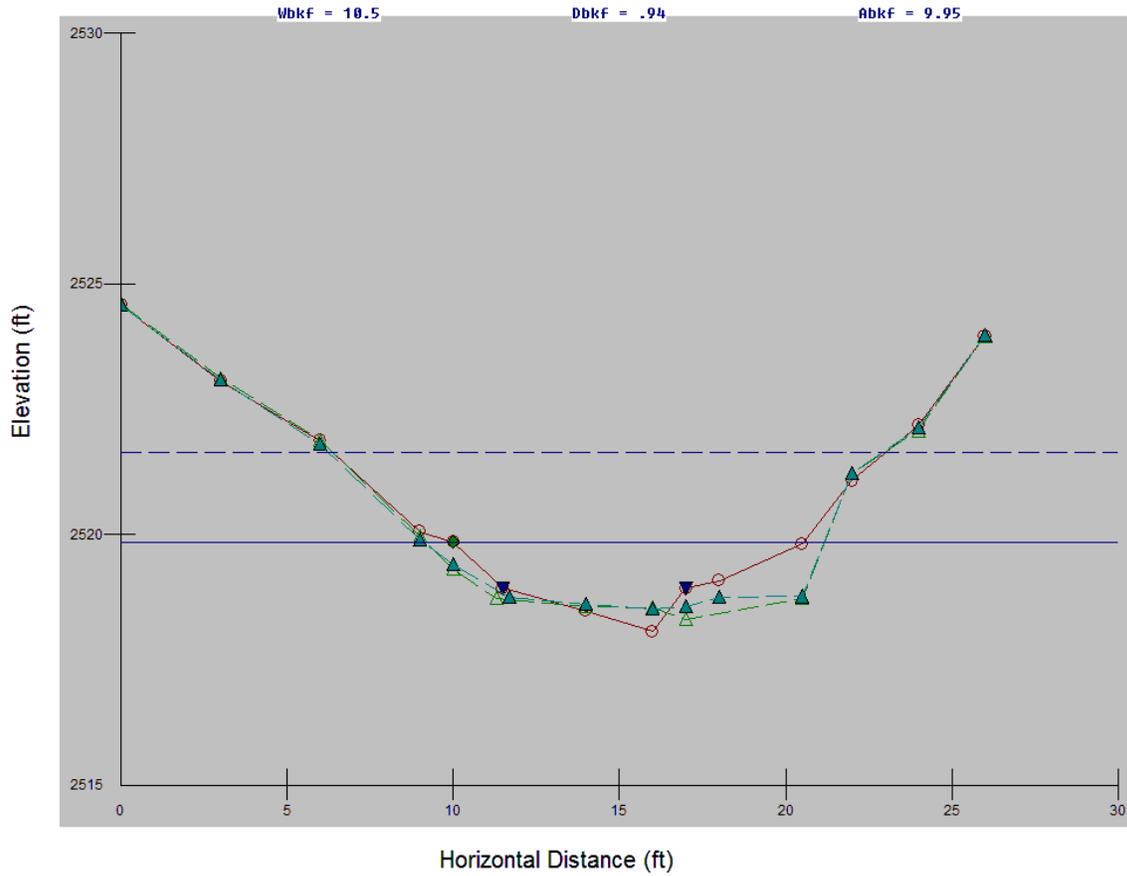
R-2518B XS-2 @ STA. 397+00

Site #12: Cross-Section #2 (Riffle) Abbreviated Morphological Summary					
	2012	2013	2014	2015	2016
Bankfull Cross Sectional Area (ft ²)	7.2	9.95			
Maximum Bankfull Depth (ft.)	0.88	1.79			
Width of the Floodprone Area (ft.)	13.03	16.64			
Bankfull Mean Depth (ft.)	0.66	0.94			
Width/Depth Ratio	16.5	11.22			
Entrenchment Ratio	1.2	1.58			
Bankfull Width (ft.)	10.89	10.55

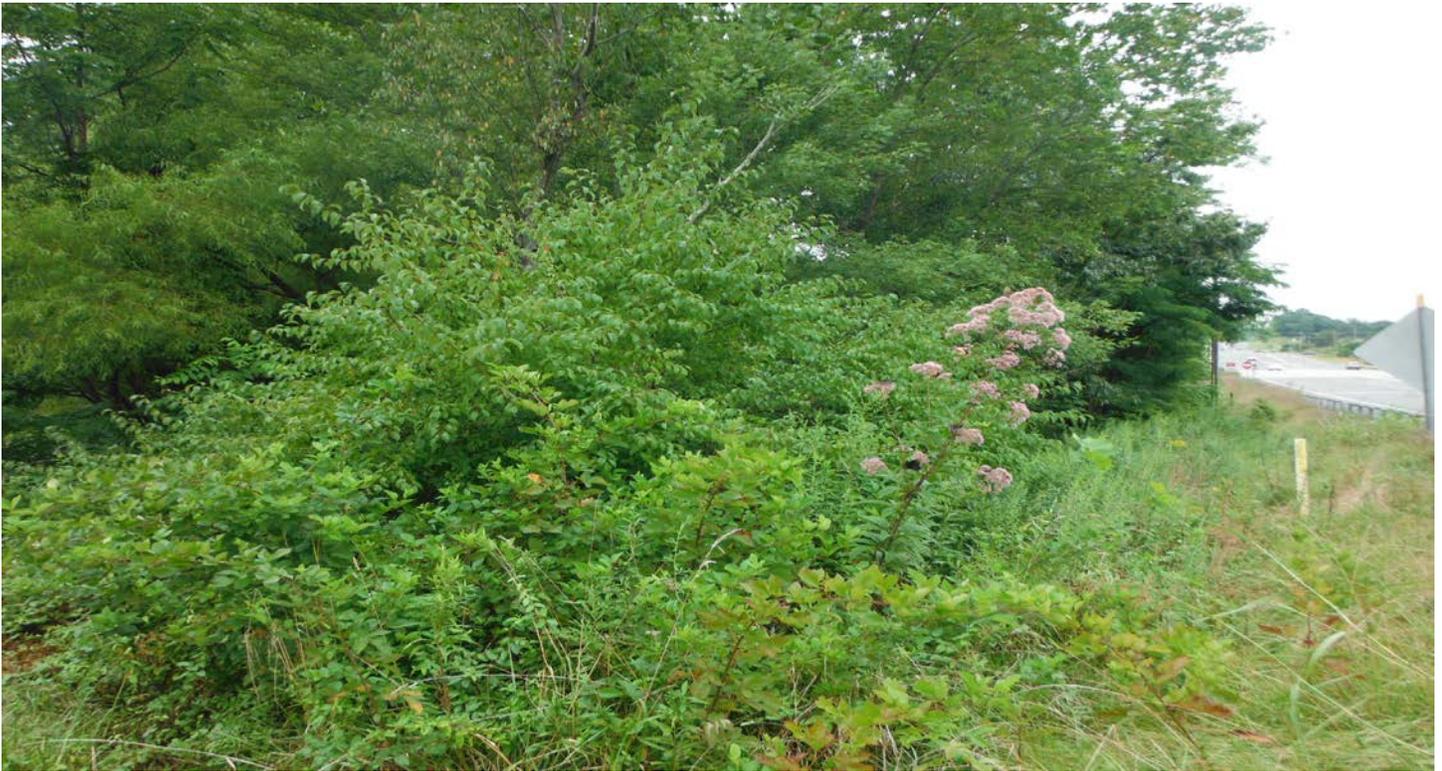
Vegetation Overview Photo (Right Buffer)

Streambank & Buffer Vegetation: The streambank reforestation was completed in March and April 2012. The Year 2 vegetation monitoring evaluation noted: Type I: Black Willow, Silky Dogwood and Type II: Green Ash were surviving at the time of the monitoring evaluation. The existing vegetation is already providing a canopy of hardwood vegetation along the reach.
