ANNUAL REPORT FOR 2016

**UT to Cane River Site #12 Mitigation Site
Yancey County
TIP No. R-2518B
COE Action ID: SAW-2007-2197-357/300
DWR #: 20071134**

Prepared By:
Natural Environment Section & Roadside Environmental Unit
North Carolina Department of Transportation
November 2016

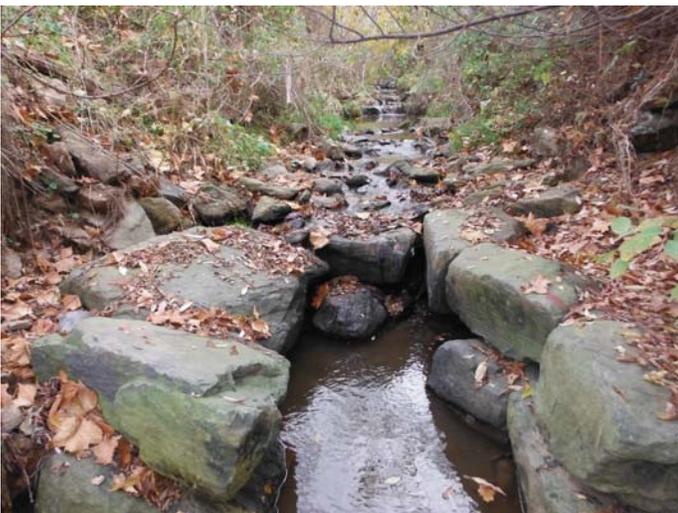
Photo Point #3 (Upstream)
(water piping under crossvane)
November 2016

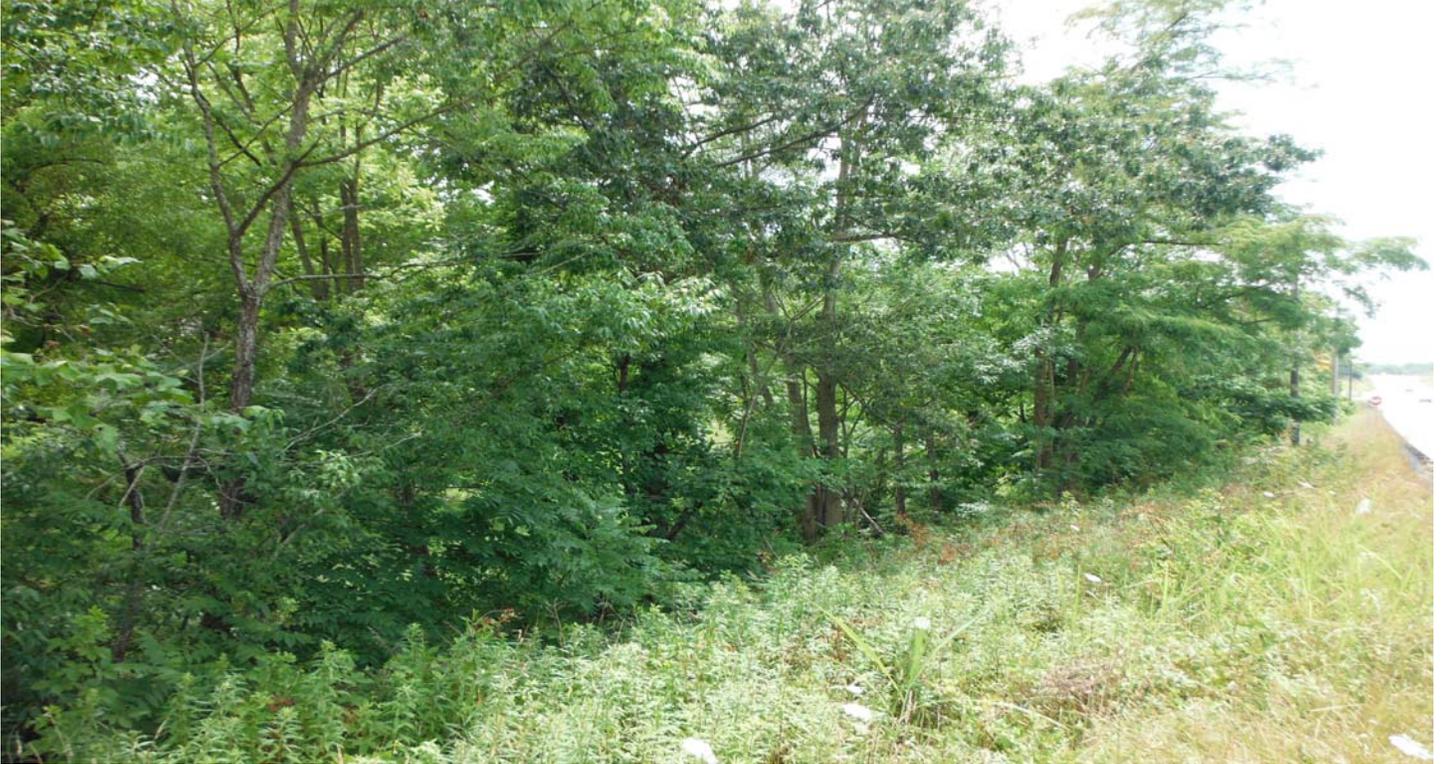
Vegetation Overview Photo (North Buffer)

Streambank & Buffer Vegetation: The streambank reforestation was completed in March and April 2012. The Year 5 vegetation monitoring evaluation noted: Type I: Black Willow, Silky Dogwood and Type II: Green Ash were surviving at the time of the monitoring evaluation. The existing vegetation is already providing a canopy of hardwood vegetation along the reach.
