ANNUAL REPORT FOR 2010

**Bald Creek Site #3 Mitigation Site
Yancey County
TIP No. R-2518B**

Prepared By:
Natural Environment Unit & Roadside Environmental Unit
North Carolina Department of Transportation
December 2010

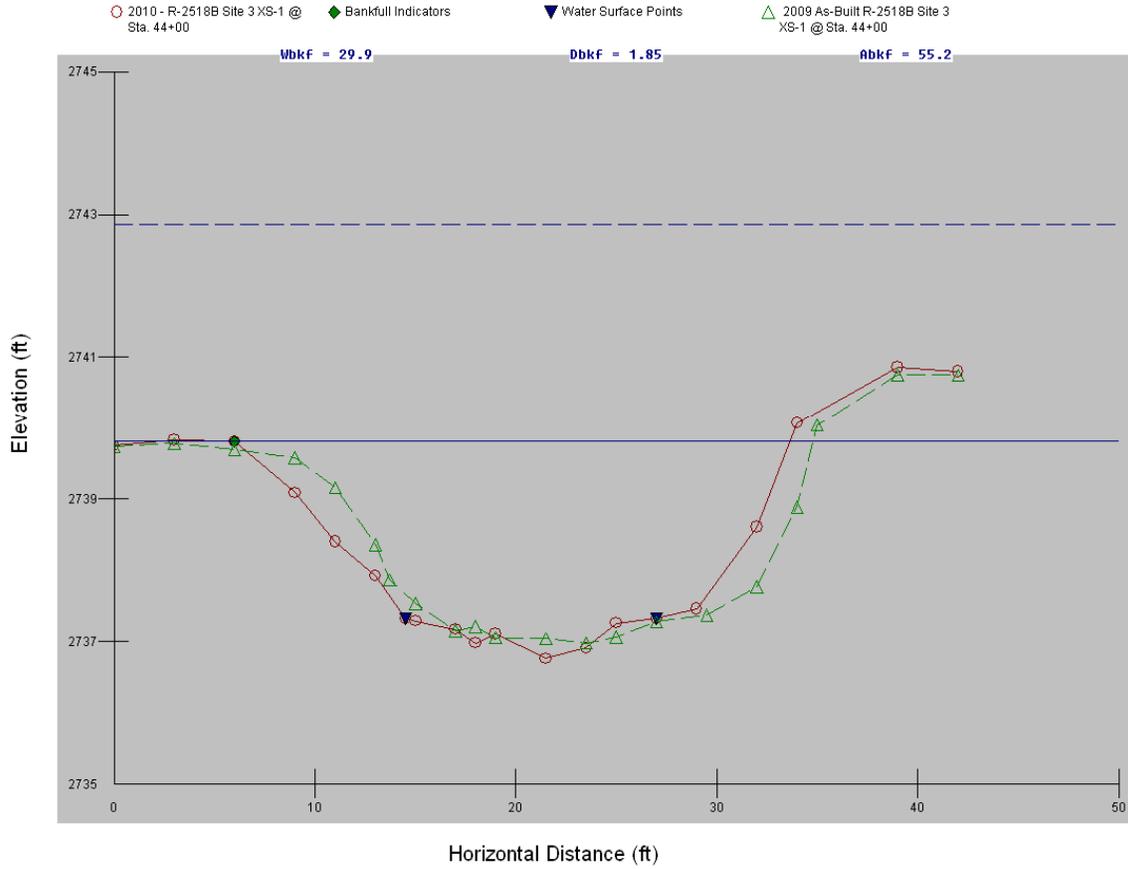
R-2518B Site 3 XS-1 @ Sta. 44+00

Site #3: Cross-Section #1 (Riffle) Abbreviated Morphological Summary					
	2010	2011	2012	2013	2014
Bankfull Cross Sectional Area (ft ²)	55.19				
Maximum Bankfull Depth (ft)	3.05				
Width of the Floodprone Area (ft)	42				
Bankfull Mean Depth (ft)	1.85				
Width/Depth Ratio	16.16				
Entrenchment Ratio	1.4				
Bankfull Width (ft)	29.89

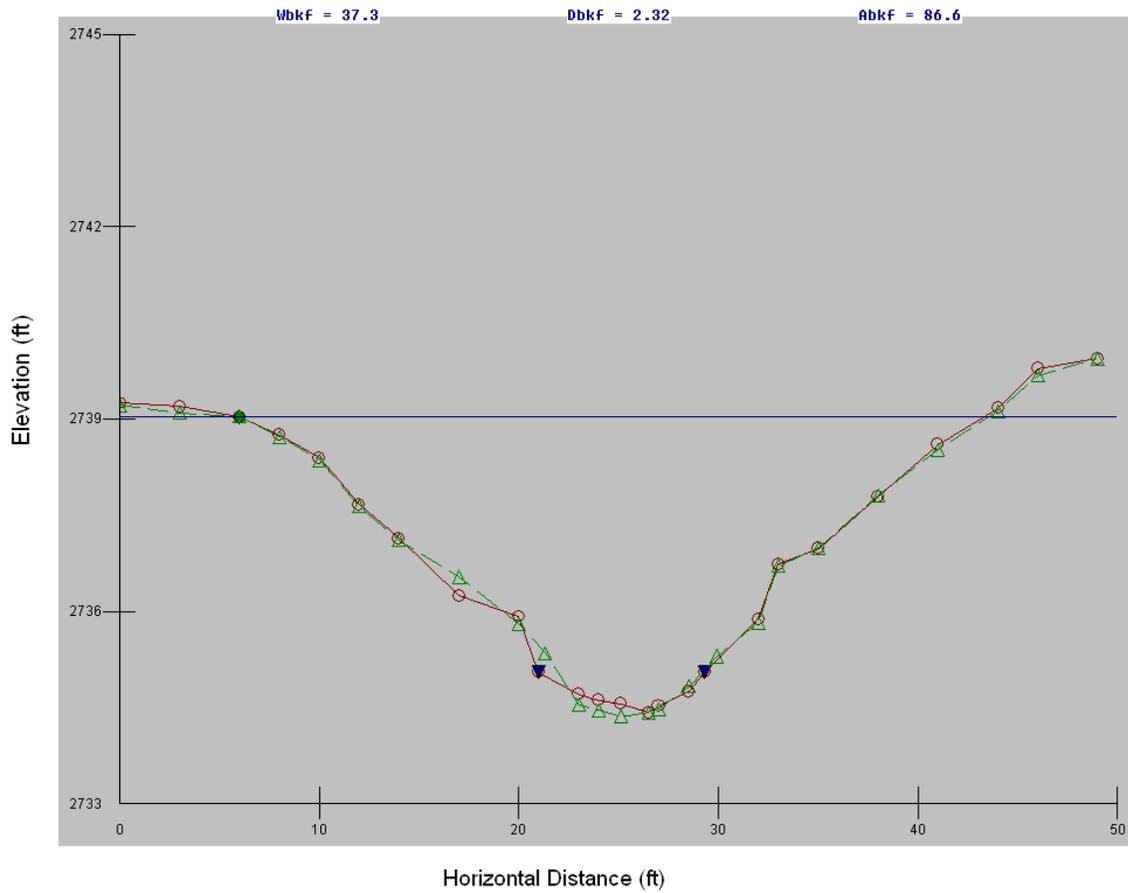
R-2518B Site 3 XS-2 @ Sta. 93+00

Site #3: Cross-Section #2 (Pool) Abbreviated Morphological Summary*					
	2010	2011	2012	2013	2014
Bankfull Cross Sectional Area (ft ²)	86.6				
Maximum Bankfull Depth (ft)	4.61				
Bankfull Mean Depth (ft)	2.32				
Bankfull Width (ft)	37.26

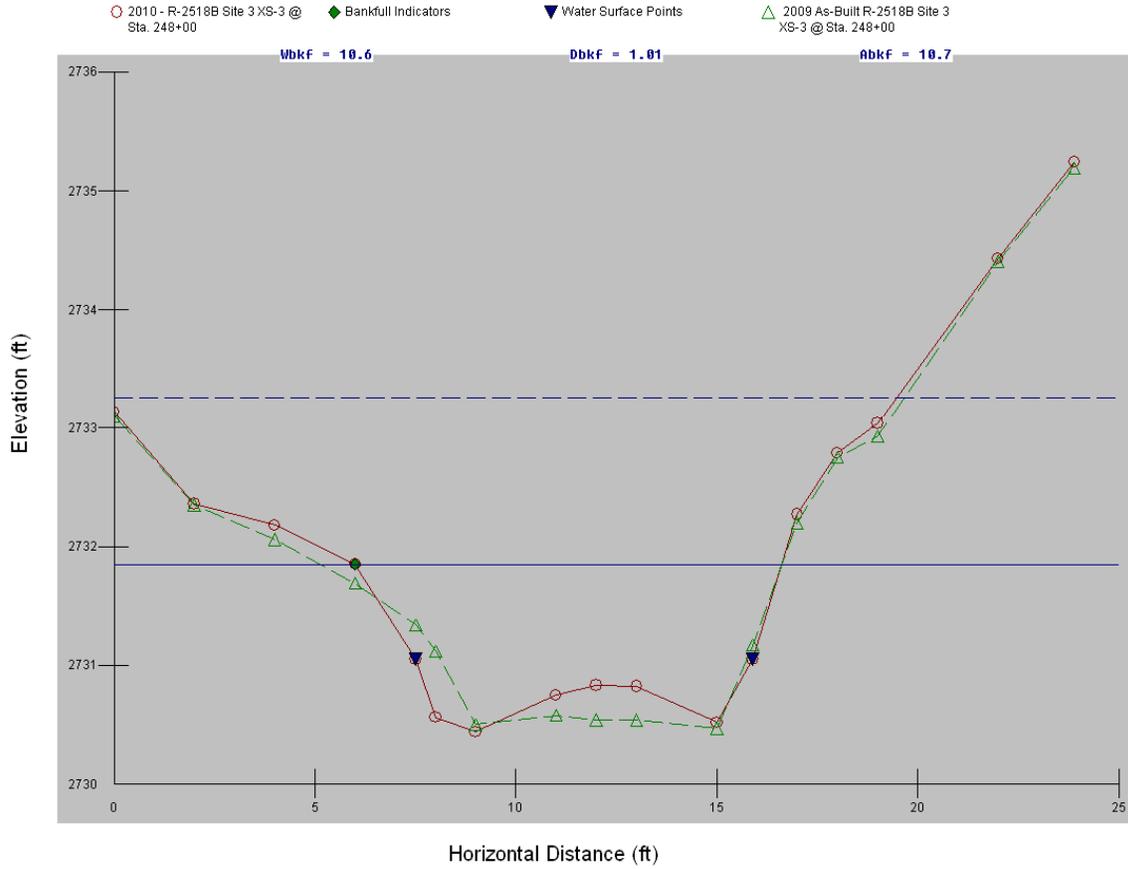
R-2518B Site 3 XS-3 @ Sta. 248+00

Site #3: Cross-Section #3 (Riffle) Abbreviated Morphological Summary					
	2010	2011	2012	2013	2014
Bankfull Cross Sectional Area (ft ²)	10.67				
Maximum Bankfull Depth (ft)	1.41				
Width of the Floodprone Area (ft)	19.47				
Bankfull Mean Depth (ft)	1.01				
Width/Depth Ratio	10.51				
Entrenchment Ratio	1.83				
Bankfull Width (ft)	10.62

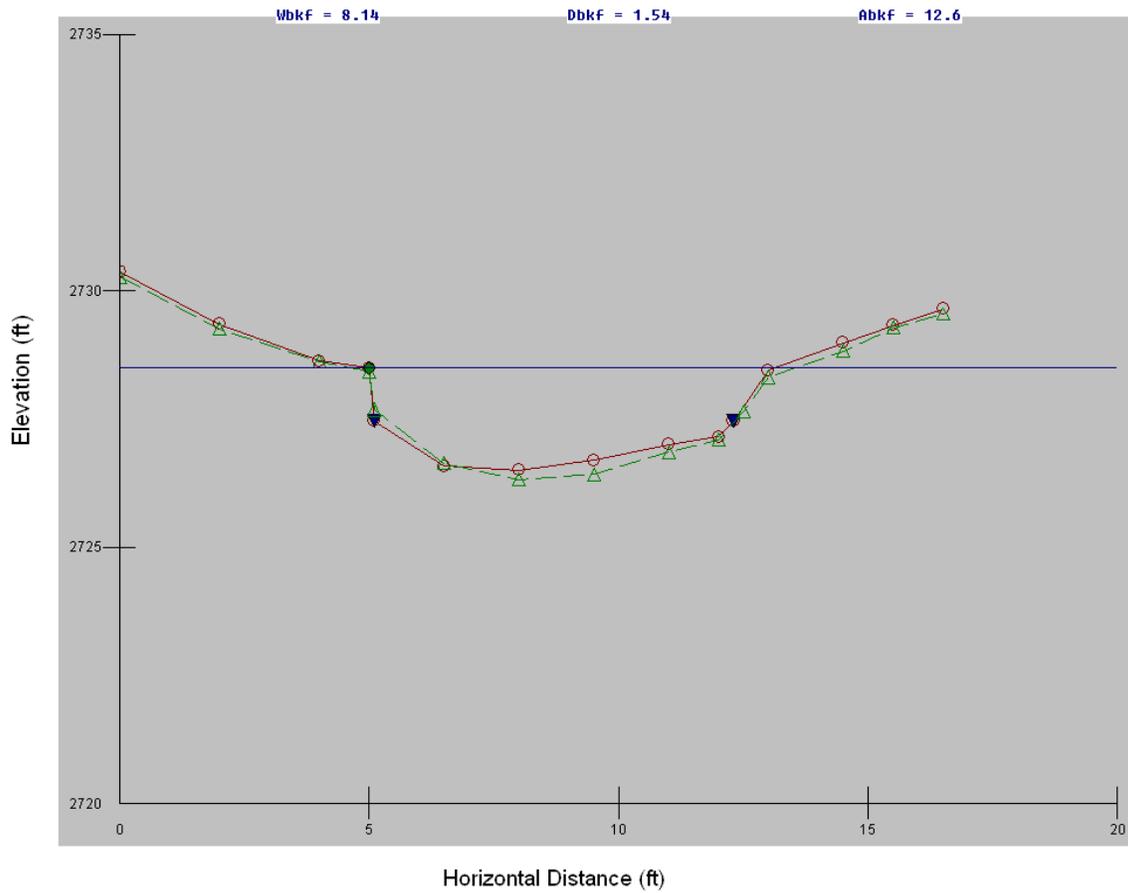
R-2518B Site 3 XS-4 @ Sta. 393+00

Site #3: Cross-Section #4 (Pool) Abbreviated Morphological Summary*					
	2010	2011	2012	2013	2014
Bankfull Cross Sectional Area (ft ²)	12.56				
Maximum Bankfull Depth (ft)	2				
Bankfull Mean Depth (ft)	1.54				
Bankfull Width (ft)	8.14
