ANNUAL REPORT FOR 2014

Georges Fork Site #26 Mitigation Site
Yancey County
TIP No. R-2519A
COE Action ID: SAW-2007-2197-357/300
DWR #: 2007-1134V.4

Prepared By:
Natural Environment Section & Roadside Environmental Unit
North Carolina Department of Transportation
December 2014

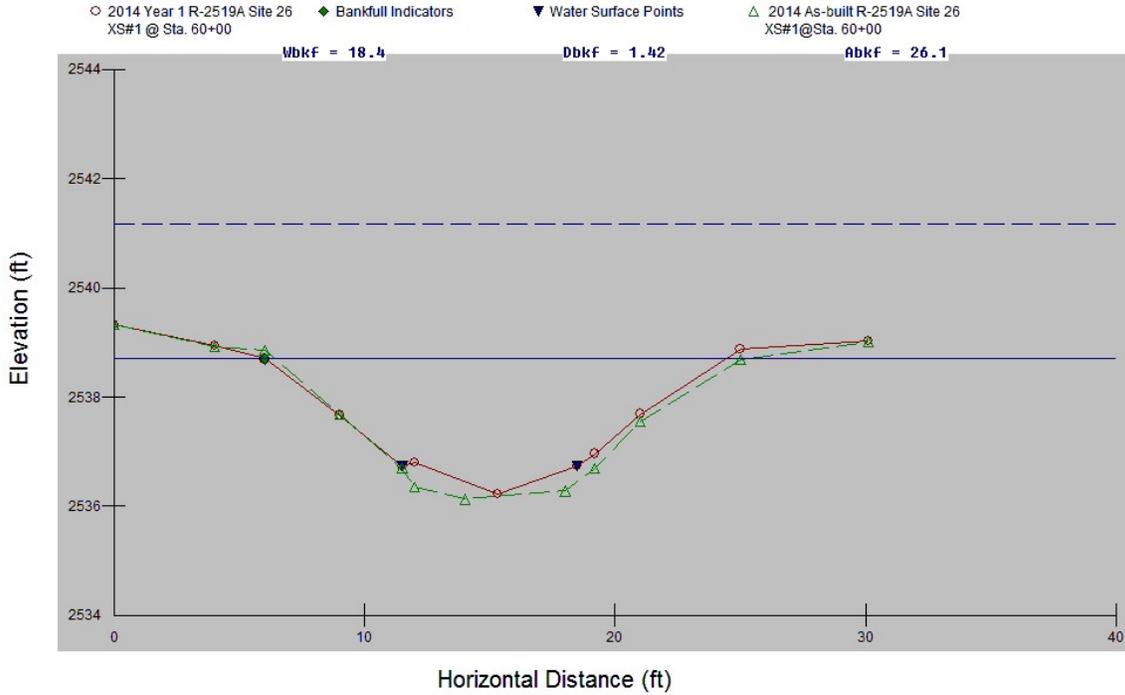
R-2519A Site 26 XS#1 @ Sta. 60+00

Site #26: Cross-Section #1 (Riffle) Abbreviated Morphological Summary					
	2014	2015	2016	2017	2018
Bankfull Cross Sectional Area (ft ²)	26.06				
Maximum Bankfull Depth (ft.)	2.48				
Width of the Floodprone Area (ft.)	30.1				
Bankfull Mean Depth (ft.)	1.42				
Width/Depth Ratio	12.95				
Entrenchment Ratio	1.64				
Bankfull Width (ft.)	18.39

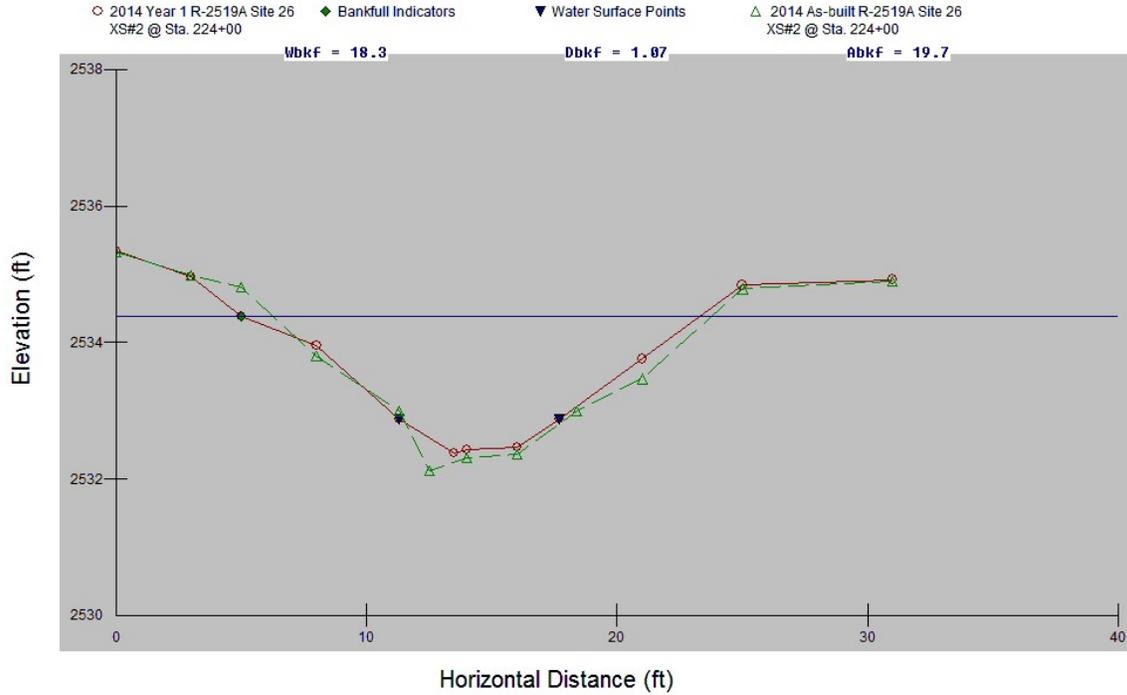
R-2519A Site 26 XS#2 @ Sta. 224+00

Site #26: Cross-Section #2 (Pool) Abbreviated Morphological Summary					
	2014	2015	2016	2017	2018
Bankfull Cross Sectional Area (ft ²)	19.66				
Maximum Bankfull Depth (ft.)	2				
Bankfull Mean Depth (ft.)	1.07				
Bankfull Width (ft.)	18.3

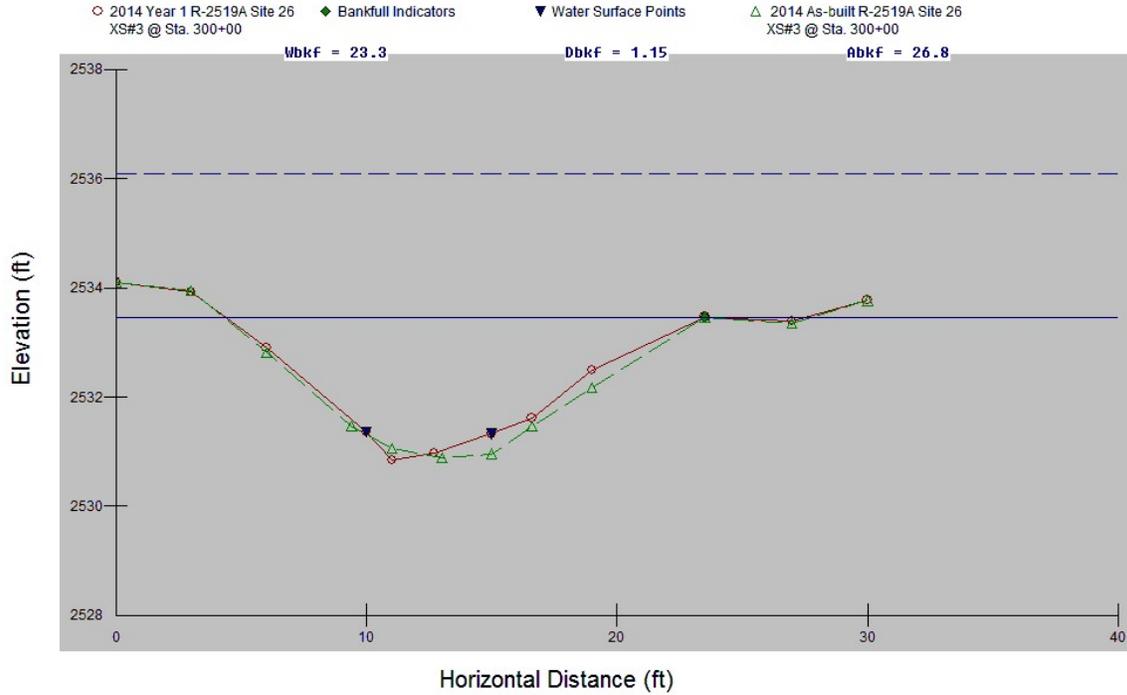
R-2519A Site 26 XS#3 @ Sta. 300+00

Site #26: Cross-Section #3 (Riffle) Abbreviated Morphological Summary					
	2014	2015	2016	2017	2018
Bankfull Cross Sectional Area (ft ²)	26.64				
Maximum Bankfull Depth (ft.)	2.62				
Width of the Floodprone Area (ft.)	30				
Bankfull Mean Depth (ft.)	1.39				
Width/Depth Ratio	13.78				
Entrenchment Ratio	1.57				
Bankfull Width (ft.)	19.16

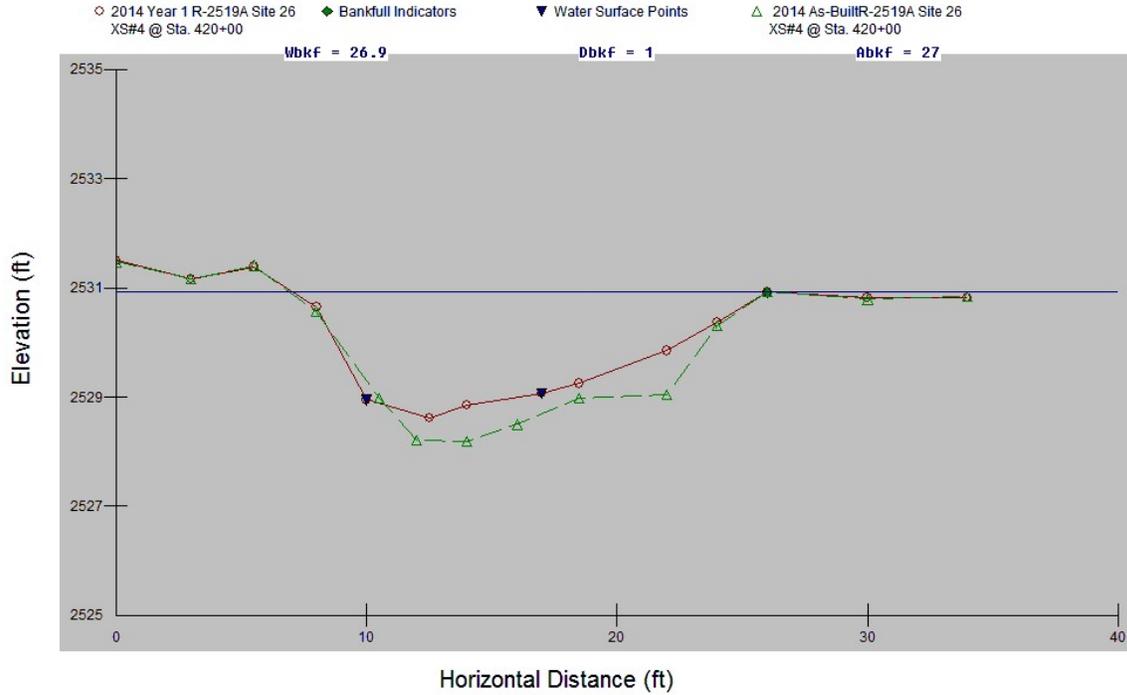
R-2519A Site 26 XS#4 @ Sta. 420+00

Site #26: Cross-Section #4 (Pool) Abbreviated Morphological Summary					
	2014	2015	2016	2017	2018
Bankfull Cross Sectional Area (ft ²)	26.46				
Maximum Bankfull Depth (ft.)	2.31				
Bankfull Mean Depth (ft.)	1.4				
Bankfull Width (ft.)	18.91
