ANNUAL REPORT FOR 2014

**Plum Branch Site #33 Mitigation Site
Yancey County
TIP No. R-2519A
COE Action ID: SAW-2007-2197-357/300
DWR #: 2007-1134V.4**

Prepared By:
Natural Environment Section & Roadside Environmental Unit
North Carolina Department of Transportation
December 2014

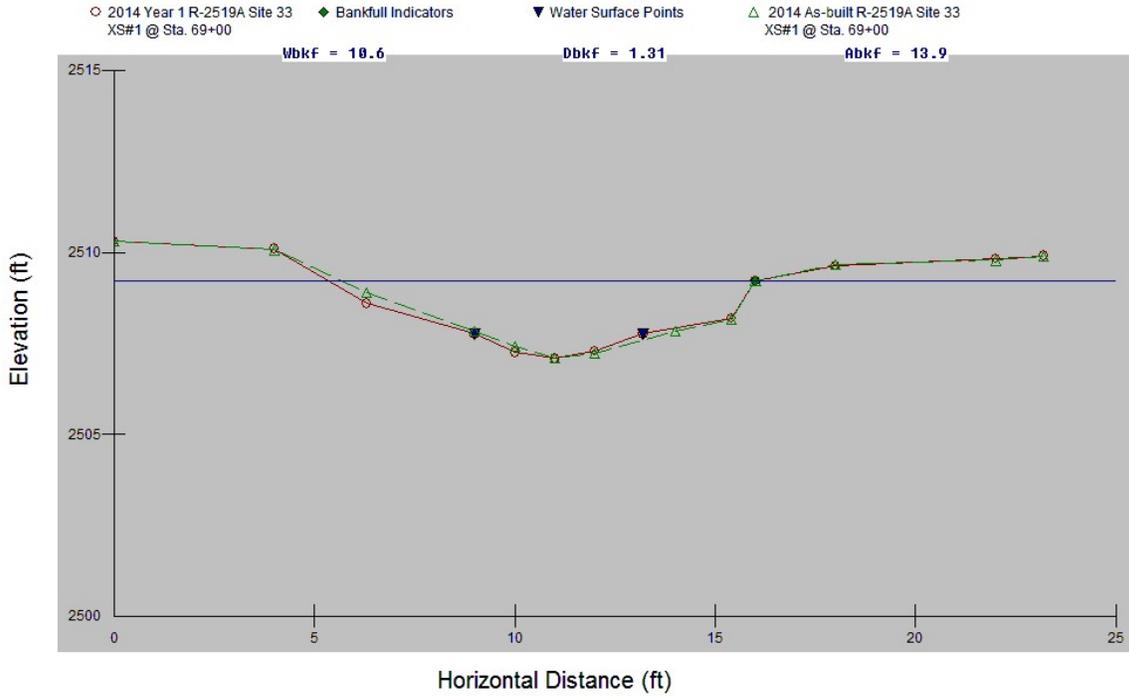
R-2519A Site 33 XS#1 @ Sta. 69+00

Site #33: Cross-Section #1 (Pool) Abbreviated Morphological Summary					
	2014	2015	2016	2017	2018
Bankfull Cross Sectional Area (ft ²)	13.93				
Maximum Bankfull Depth (ft.)	2.13				
Bankfull Mean Depth (ft.)	1.31				
Bankfull Width (ft.)	10.64

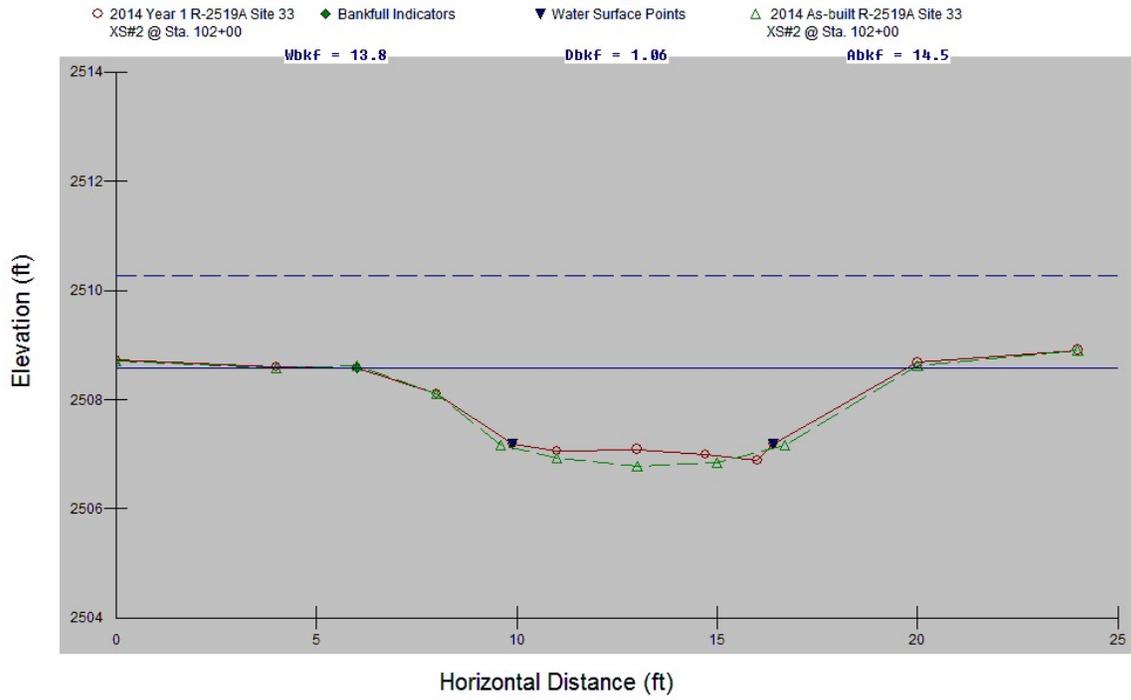
R-2519A Site 33 XS#2 @ Sta. 102+00

Site #33: Cross-Section #2 (Riffle) Abbreviated Morphological Summary					
	2014	2015	2016	2017	2018
Bankfull Cross Sectional Area (ft ²)	14.53				
Maximum Bankfull Depth (ft.)	1.69				
Width of the Floodprone Area (ft.)	24				
Bankfull Mean Depth (ft.)	1.06				
Width/Depth Ratio	12.98				
Entrenchment Ratio	1.74				
Bankfull Width (ft.)	13.76
