ANNUAL REPORT FOR 2014

**Plum Branch Tributary Site #32 Mitigation Site
Yancey County
TIP No. R-2519A
COE Action ID: SAW-2007-2197-357/300
DWR #: 2007-1134V.4**

Prepared By:
Natural Environment Section & Roadside Environmental Unit
North Carolina Department of Transportation
December 2014

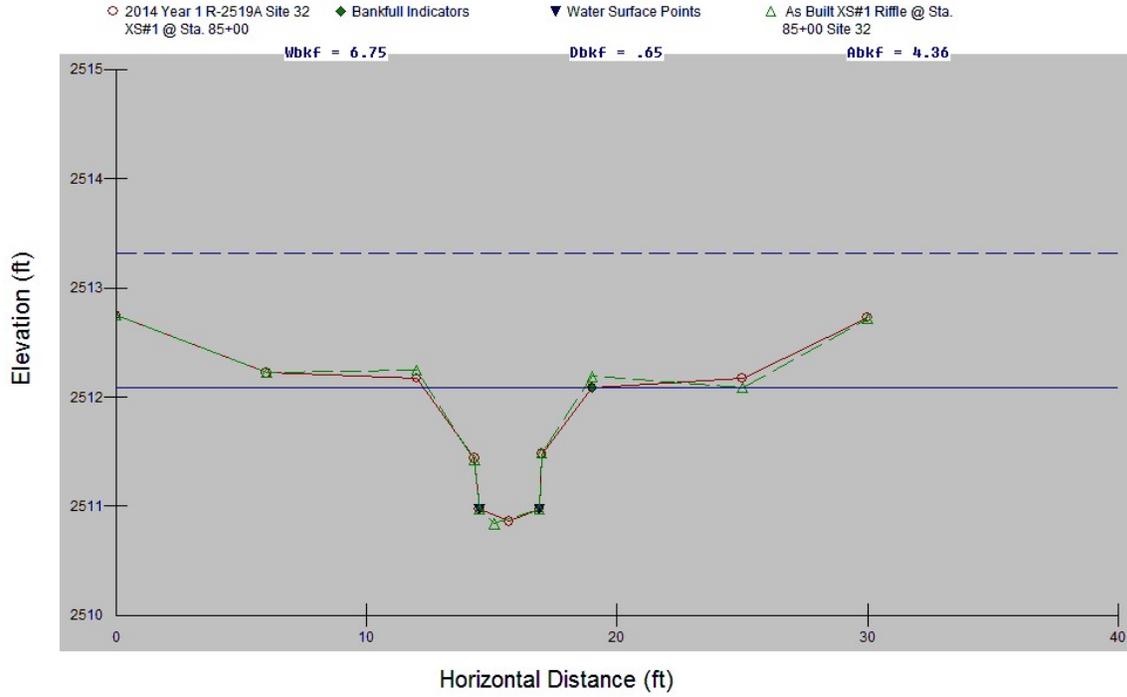
R-2519A Site 32 XS#1 @ Sta. 85+00

Site #32: Cross-Section #1 (Riffle) Abbreviated Morphological Summary					
	2014	2015	2016	2017	2018
Bankfull Cross Sectional Area (ft ²)	4.36				
Maximum Bankfull Depth (ft.)	1.23				
Width of the Floodprone Area (ft.)	30				
Bankfull Mean Depth (ft.)	0.65				
Width/Depth Ratio	10.38				
Entrenchment Ratio	4.45				
Bankfull Width (ft.)	6.75

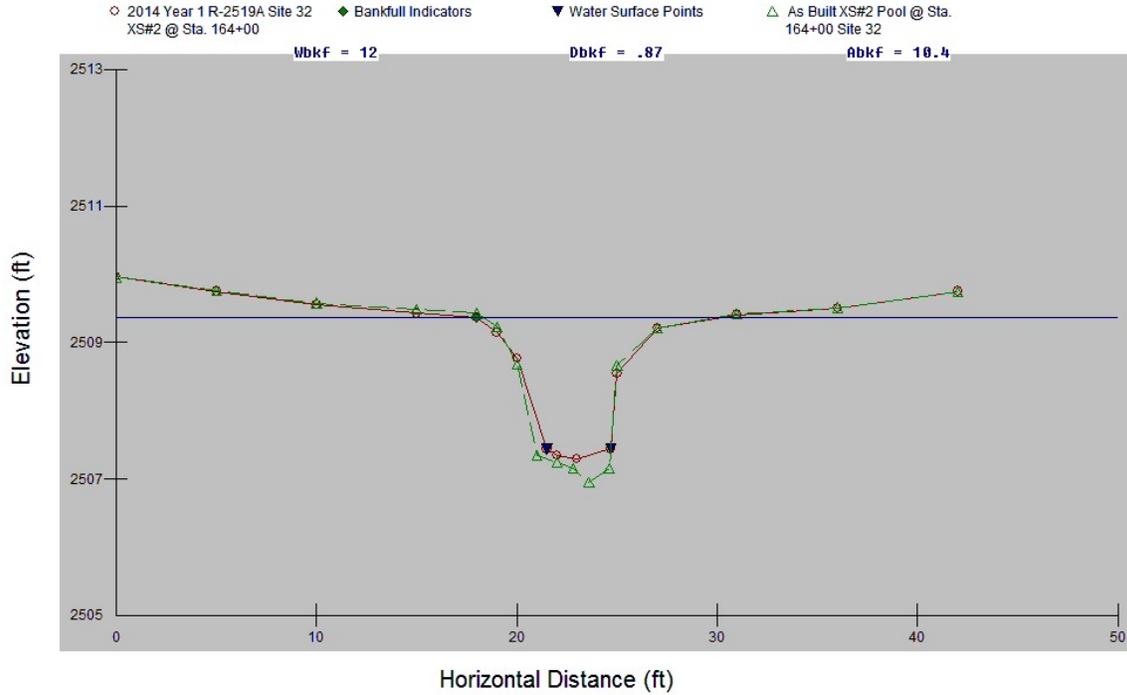
R-2519A Site 32 XS#2 @ Sta. 164+00

Site #32: Cross-Section #2 (Pool) Abbreviated Morphological Summary					
	2014	2015	2016	2017	2018
Bankfull Cross Sectional Area (ft ²)	10.43				
Maximum Bankfull Depth (ft.)	2.07				
Bankfull Mean Depth (ft.)	0.87				
Bankfull Width (ft.)	12

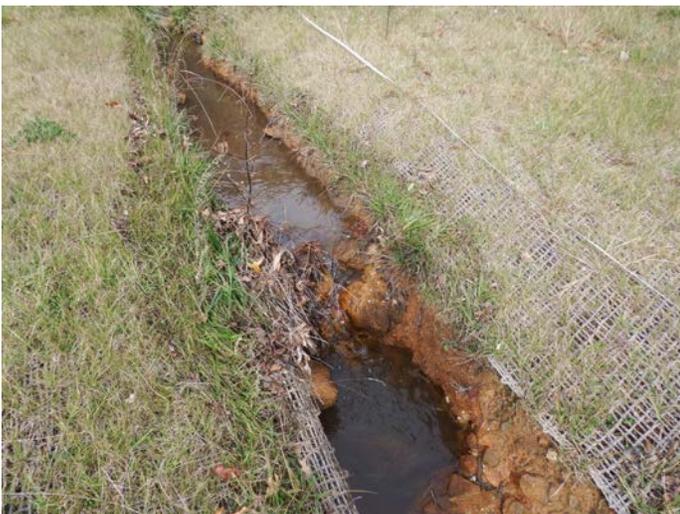
The Plum Branch Tributary Site #32 Mitigation Site has met the required monitoring protocols for the first formal year of monitoring. A headcut and bank scouring that were noted will continue to be monitored to see if remedial action is needed. NCDOT plans on planting the streambank and buffer in 2015. NCDOT will monitor the planted vegetation once it is established.

Headcut @ Long. Profile Sta. 140+00

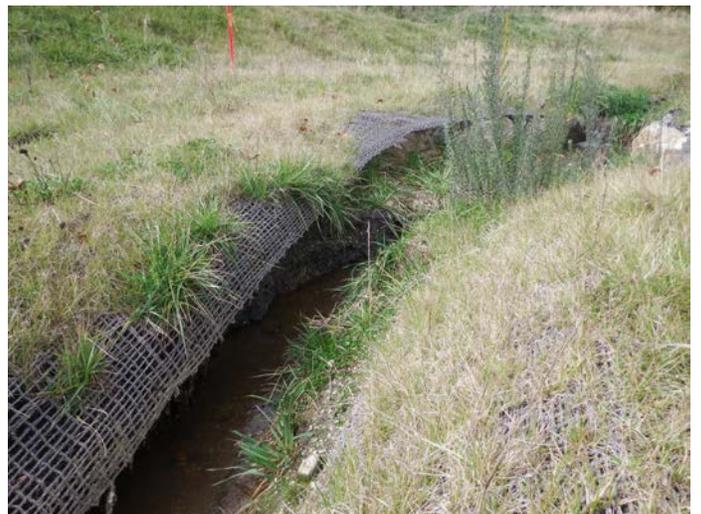
Right bank scour @ Long. Profile Sta. 179+00
