# ANNUAL REPORT FOR 2015

**Plum Branch Tributary Site #32 Mitigation Site  
Yancey County  
TIP No. R-2519A  
COE Action ID: SAW-2007-2197-357/300  
DWR #: 2007-1134V.4**

Prepared By:  
Natural Environment Section & Roadside Environmental Unit  
North Carolina Department of Transportation  
December 2015

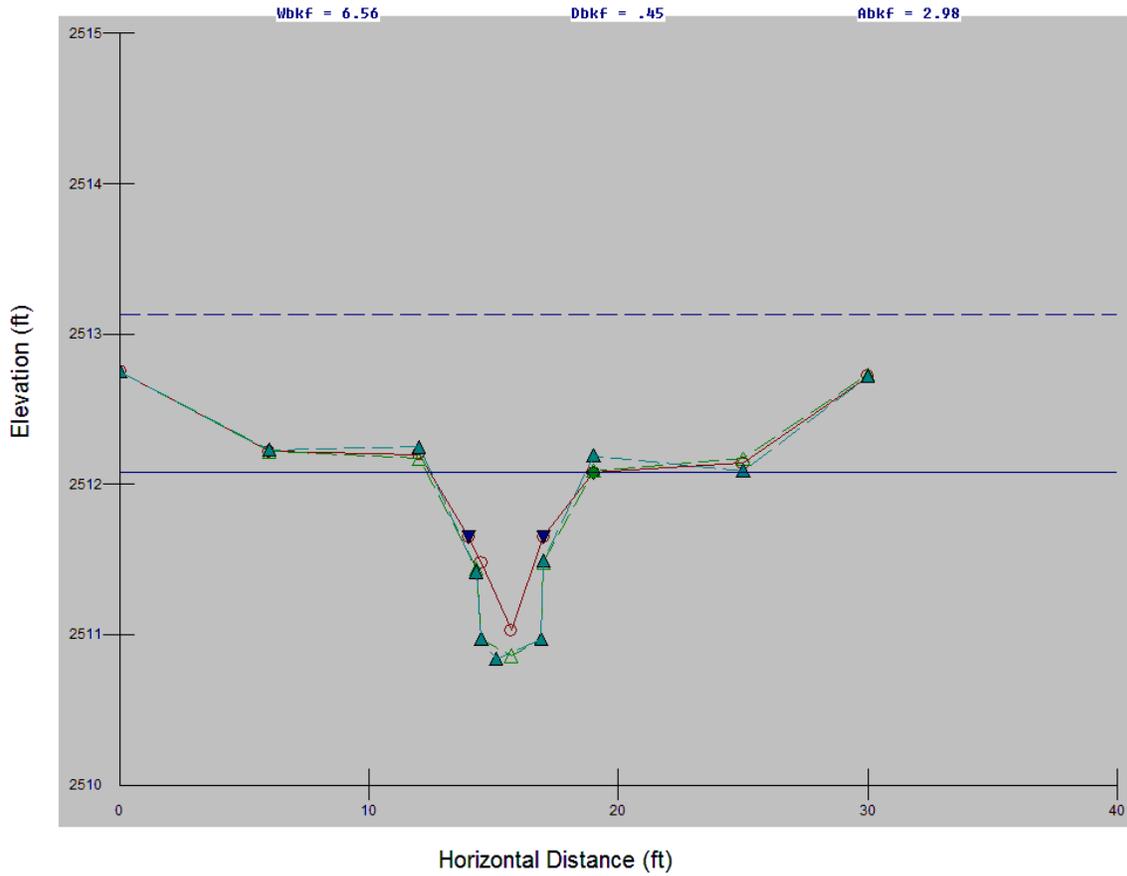
### R-2519A Site 32 XS#1 @ STA 85+00

Based on comparisons of the As-Built to the monitoring data, all of the cross sections appear stable with little or no active bank erosion. Some sediment deposition was noted within the upstream portion of the site as seen in Cross Section #1. Graphs of the cross sections are presented in Appendix A. Future survey data will vary depending on actual location of rod placement and alignment; however, this information should remain similar in appearance. The longitudinal profile showed that the channel bed had formed a headcut at longitudinal profile Sta. 140+00. The right bank at longitudinal profile Sta. 179+00 is scouring causing an undercut bank. NCDOT plans to repair the stream. Pebble counts were not required per the permit conditions and therefore were not completed. One bankfull event was documented visually by a noted wrack line at Site #32 during the 2014 monitoring year but none were visually noted in 2015.

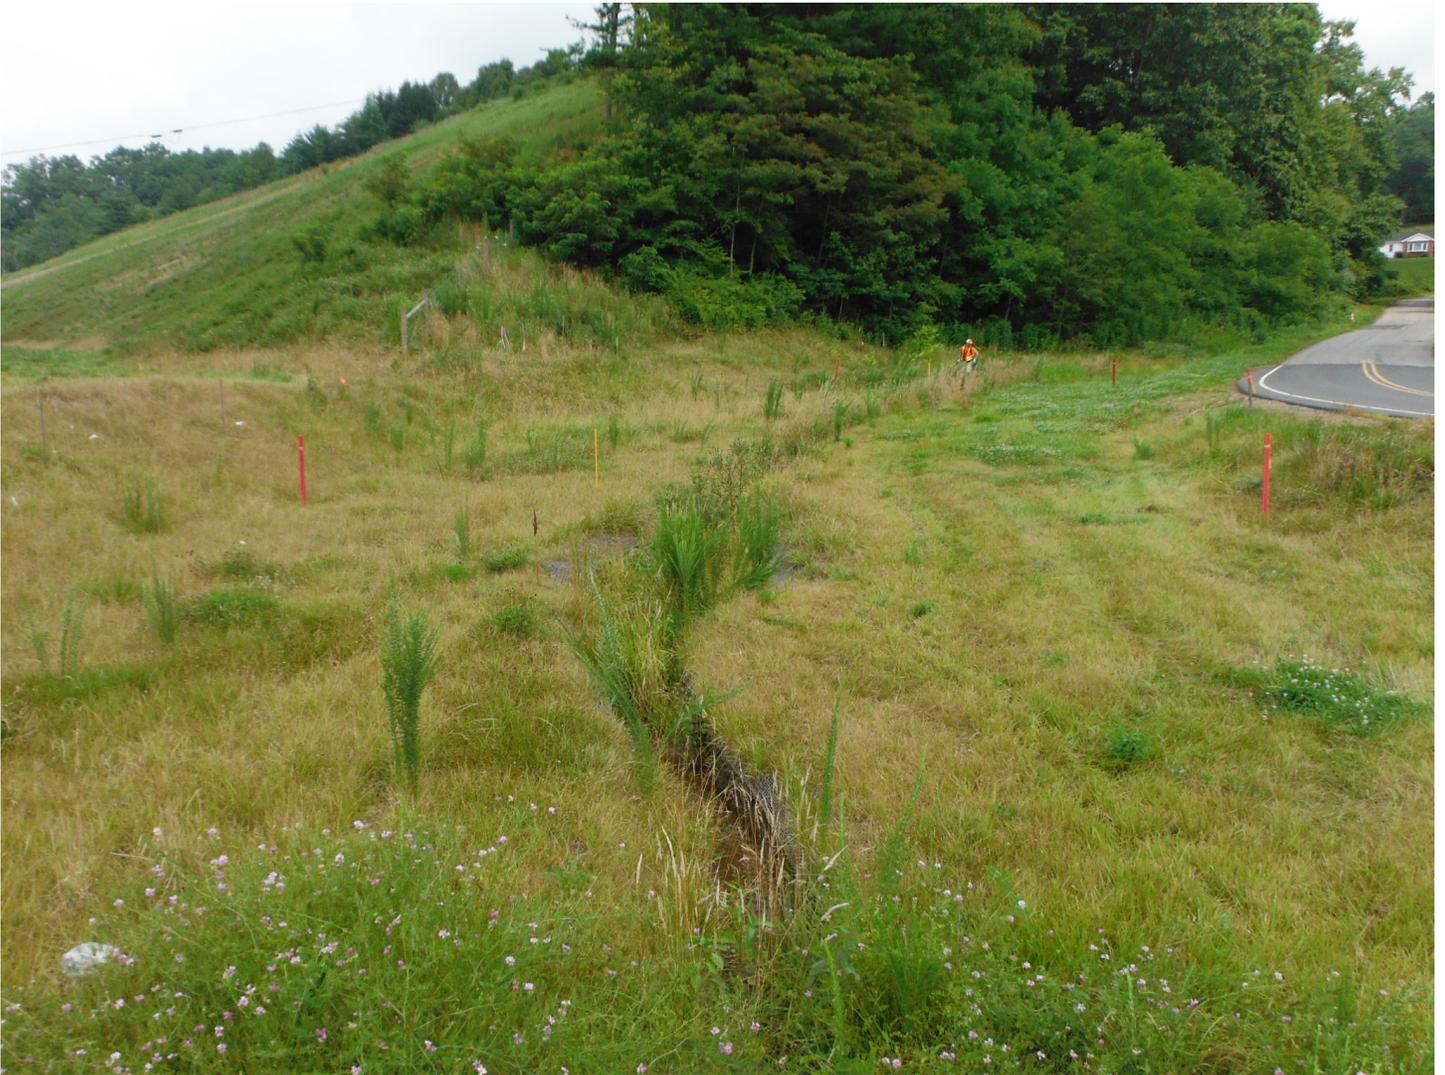
Vegetation Overview Photo

**Streambank & Buffer Vegetation:** The streambank reforestation was completed in March 2015. Approximately half of the streambank reforestation was completed due to stream repairs scheduled to be made in the future. The Year 1 vegetation monitoring evaluation noted Type I: Silky Willow and Silky Dogwood and Type II: Green Ash and Tulip Poplar were surviving at the time of the monitoring evaluation. Majority of the northeast buffer had been mowed after planting took place.

NCDOT will replant the entire site after the stream repairs are made. NCDOT will also sign the perimeter of the site to prevent further encroachments.
