ANNUAL REPORT FOR 2014

**Shoal Creek Site #29 Mitigation Site
Yancey County
TIP No. R-2519A
COE Action ID: SAW-2007-2197-357/300
DWR #: 2007-1134V.4**

Prepared By:
Natural Environment Section & Roadside Environmental Unit
North Carolina Department of Transportation
December 2014

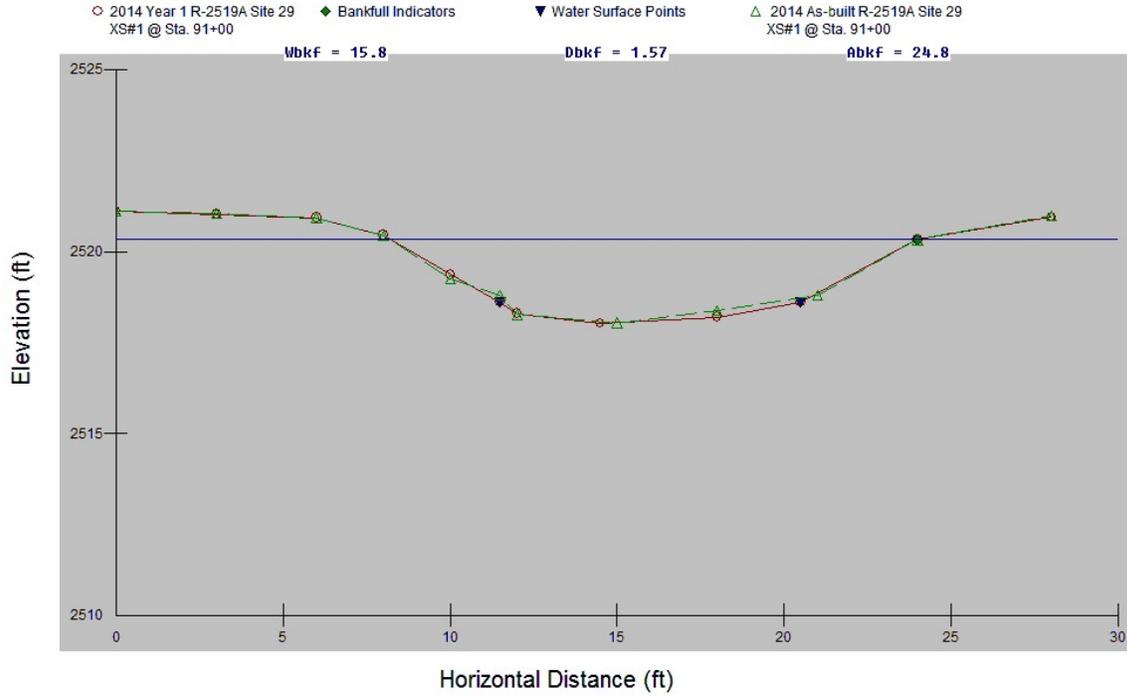
R-2519A Site 29 XS#1 @ Sta. 91+00

Based on comparisons of the As-Built to the monitoring data, all of the cross sections appear stable with little or no active bank erosion. Graphs of the cross sections are presented in Appendix A. Future survey data will vary depending on actual location of rod placement and alignment; however, this information should remain similar in appearance. The longitudinal profile showed that the channel was stable for the 2014 monitoring evaluation. Pebble counts were not required per the permit conditions and therefore were not completed. One bankfull event was documented visually by a noted wrack line at Site #29 during the 2014 monitoring year.

Site #29: Cross-Section #1 (Pool) Abbreviated Morphological Summary					
	2014	2015	2016	2017	2018
Bankfull Cross Sectional Area (ft ²)	24.81				
Maximum Bankfull Depth (ft.)	2.3				
Bankfull Mean Depth (ft.)	1.57				
Bankfull Width (ft.)	15.78

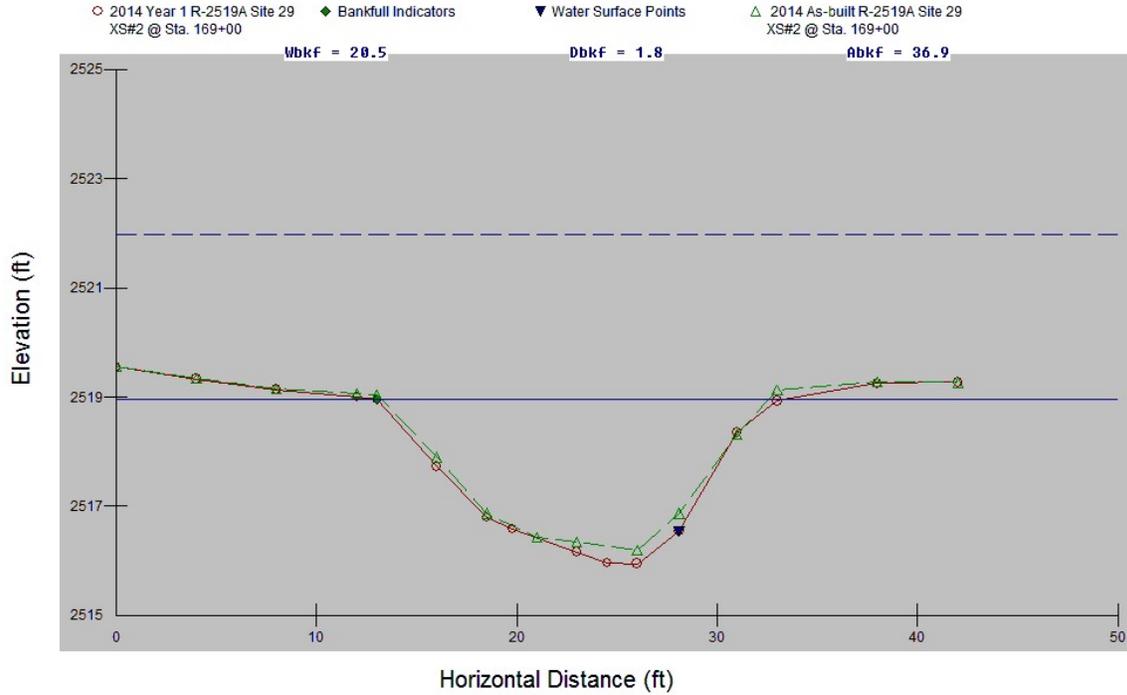
R-2519A Site 29 XS#2 @ Sta. 169+00

Site #29: Cross-Section #2 (Riffle) Abbreviated Morphological Summary					
	2014	2015	2016	2017	2018
Bankfull Cross Sectional Area (ft ²)	36.94				
Maximum Bankfull Depth (ft.)	3.01				
Width of the Floodprone Area (ft.)	42				
Bankfull Mean Depth (ft.)	1.8				
Width/Depth Ratio	11.37				
Entrenchment Ratio	2.05				
Bankfull Width (ft.)	20.47
