# ANNUAL REPORT FOR 2015

**Shoal Creek Site #29 Mitigation Site  
Yancey County  
TIP No. R-2519A  
COE Action ID: SAW-2007-2197-357/300  
DWR #: 2007-1134V.4**

Prepared By:  
Natural Environment Section & Roadside Environmental Unit  
North Carolina Department of Transportation  
November 2015

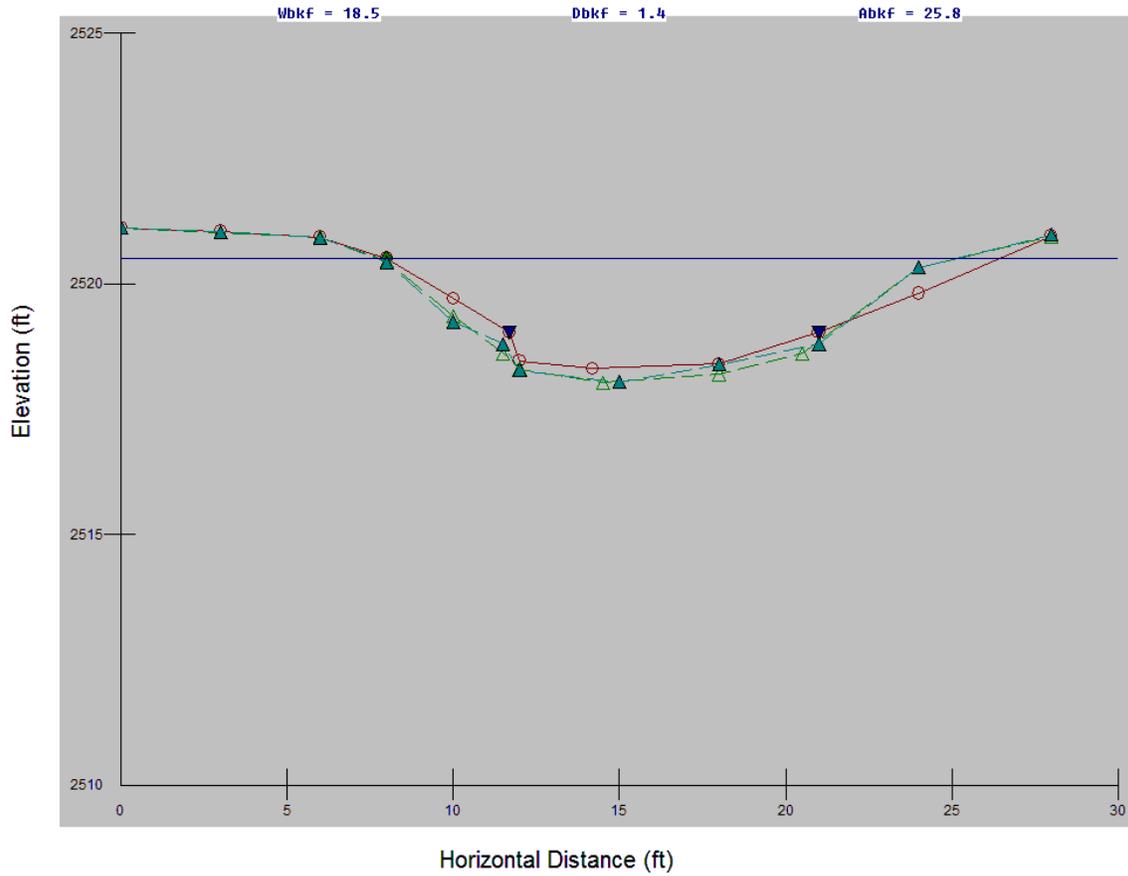
### R-2519A Site 29 XS#1 @ STA 91+00

Based on comparisons of the As-Built to the monitoring data, all of the cross sections appear stable with little or no active bank erosion. Graphs of the cross sections are presented in Appendix A. Future survey data will vary depending on actual location of rod placement and alignment; however, this information should remain similar in appearance. The longitudinal profile showed that the channel was stable for the 2015 monitoring evaluation. Pebble counts were not required per the permit conditions and therefore were not completed. Two bankfull events were documented visually by a noted wrack line at Site #29 during the 2014 and 2015 monitoring years.

Site #29: Cross-Section #1 (Pool) Abbreviated Morphological Summary					
	2014	2015	2016	2017	2018
<b>Bankfull Cross Sectional Area (ft<sup>2</sup>)</b>	24.81	25.81			
<b>Maximum Bankfull Depth (ft.)</b>	2.3	2.21			
<b>Bankfull Mean Depth (ft.)</b>	1.57	1.4			
<b>Bankfull Width (ft.)</b>	15.78	18.47

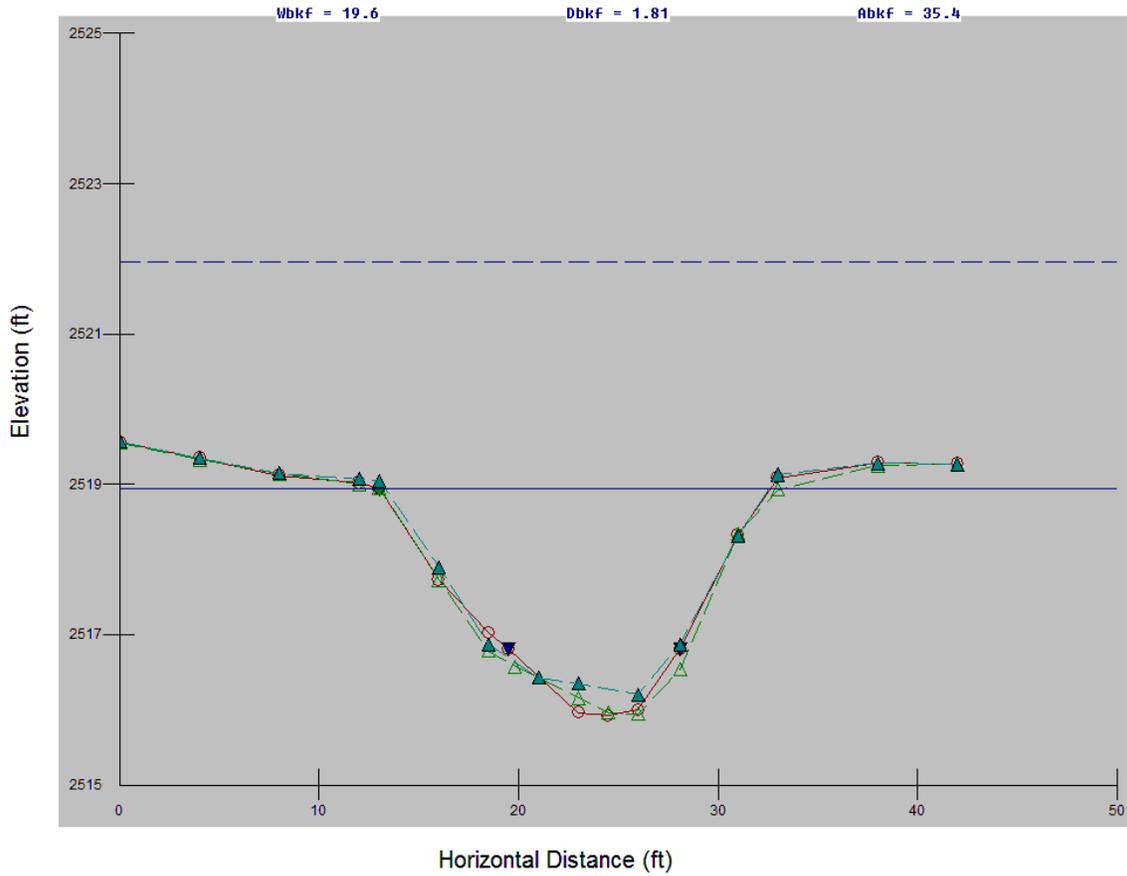
### R-2519A Site 29 XS#2 @ STA 169+00

Site #29: Cross-Section #2 (Riffle) Abbreviated Morphological Summary					
	2014	2015	2016	2017	2018
Bankfull Cross Sectional Area (ft <sup>2</sup> )	36.94	35.43			
Maximum Bankfull Depth (ft.)	3.01	3.02			
Width of the Floodprone Area (ft.)	42	42			
Bankfull Mean Depth (ft.)	1.8	1.81			
Width/Depth Ratio	11.37	10.83			
Entrenchment Ratio	2.05	2.14			
Bankfull Width (ft.)	20.47	19.61

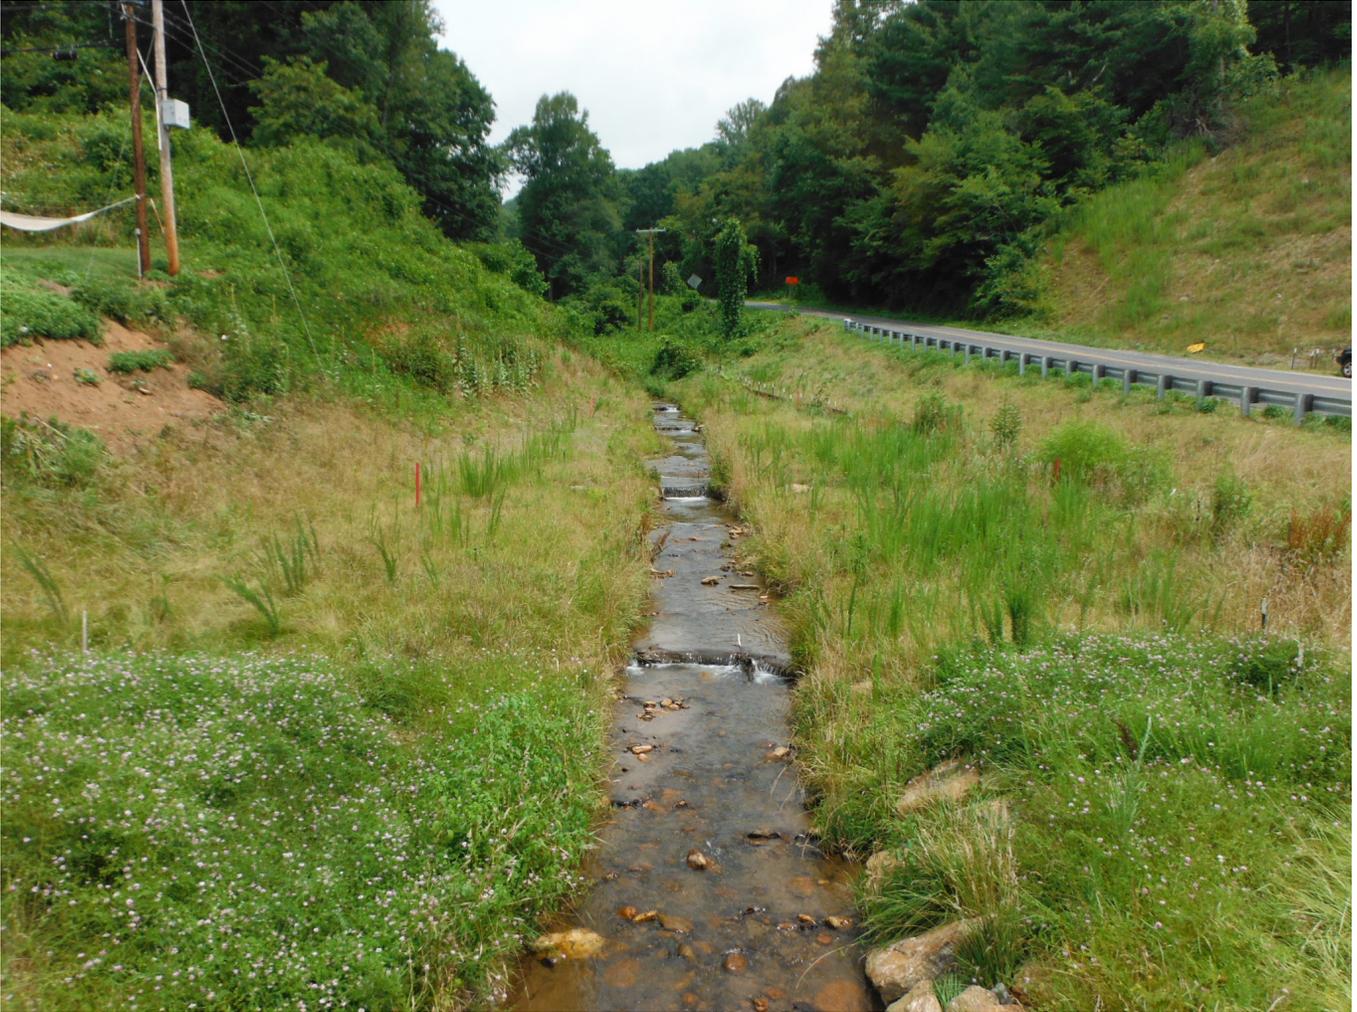
Vegetation Overview Photo

**Streambank & Buffer Vegetation:** The streambank reforestation was completed in March 2015. The Year 1 vegetation monitoring evaluation noted Type I: Silky Willow and Silky Dogwood and Type II: Yellow Poplar, Sycamore, Green Ash, and White Oak were surviving at the time of the monitoring evaluation. The kudzu and Japanese knotweed that was noted onsite was sprayed in July 2015.
