ANNUAL REPORT FOR 2011

**UT to Irish Buffalo Creek Mitigation Site
Cabarrus County
TIP No. R-2533B (Site 12)**

Prepared By:
Natural Environment Unit & Roadside Environmental Unit
North Carolina Department of Transportation
September 2011

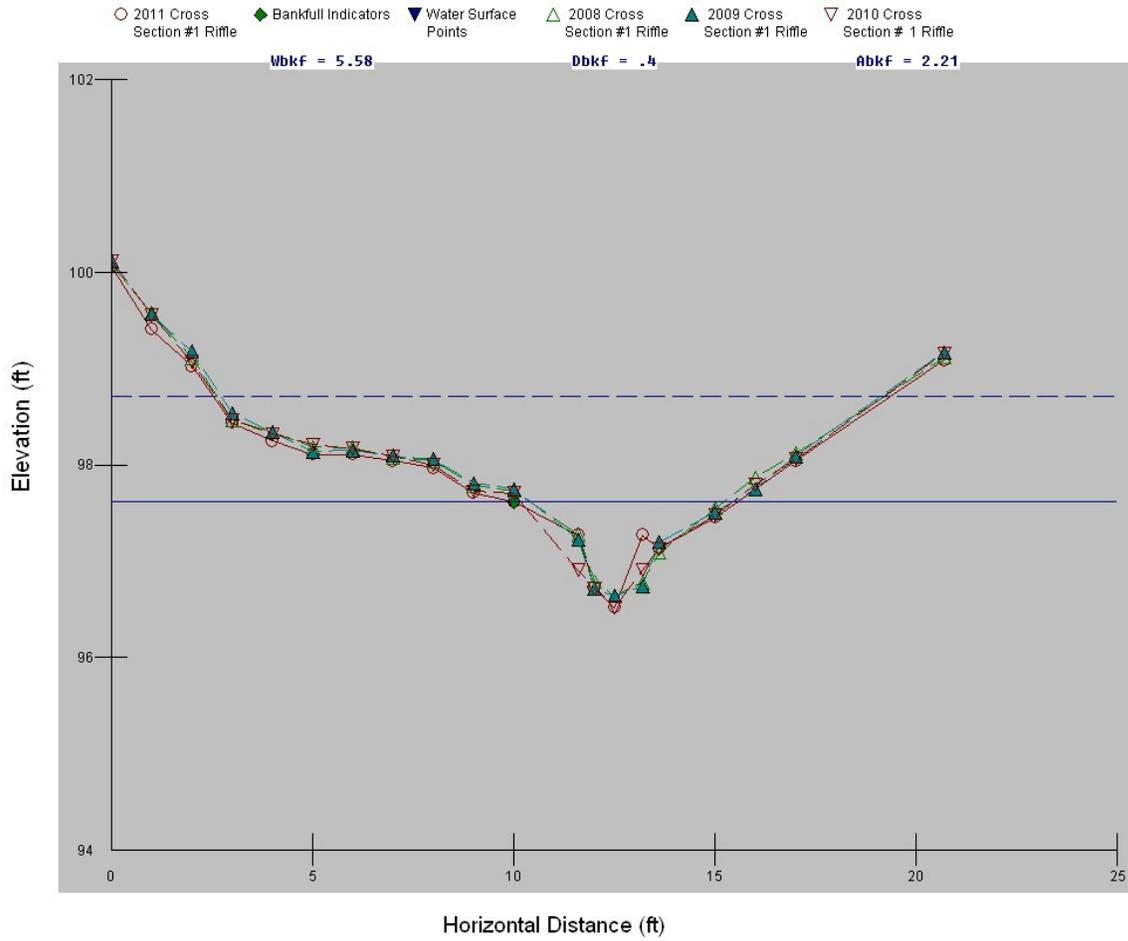
Cross Section #1 Riffle

Based on comparisons of all four years of monitoring data, all of the cross sections appear stable with little or no active bank erosion. Graphs of the cross sections are presented in Appendix A. Future survey data will vary depending on actual location of rod placement and alignment; however, this information should remain similar in appearance. Pebble counts were not required per the permit conditions and therefore were not completed.
