# ANNUAL REPORT FOR 2009

**UT to Cold Water Creek Mitigation Site  
Cabarrus County  
TIP No. R-2533B (Site 23)**

Prepared By:  
Natural Environment Unit & Roadside Environmental Unit  
North Carolina Department of Transportation  
October 2009

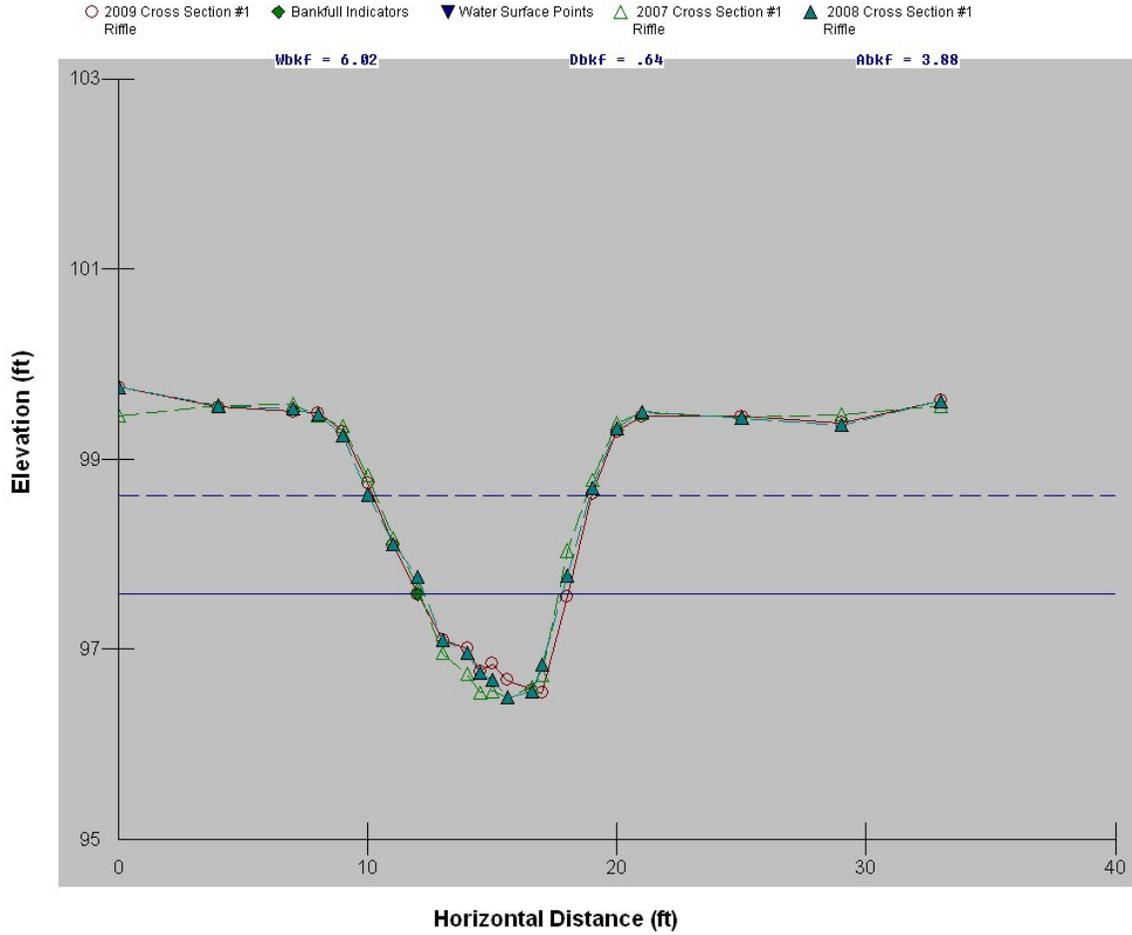
### R-2533B Site #23 XS-1 Riffle

Based on comparisons of Year 2008 and Year 2009 monitoring data, all of the cross sections appear stable with little or no active bank erosion. Graphs of the cross sections are presented in Appendix A. Future survey data will vary depending on actual location of rod placement and alignment; however, this information should remain similar in appearance. Pebble counts were not required per the permit conditions and therefore were not completed.

Site #23: Cross-Section #1 (Riffle) Abbreviated Morphological Summary

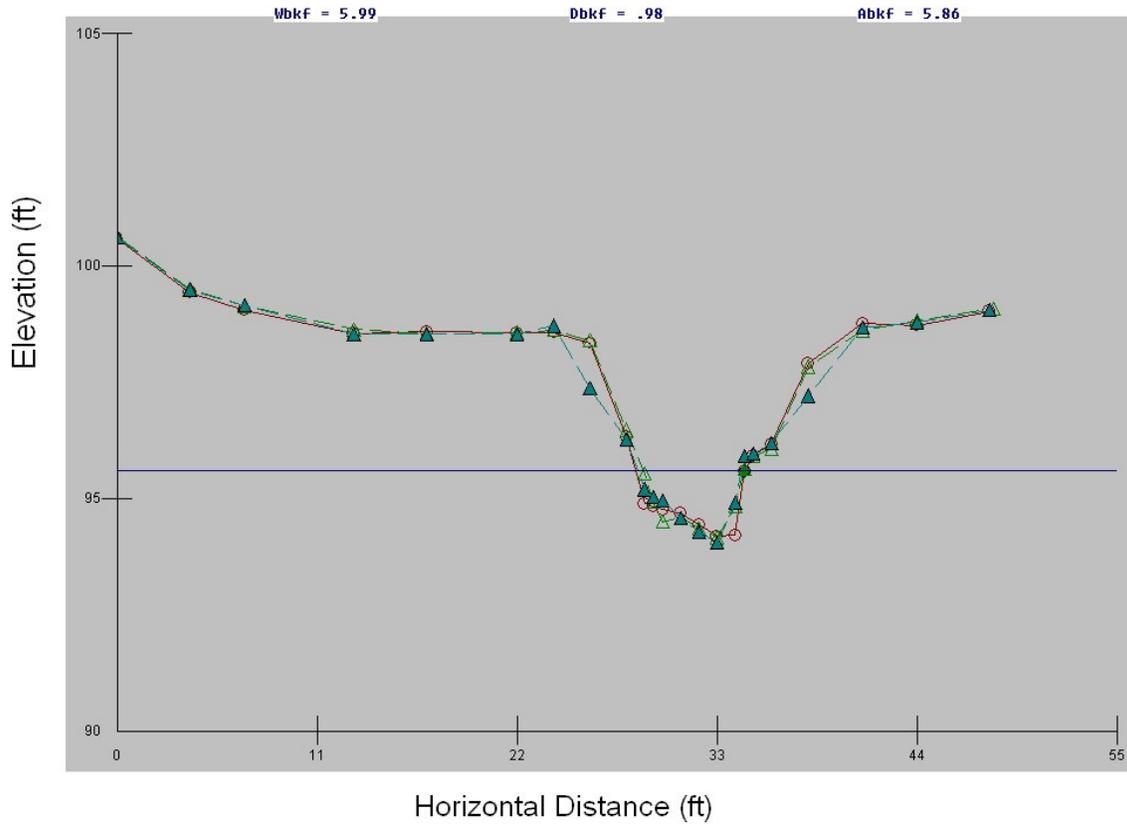
# R-2533 Site #23 XS-2 Pool

**Site #23: Cross-Section #2 (Pool) Abbreviated Morphological Summary\***
