# ANNUAL REPORT FOR 2013

**Unnamed Tributary to Howell Branch  
Wayne County  
TIP No. R-2554BA – Site 5  
COE Action ID: SAW 2008–00252  
DWQ #: 20080570**

Prepared By:  
Roadside Environmental Unit & Natural Environment Section  
North Carolina Department of Transportation  
July 2013

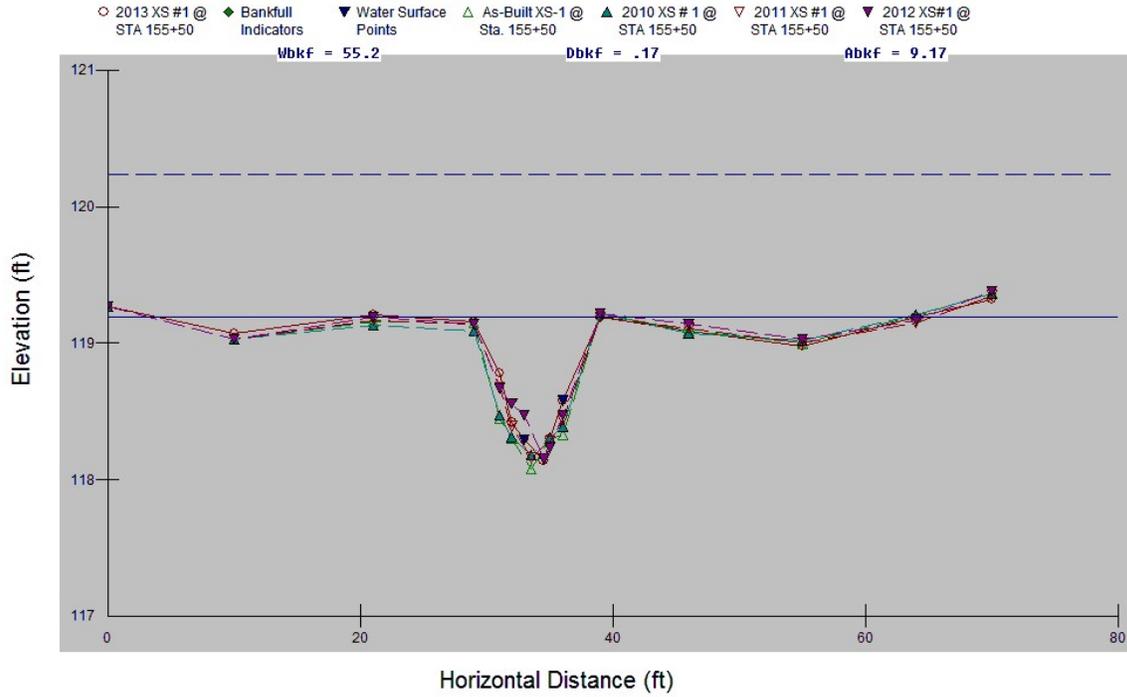
### Riffle Cross Section #1 @ Sta. 155+50

Based on comparisons of the as-built to the monitoring data, all four cross sections appear stable with little or no active bank erosion. Graphs of the cross sections are presented in Appendix A. Future survey data will vary depending on actual location of rod placement and alignment; however this information should remain similar in appearance.

Cross-Section #1 (Riffle) Abbreviated Morphological Summary					
	2010	2011	2012	2013	2014
Bankfull Width (ft)	10	10	10	10	
Bankfull Mean Depth (ft)	0.67	0.6	0.58	0.55	
Width/Depth Ratio	14.93	16.67	17.24	18.18	
Bankfull Cross Sectional Area (ft <sup>2</sup> )	6.75	6	5.81	5.48	
Maximum Bankfull Depth (ft)	1.04	1.03	1.07	1.05	
Width of the Floodprone Area (ft)	70	70	70	70	
Entrenchment Ratio	7	7	7	7

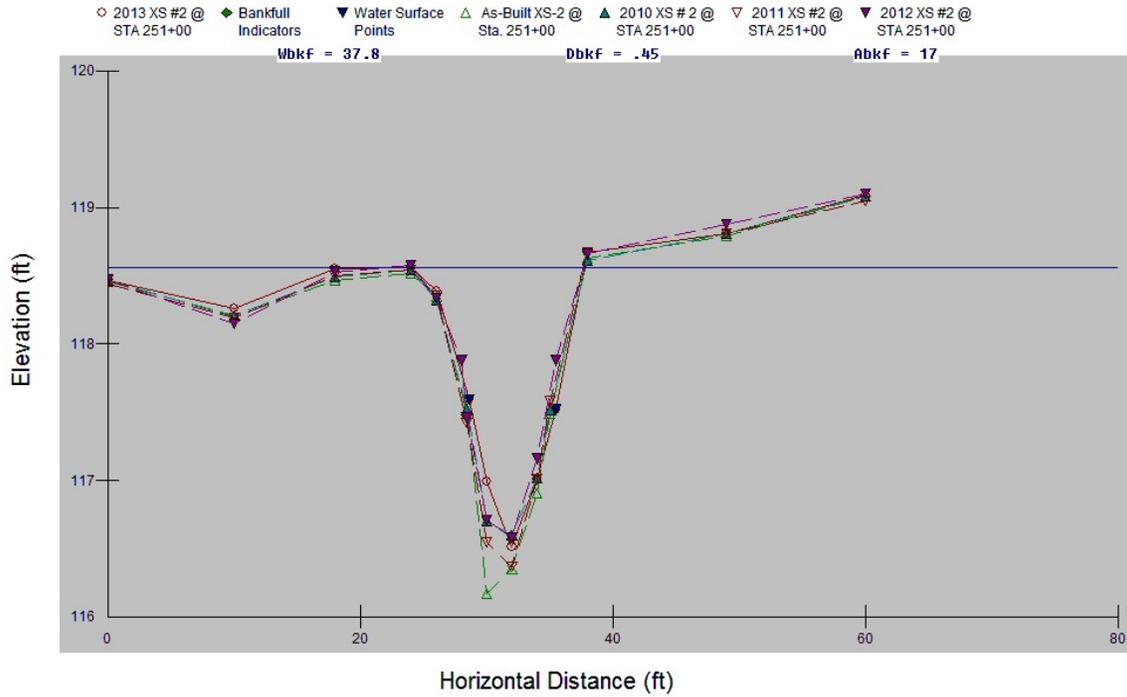
### Pool Cross Section #2 @ STA 251+00

Cross-Section #2 (Pool) Abbreviated Morphological Summary*					
	2010	2011	2012	2013	2014
Bankfull Cross Sectional Area (ft <sup>2</sup> )	13.94	14.62	13.6	13.77	
Maximum Bankfull Depth (ft)	1.94	2.17	2	2.05	
Bankfull Mean Depth (ft)	1.01	1.07	0.99	1	
Bankfull Width (ft)	13.81	13.64	13.74	13.76

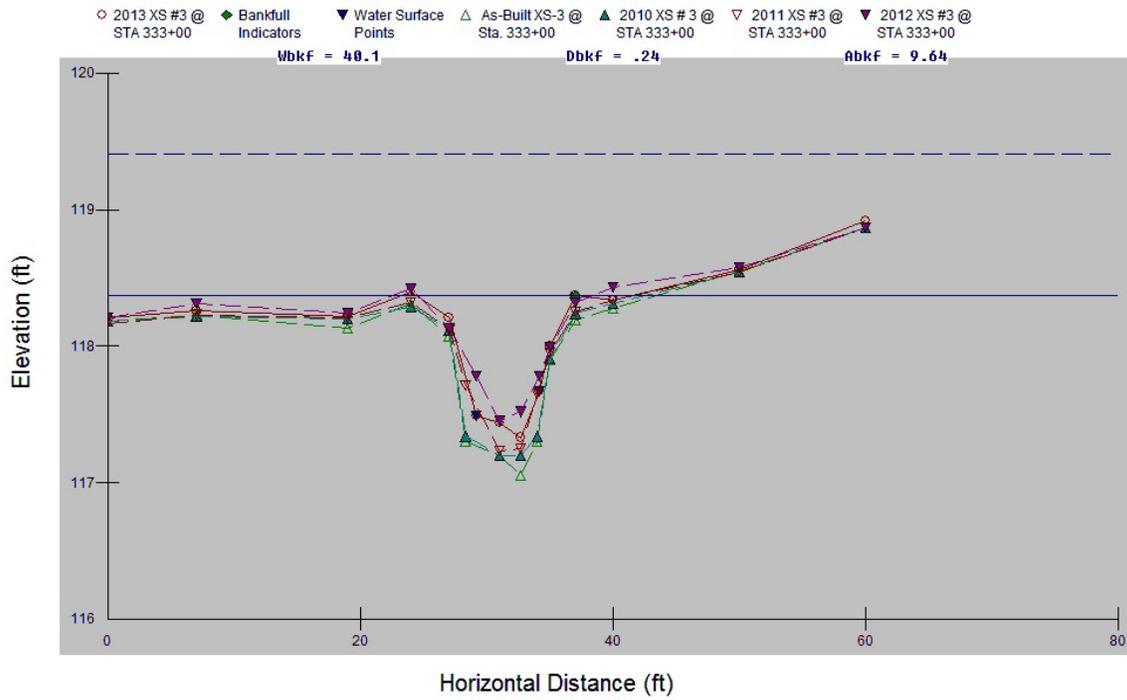
### Riffle Cross Section #3 @ STA 333+00

Cross-Section #3 (Riffle) Abbreviated Morphological Summary					
	2010	2011	2012	2013	2014
Bankfull Width (ft)	12.12	11.95	11.97	12.53	
Bankfull Mean Depth (ft)	0.61	0.52	0.45	0.54	
Width/Depth Ratio	19.87	22.98	26.6	23.2	
Bankfull Cross Sectional Area (ft <sup>2</sup> )	7.38	6.18	5.36	6.75	
Maximum Bankfull Depth (ft)	1.04	1.02	0.87	1.04	
Width of the Floodprone Area (ft)	60	60	60	60	
Entrenchment Ratio	4.95	5.02	5.01	4.79

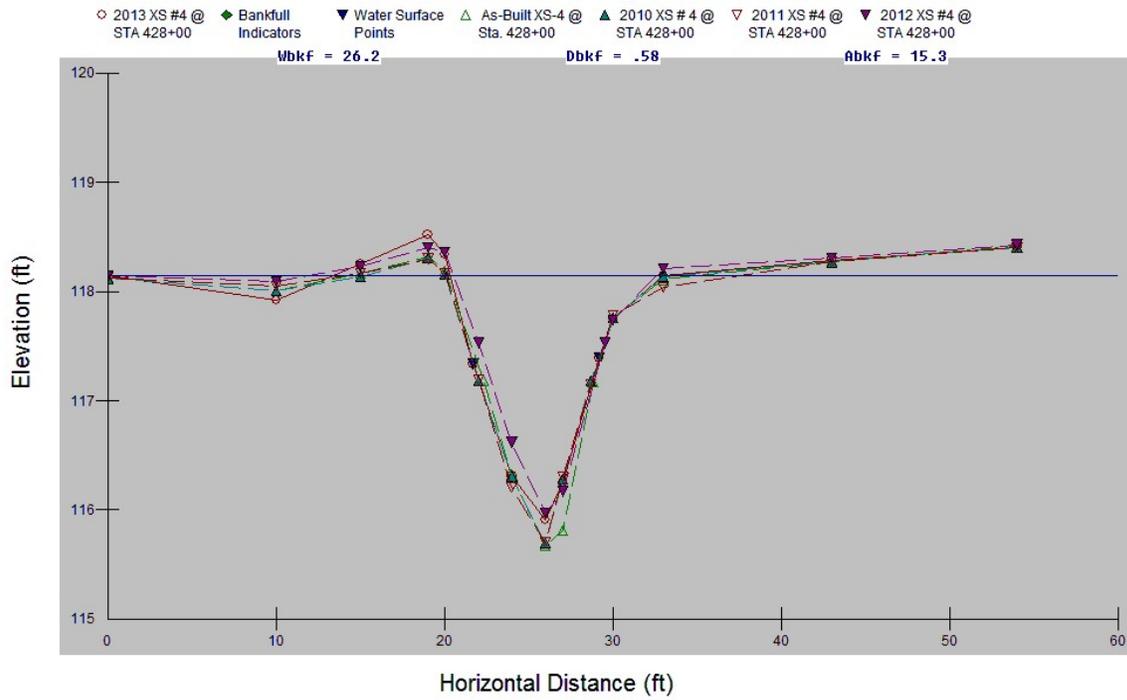
### Pool Cross Section #4 @ STA 428+00

Cross-Section #4 (Pool) Abbreviated Morphological Summary*					
	2010	2011	2012	2013	2014
Bankfull Cross Sectional Area (ft <sup>2</sup> )	13.99	12.73	13.19	13.75	
Maximum Bankfull Depth (ft)	2.44	2.34	2.24	2.24	
Bankfull Mean Depth (ft)	1.08	1.02	1.04	1.08	
Bankfull Width (ft)	12.96	12.73	12.64	12.68

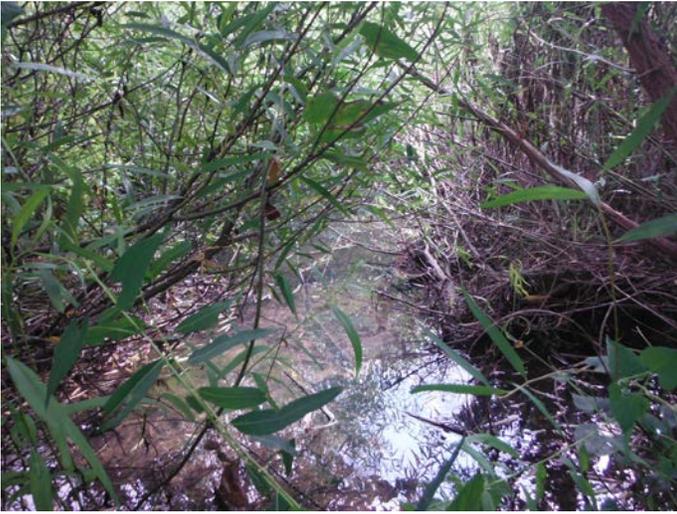
Photo Point #1 (Upstream)

A visual inspection of the channel and photos taken from photo points 1 through 4 showed that the channel bed is stable throughout the stream relocation at this time.
