ANNUAL REPORT FOR 2014

**Unnamed Tributary to Smith Mill Run
Wayne County
TIP No. R-2554BA – Permitted Site 4
COE Action ID: SAW-200-00252
DWQ #: 20080570**

Prepared By:
Roadside Environmental Unit & Natural Environment Section
North Carolina Department of Transportation
August 2014

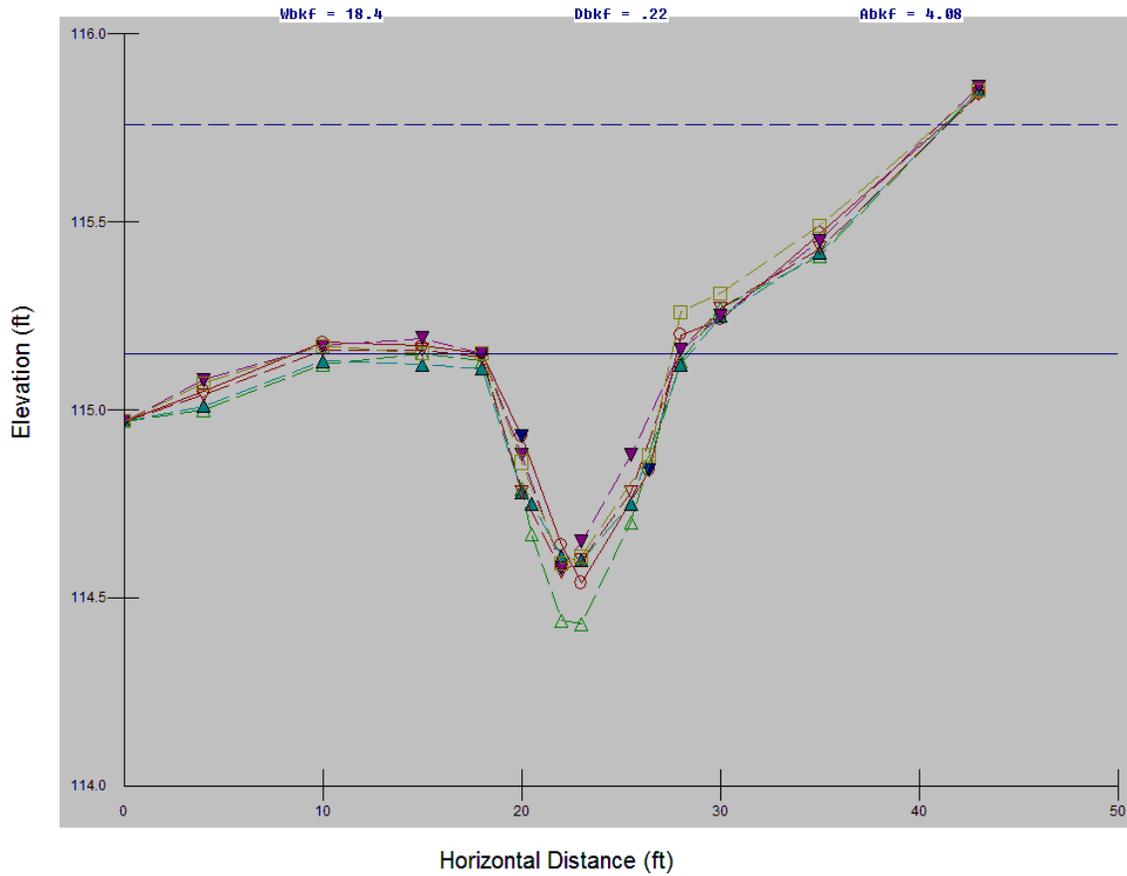
R-2554BA Site 4 XS-1 @ Sta. 166+00

Cross-Section #1 (Riffle) Abbreviated Morphological Summary					
	2010	2011	2012	2013	2014
Bankfull Width (ft)	9.93	9.87	9.91	9.54	9.78
Bankfull Mean Depth (ft)	0.32	0.34	0.30	0.34	0.34
Width/Depth Ratio	31.03	29.03	33.03	28.06	28.76
Bankfull Cross Sectional Area (ft ²)	3.18	3.4	2.93	3.22	3.29
Maximum Bankfull Depth (ft)	0.51	0.57	0.57	0.56	0.61
Width of the Floodprone Area (ft)	43	40.46	40.27	39.89	41.27
Entrenchment Ratio	3.9	4.1	4.06	4.18	4.22

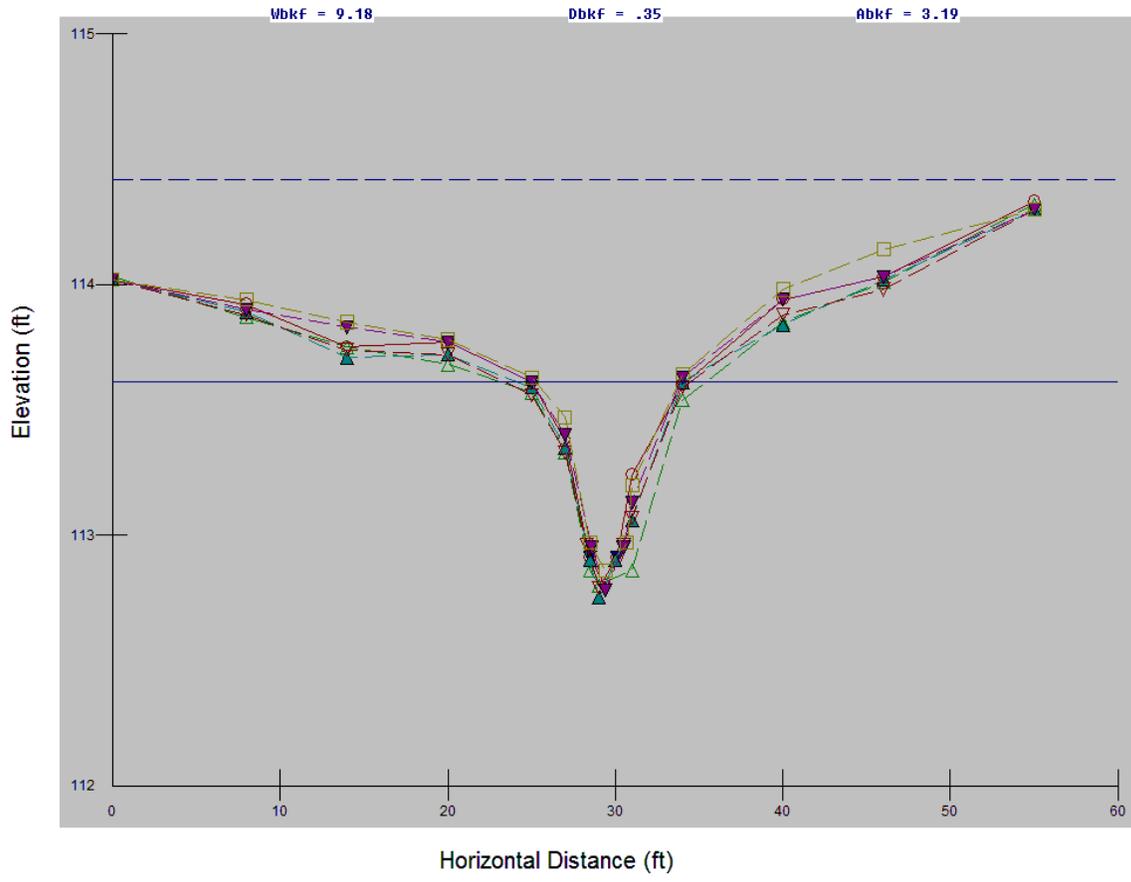
R-2554BA Site 4 XS-3 @ Sta 329+00

Cross-Section #3 (Riffle) Abbreviated Morphological Summary					
	2010	2011	2012	2013	2014
Bankfull Width (ft)	8.89	8.83	8.88	8.93	9.18
Bankfull Mean Depth (ft)	0.39	0.37	0.37	0.35	0.35
Width/Depth Ratio	22.79	23.86	24	25.51	26.23
Bankfull Cross Sectional Area (ft ²)	3.46	3.24	3.3	3.14	3.19
Maximum Bankfull Depth (ft)	0.84	0.77	0.83	0.77	0.81
Width of the Floodprone Area (ft)	55	55	55	55	55
Entrenchment Ratio	6.19	6.23	6.19	6.16	5.99

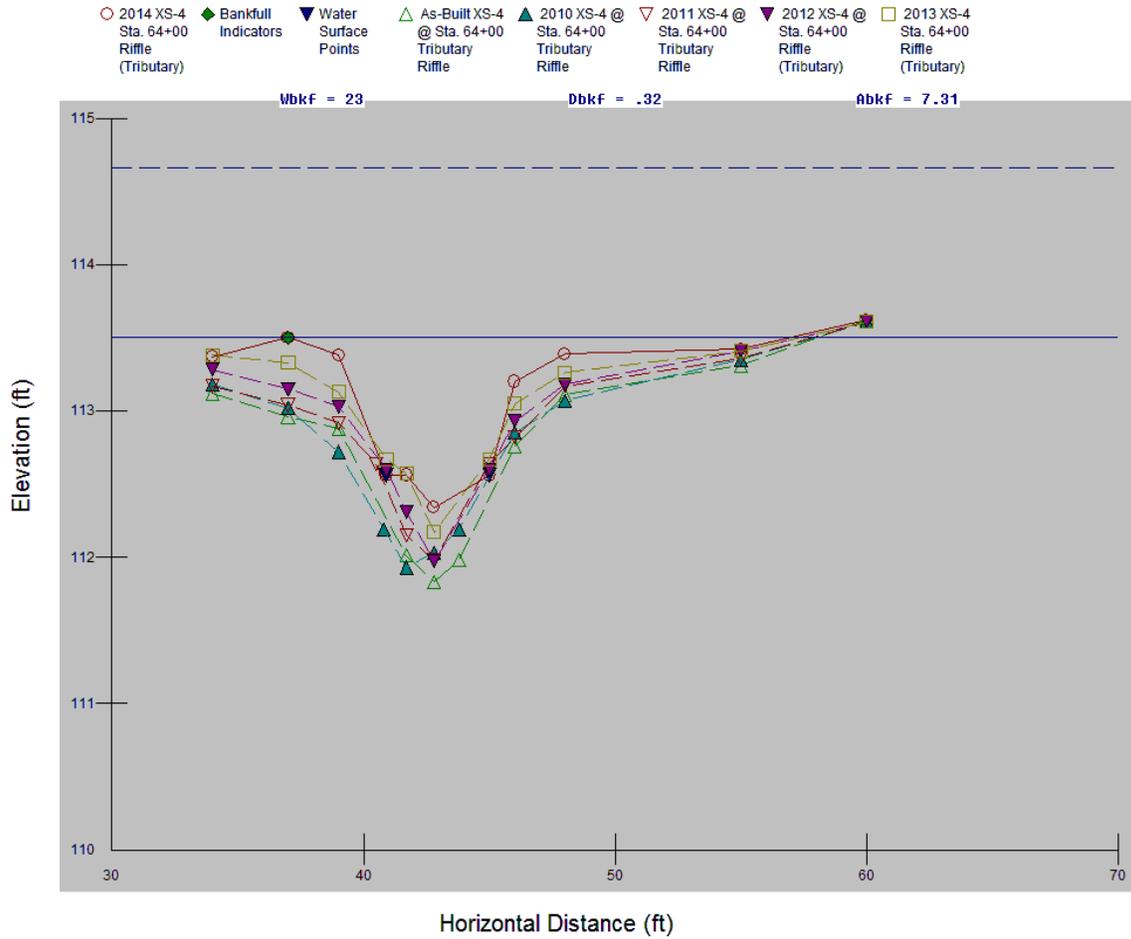
R-2554BA Site 4 Riffle XS-4 @ Sta. 64+00 (Tributary)

Cross-Section #4 (Tributary Riffle) Abbreviated Morphological Summary					
	2010	2011	2012	2013	2014
Bankfull Width (ft)	10.55	10.26	10.76	14.27	11
Bankfull Mean Depth (ft)	0.52	0.43	0.46	0.39	0.58
Width/Depth Ratio	20.29	23.86	23.39	36.59	18.97
Bankfull Cross Sectional Area (ft ²)	5.47	4.41	4.91	5.58	6.37
Maximum Bankfull Depth (ft)	1.09	1.06	1.18	1.16	1.16
Width of the Floodprone Area (ft)	26	26	26	26	26
Entrenchment Ratio	2.47	2.53	2.42	1.82	2.36

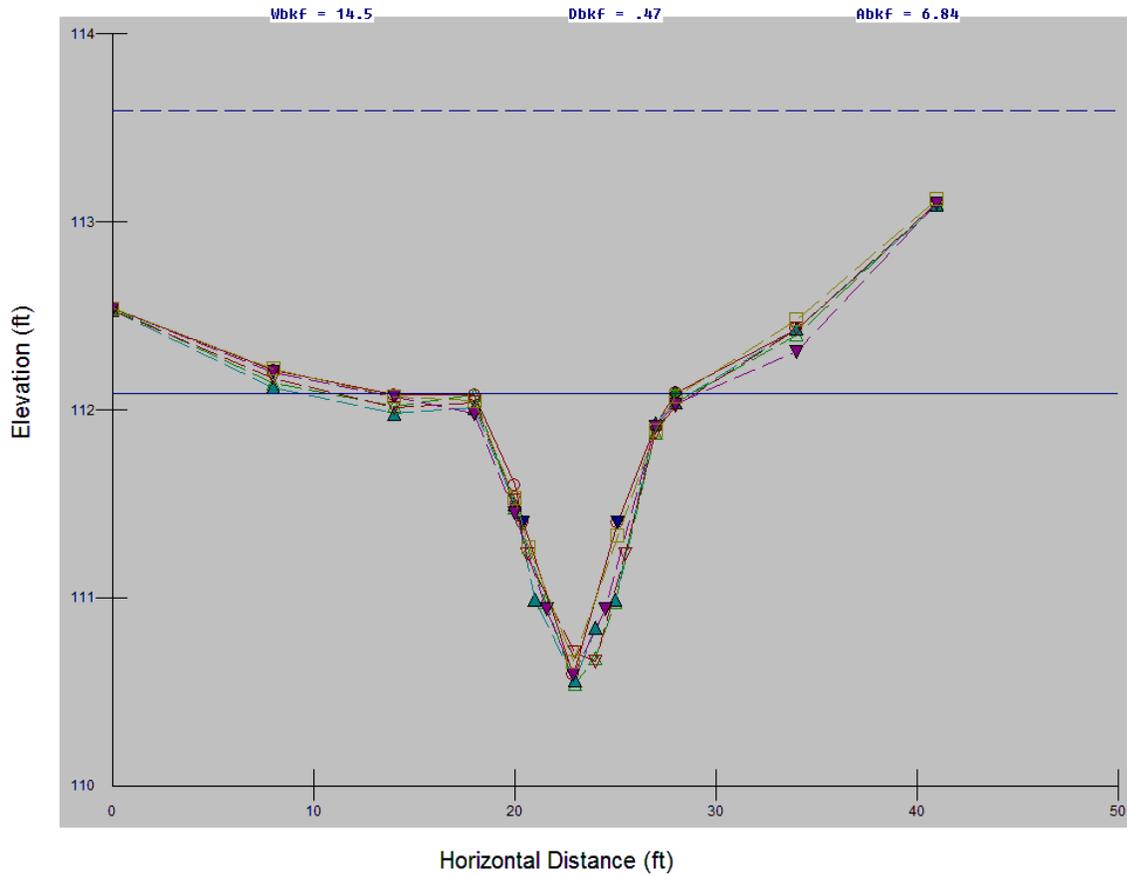
R-2554BA Site 4 XS-6 @ Sta. 805+00

Based on comparisons of the as-built to the monitoring data, all six cross sections appear stable with little or no active bank erosion. Graphs of the cross sections are presented in Appendix A. Future survey data will vary depending on actual location of rod placement and alignment; however this information should remain similar in appearance.

Cross-Section #6 (Riffle) Abbreviated Morphological Summary					
	2010	2011	2012	2013	2014
Bankfull Width (ft)	9.73	9.92	12.22	14	14.46
Bankfull Mean Depth (ft)	0.75	0.72	0.59	0.49	0.47
Width/Depth Ratio	12.97	13.78	20.71	28.57	30.77
Bankfull Cross Sectional Area (ft ²)	7.28	7.1	7.26	6.83	6.84
Maximum Bankfull Depth (ft)	1.45	1.36	1.44	1.41	1.5
Width of the Floodprone Area (ft)	41	41	41	41	41
Entrenchment Ratio	4.21	4.13	3.35	2.93	2.84

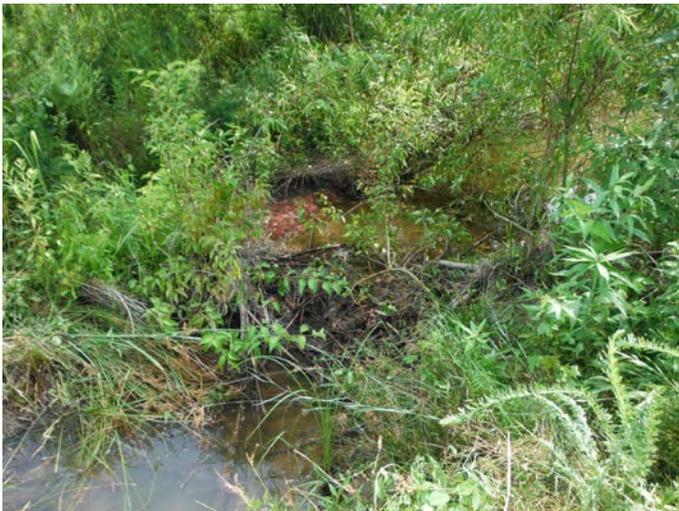
A visual inspection of the channel and photos taken from photo points 1 through 6 showed that the channel bed is stable throughout the stream relocation at this time. Two small beaver dams were noted up and downstream of Cross Section #6. USDA will be contacted to remove the beavers and dams.

Beaver dam upstream of Cross Section #6

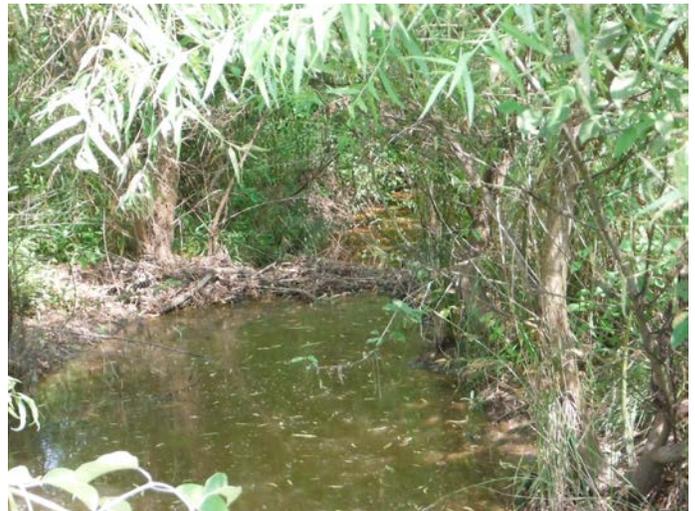
Beaver dam downstream of Cross Section #6
