ANNUAL REPORT FOR 2014

UT to Muddy Creek Mitigation Site

Randolph County

TIP No. R-2606WM

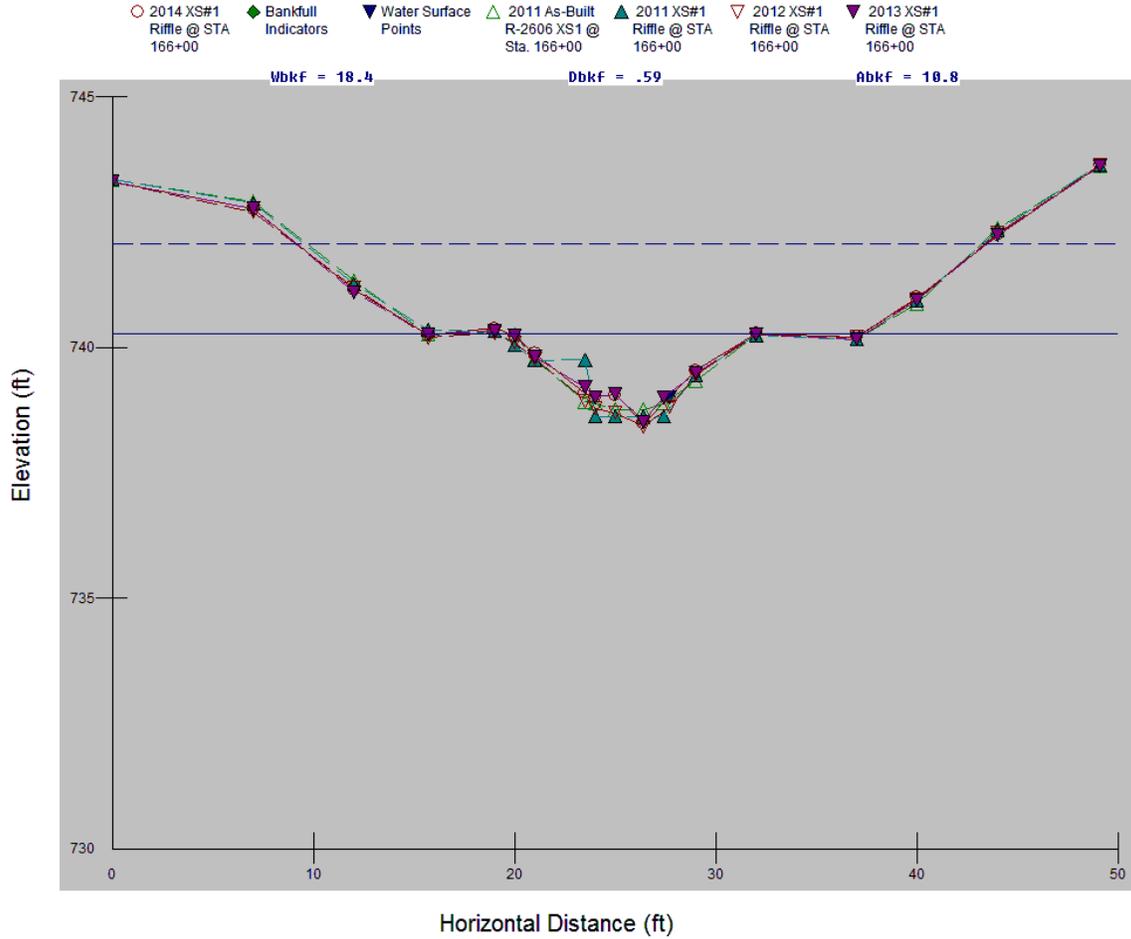
R-2606 XS#1 Riffle @ STA 166+00

Cross-Section #1 (Riffle) Abbreviated Morphological Summary					
	2011	2012	2013	2014	2015
Bankfull Width (ft.)	12.71	12.75	12.3	12.27	
Bankfull Mean Depth (ft.)	0.85	0.94	0.84	0.86	
Width/Depth Ratio	14.95	13.56	14.64	14.27	
Bankfull Cross Sectional Area (ft ²)	10.84	11.93	10.31	10.6	
Maximum Bankfull Depth (ft.)	1.63	1.82	1.75	1.79	
Width of the Floodprone Area (ft.)	32.59	34.21	34.03	34.3	
Entrenchment Ratio	2.56	2.68	2.77	2.8

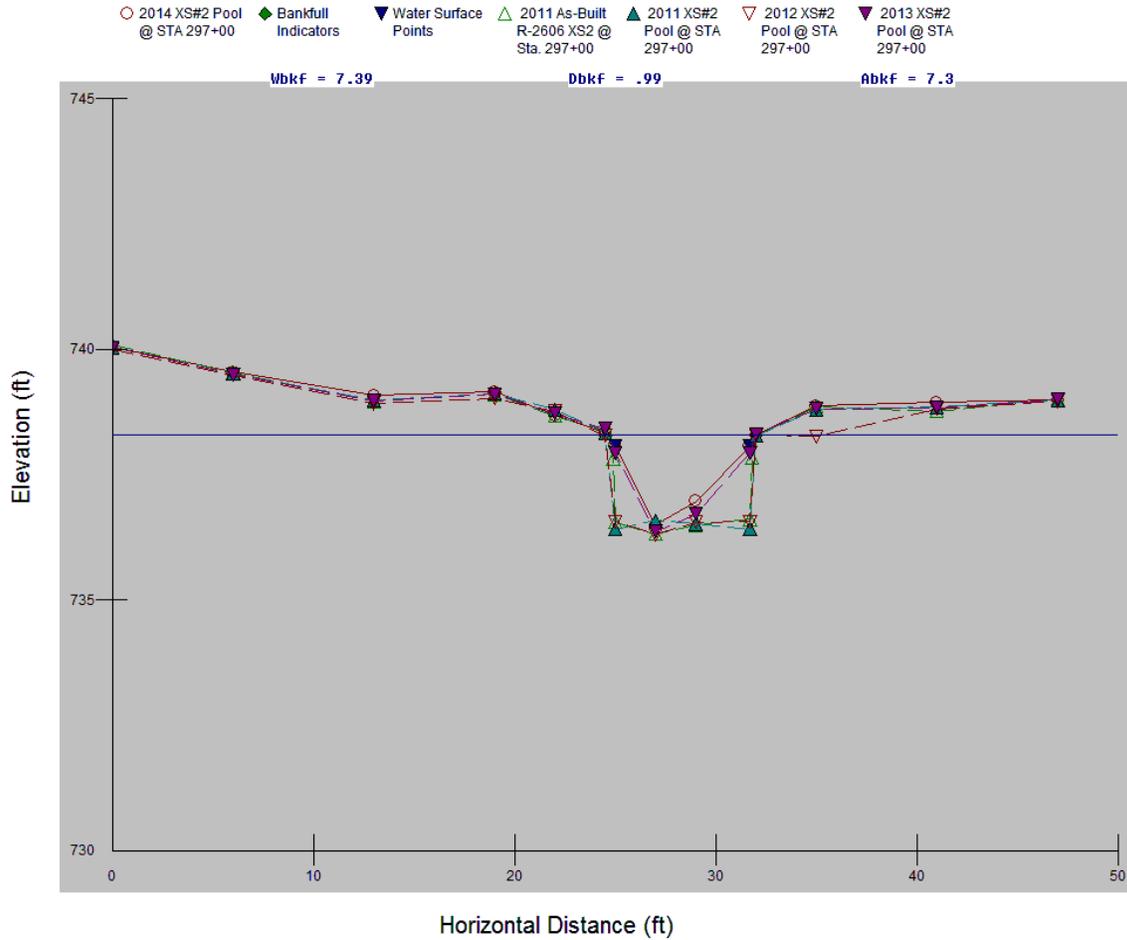
R-2606 XS#2 Pool @ STA 297+00

Cross-Section #2 (Pool) Abbreviated Morphological Summary*					
	2011	2012	2013	2014	2015
Bankfull Cross Sectional Area (ft ²)	17.95	12.52	8.66	7.3	
Maximum Bankfull Depth (ft.)	2.39	1.98	1.95	1.8	
Bankfull Mean Depth (ft.)	1.38	1.15	1.17	0.99	
Bankfull Width (ft.)	13	10.93	7.39	7.39

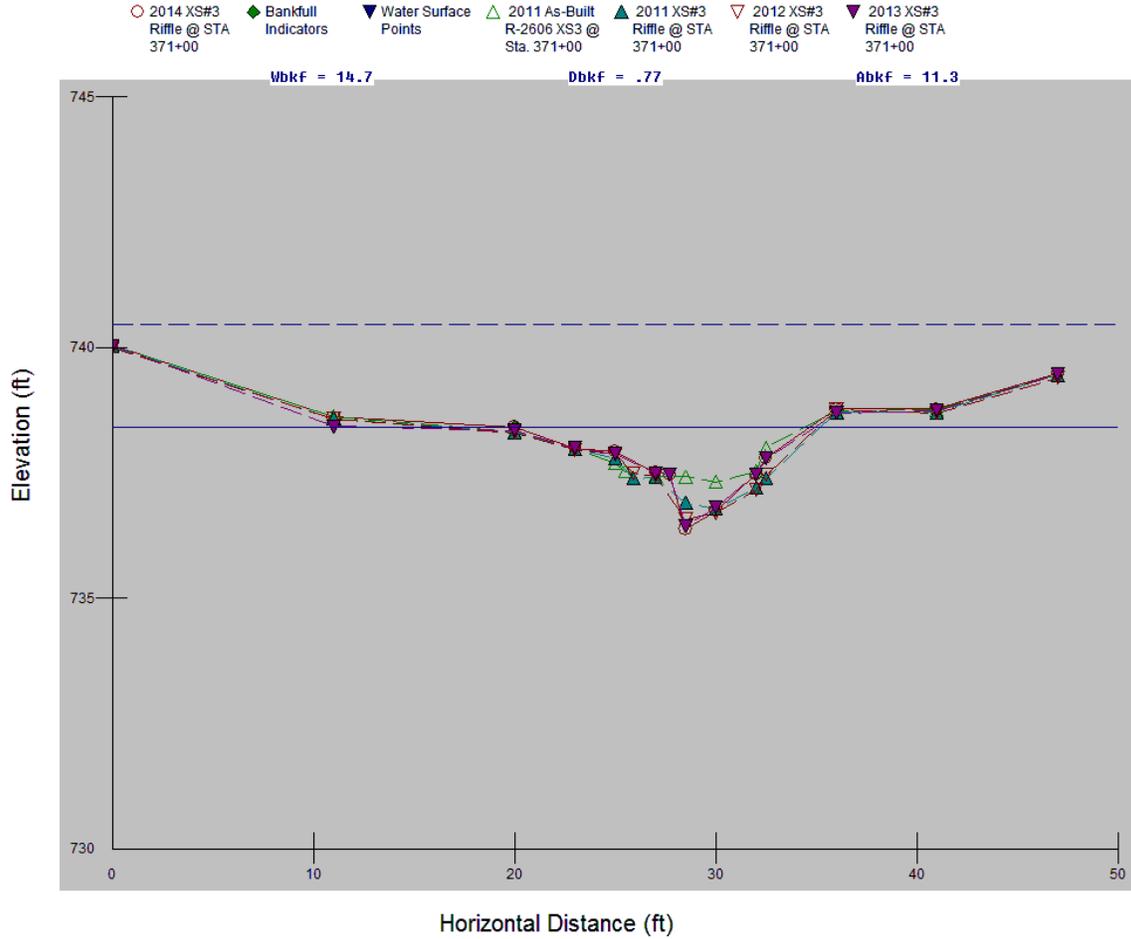
R-2606 XS#3 Riffle @ STA 371+00

Cross-Section #3 (Riffle) Abbreviated Morphological Summary					
	2011	2012	2013	2014	2015
Bankfull Width (ft.)	14.94	14.76	14.65	14.71	
Bankfull Mean Depth (ft.)	0.75	0.77	0.71	0.77	
Width/Depth Ratio	19.92	19.17	20.63	19.1	
Bankfull Cross Sectional Area (ft ²)	11.18	11.38	10.37	11.29	
Maximum Bankfull Depth (ft.)	1.53	1.73	1.91	2.04	
Width of the Floodprone Area (ft.)	45.62	47	47	47	
Entrenchment Ratio	3.05	3.18	3.21	3.19

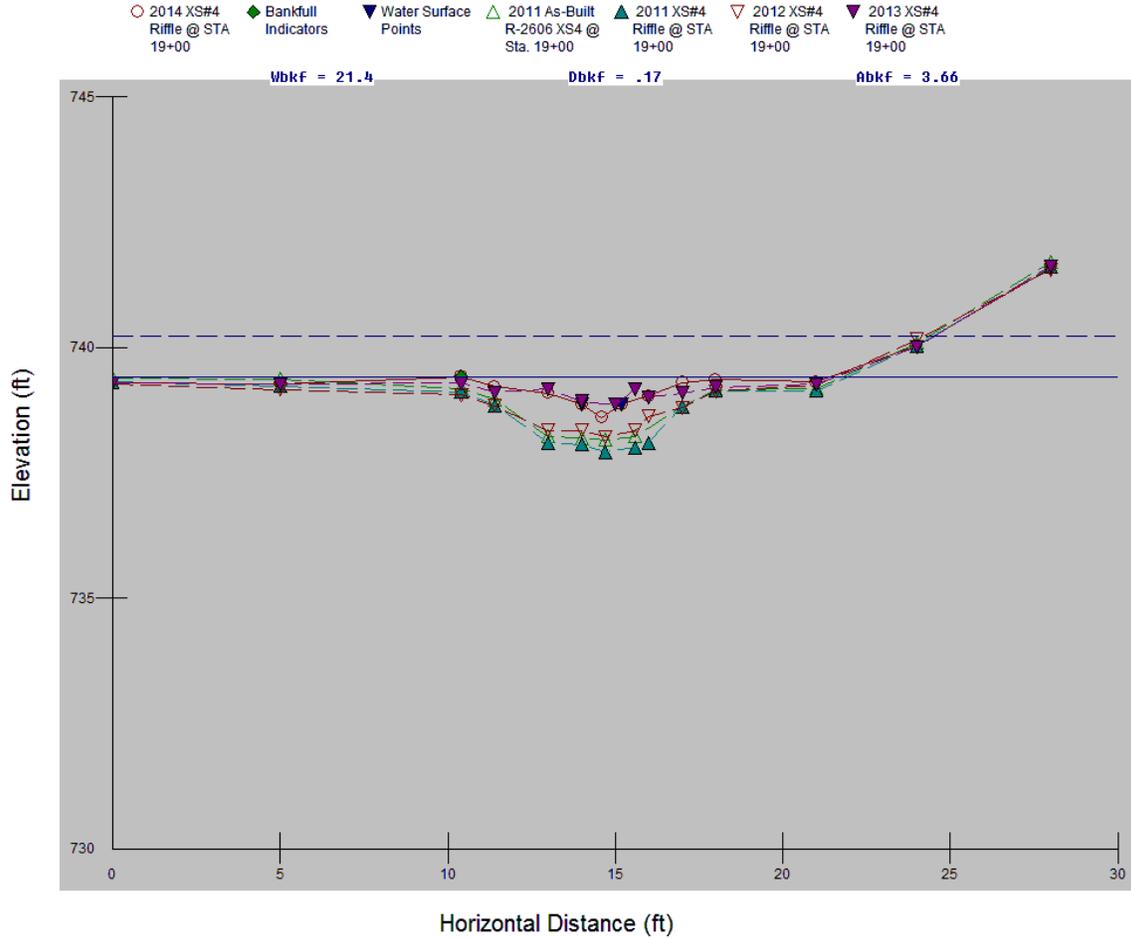
R-2606 XS#4 Riffle @ STA 19+00

Cross-Section #4 (Riffle) Abbreviated Morphological Summary					
	2011	2012	2013	2014	2015
Bankfull Width (ft.)	8.95	7.39	10.68	10.6	
Bankfull Mean Depth (ft.)	0.61	0.47	0.17	0.25	
Width/Depth Ratio	14.67	15.72	62.82	42.4	
Bankfull Cross Sectional Area (ft ²)	5.42	3.48	1.76	2.66	
Maximum Bankfull Depth (ft.)	1.22	0.84	0.43	0.81	
Width of the Floodprone Area (ft.)	24.84	23.11	22.82	24.47	
Entrenchment Ratio	3.05	3.13	2.14	2.31

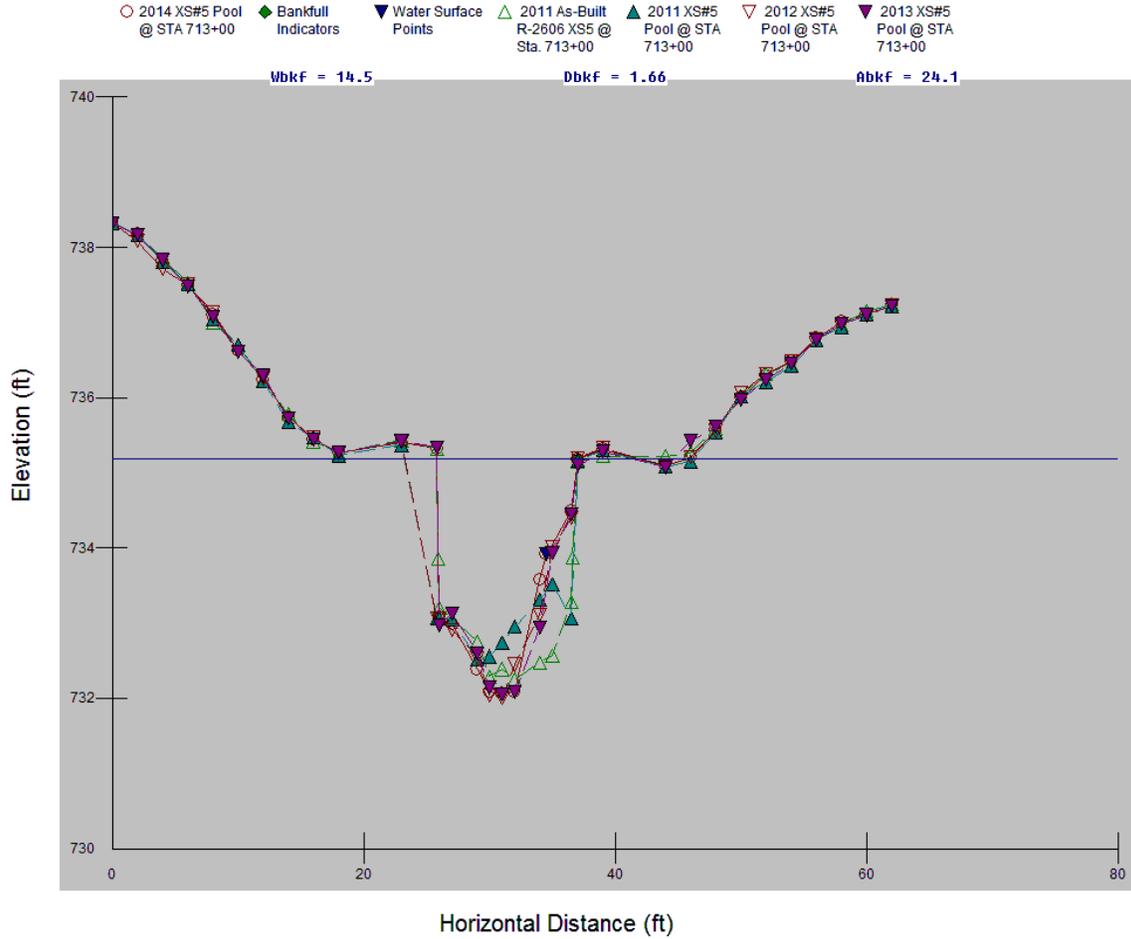
R-2606 XS#5 Pool @ STA 713+00

Cross-Section #5 (Pool) Abbreviated Morphological Summary*					
	2011	2012	2013	2014	2015
Bankfull Cross Sectional Area (ft ²)	26.83	27.78	23.86	24.12	
Maximum Bankfull Depth (ft.)	2.65	3.19	3.04	3.11	
Bankfull Mean Depth (ft.)	1.5	1.55	1.98	1.66	
Bankfull Width (ft.)	17.9	17.87	12.07	14.55

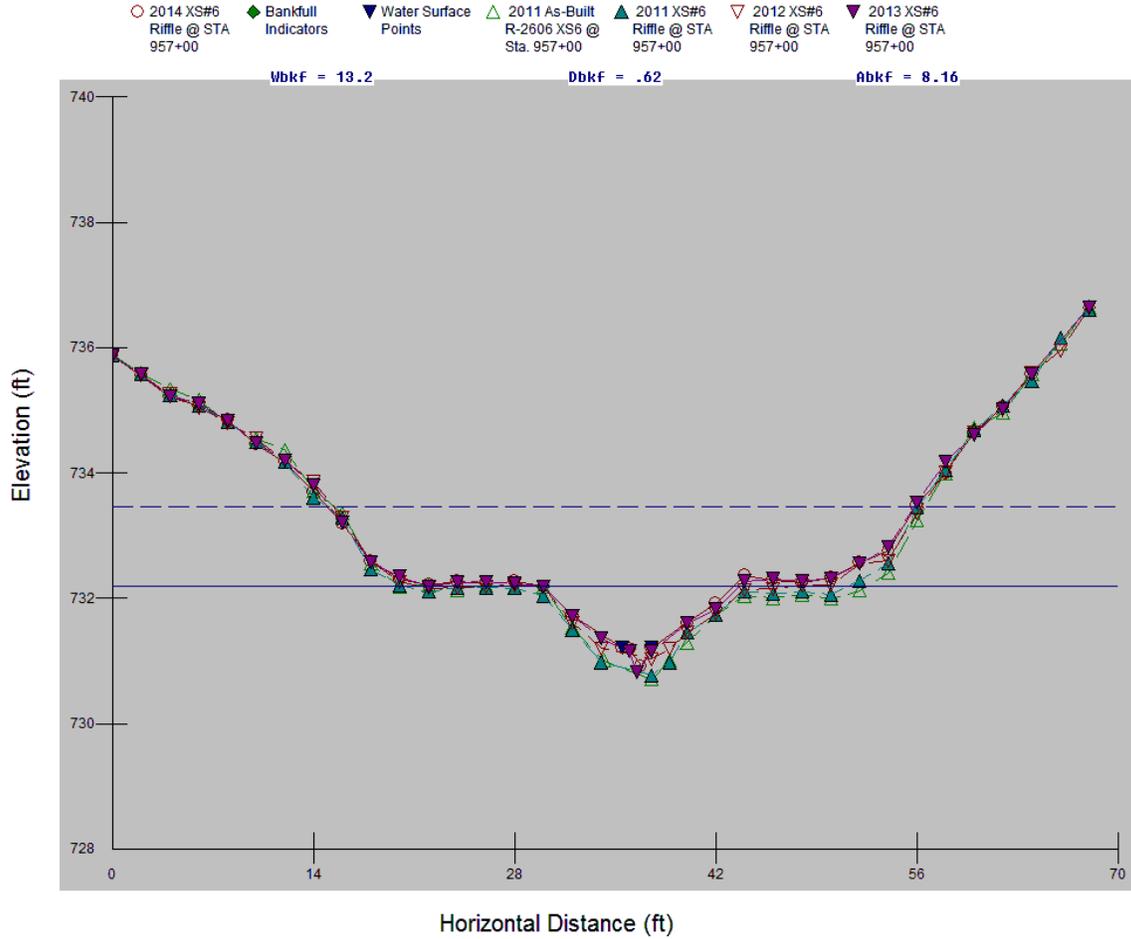
R-2606 XS#6 Riffle @ STA 957+00

Cross-Section #6 (Riffle) Abbreviated Morphological Summary					
	2011	2012	2013	2014	2015
Bankfull Width (ft.)	15	13.79	14	13.23	
Bankfull Mean Depth (ft.)	0.71	0.67	0.7	0.62	
Width/Depth Ratio	21.13	20.58	20	21.34	
Bankfull Cross Sectional Area (ft ²)	10.72	9.21	9.85	8.16	
Maximum Bankfull Depth (ft.)	1.33	1.1	1.45	1.27	
Width of the Floodprone Area (ft.)	40.86	39.49	42.32	40.98	
Entrenchment Ratio	2.72	2.86	3.02	3.1

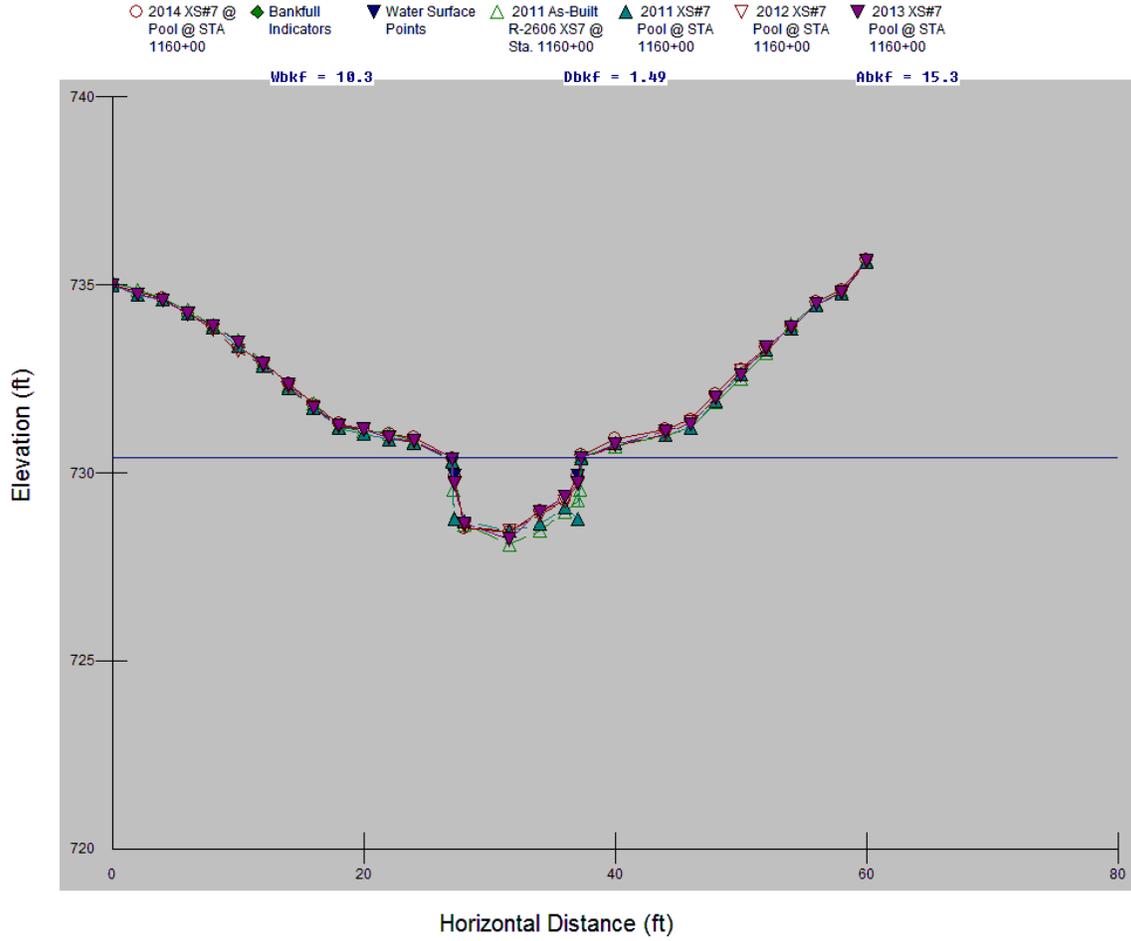
R-2606 XS#7 @ Pool @ STA 1160+00

Cross-Section #7(Pool) Abbreviated Morphological Summary*					
	2011	2012	2013	2014	2015
Bankfull Cross Sectional Area (ft ²)	16.32	15.44	15.55	15.33	
Maximum Bankfull Depth (ft.)	1.85	1.92	2.14	1.97	
Bankfull Mean Depth (ft.)	1.59	1.5	1.51	1.49	
Bankfull Width (ft.)	10.3	10.3	10.29	10.26
