Channel Mitigation Monitoring Sheets I, II, III, AND IV

Project Title: R-2633A COE Action ID: SAW 1994-03552
Stream Name: Bishop Branch DWQ Number: 20100867
DCM Number: 20100138

City, County and other Location Information: Brunswick County, approximately 7 miles southwest of Leland in Bishop, NC on NC 87 (Maco Rd NE) where it departs from US 17 (Ocean Highway E).

August 2015

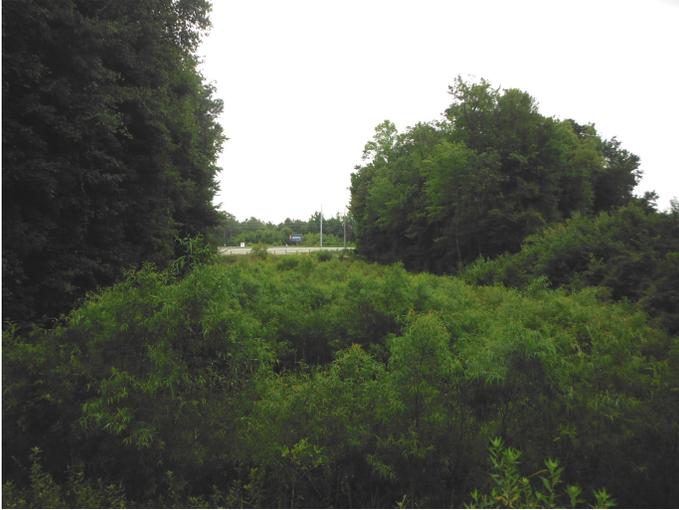
PP #1 looking South

The restoration of the Bishop Branch site involved the removal of the existing pavement and roadway fill of NC 87 Maco Road as well as the existing 72" by 96" CMA and associated headwall. Bishop Branch is stable for the Year 2 monitoring evaluation. A bankfull event was visually documented at this site. NCDOT will continue to monitor channel stability at the Bishop Branch Mitigation Site in 2016.
