Channel Mitigation Monitoring Sheets I, II, III, AND IV  
Monitoring Data Record

Project Title: R-2633A COE Action ID: SAW 1994-03552  
Stream Name: Bishop Branch DWQ Number: 20100867  
DCM Number: 20100138

City, County and other Location Information: Brunswick County, approximately 7 miles southwest of Leland in Bishop, NC on NC 87 (Maco Rd NE) where it departs from US 17 (Ocean Highway E).

Monitoring DATA collected by: J. Young and M. Green Date: 6/24/14

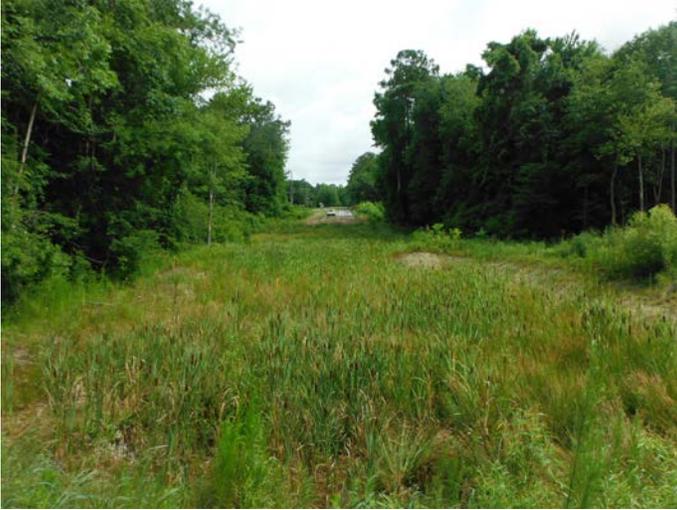
PP #1 looking South

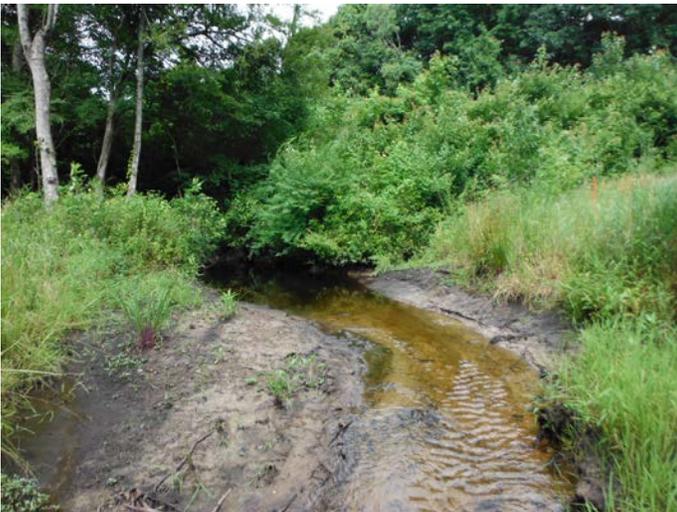
PP #2 looking West (Upstream)

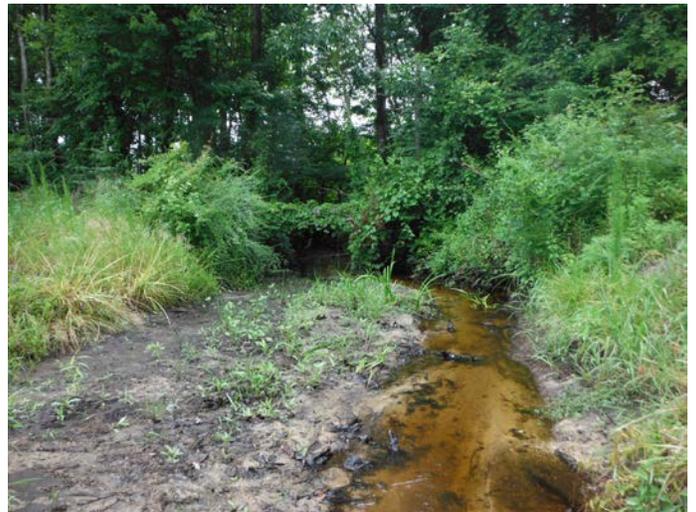
PP #2 looking East (Downstream)

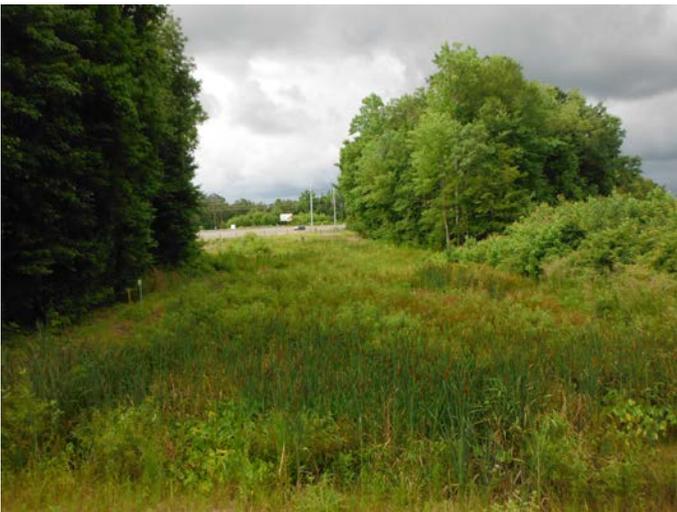
PP #3 looking North
