Monitoring Data Record

Project Title: R-2635C Western Wake Freeway COE Action ID: 2007-02903-292

Stream Name: UT Reedy Branch – Site 3 DWQ Number: 20071470

Monitoring Year: ( 3 ) of 5

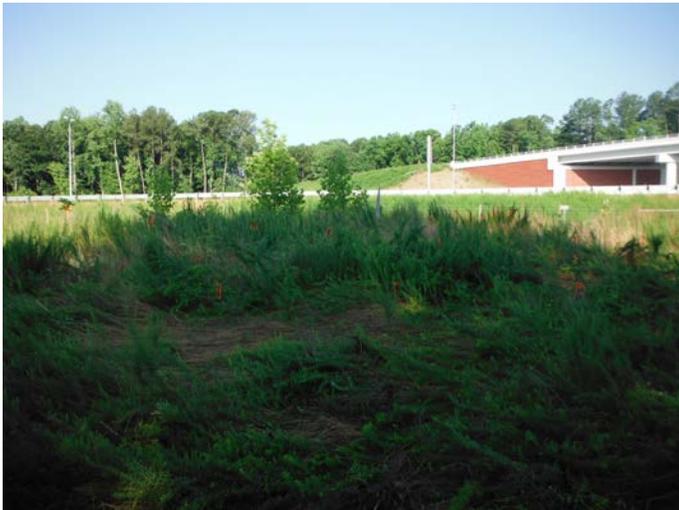
Vegetation Plot #1

Plot #	Tulip Poplar	Sycamore	River Birch	Green Ash	Total (Year 3)	Total (at planting)	Density (Trees Per Acre)
1	5	8	16	8	37	41	614
2	1	5	23	6	35	39	610
<b>Average Density (Trees/Acre)</b>							<b>612</b>

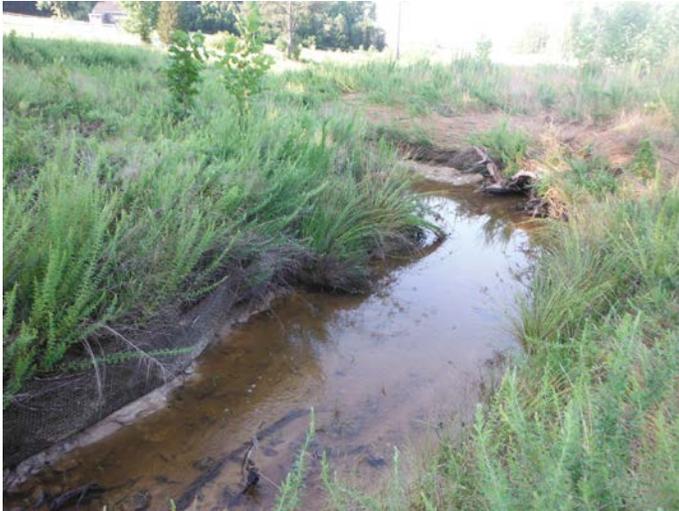
Left Bank @ Sta. 321+50-L- is stable

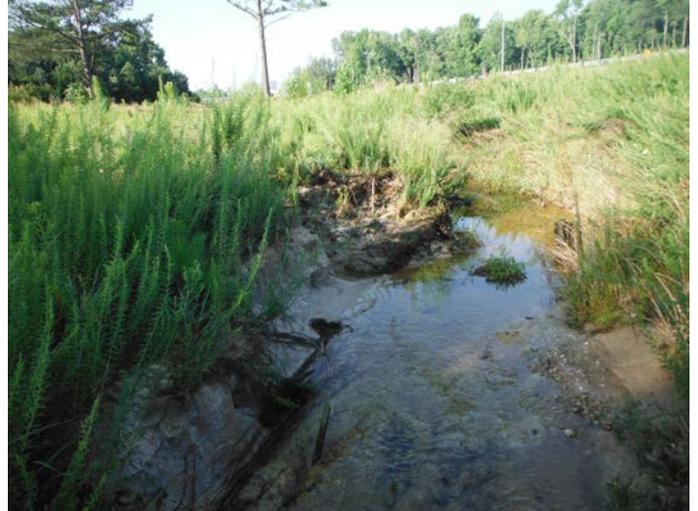
The UT to Reedy Branch stream relocation has continued to show some signs of bank scouring and headcutting for the Year 3 Summer evaluation with little to no change since the last evaluation. See areas noted below. There is Triassic rock along this stream relocation which is a attributing factor to the bank scouring and headcutting. A bankfull event had occurred since the last evaluation. NCDOT met with the resource agencies and the contractor in November 2012. The resource agencies had no concerns with the existing stability issues at that time. NCDOT will continue to monitor the channel stability at this stream relocation.

Left Bank Scouring @ Sta.320+80-L-

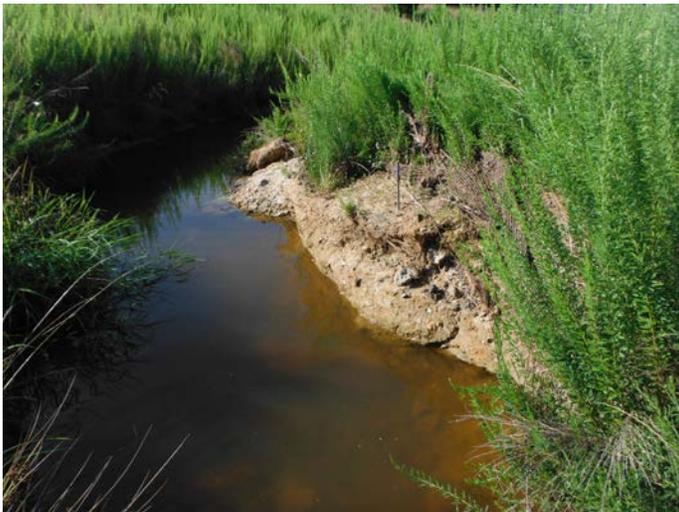
Right Bank Scouring @ Sta. 320+20-L-

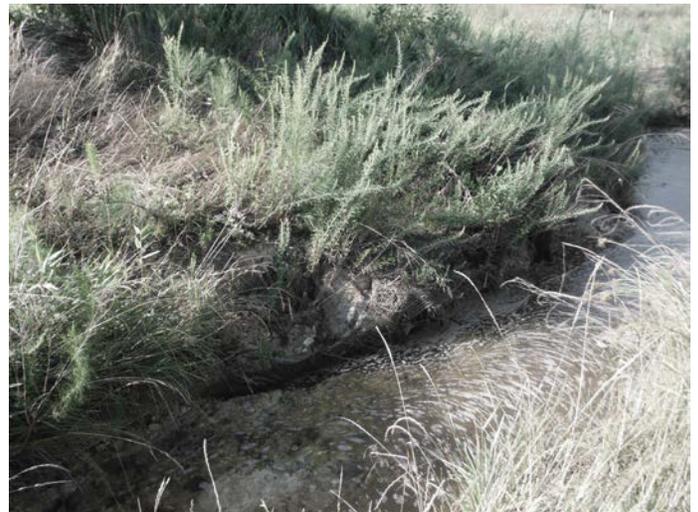
Left bank erosion @ Sta. 319+00-L-

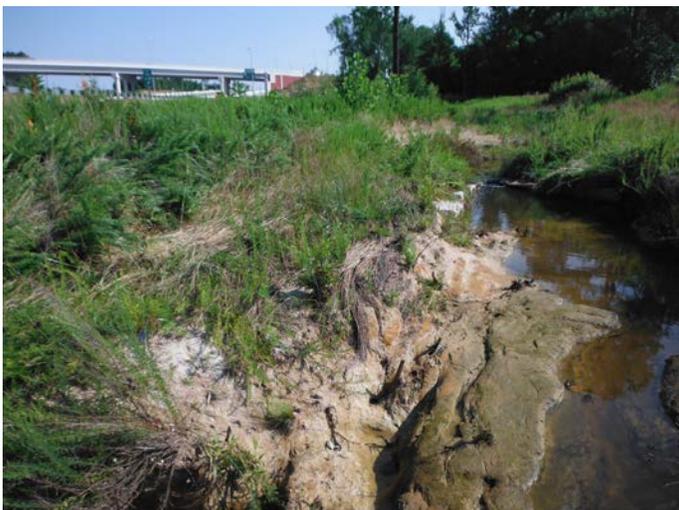
Right bank scouring @ Sta. 317+70-L-

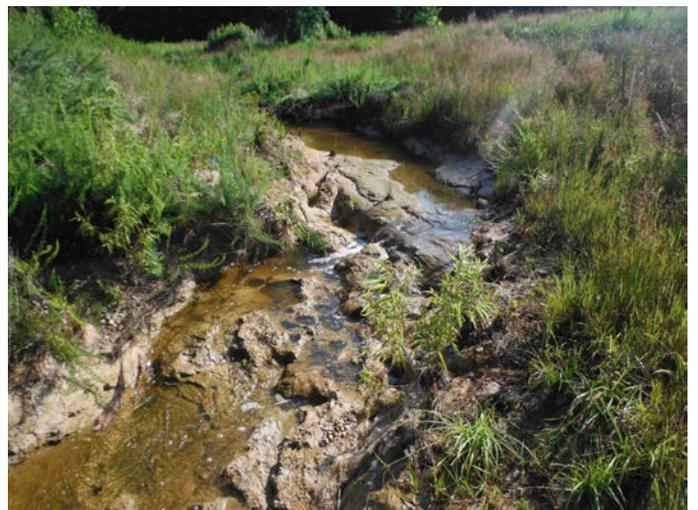
Headcut @ Sta. 317+70-L-
