Monitoring Data Record

Project Title: R-2635C Western Wake Freeway COE Action ID: 2007-02903-292

Stream Name: UT Reedy Branch – Site 3 DWQ Number: 20071470

Year 4 Summer – August 2014

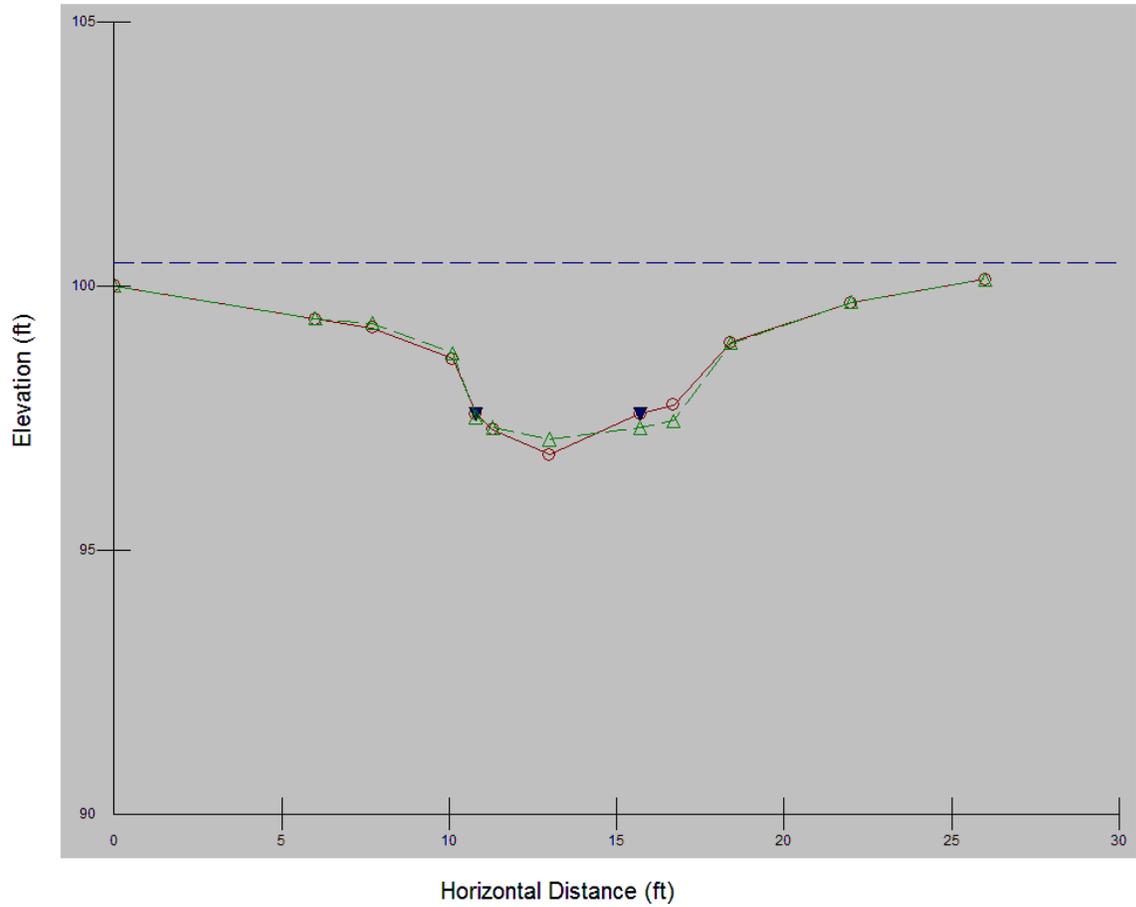
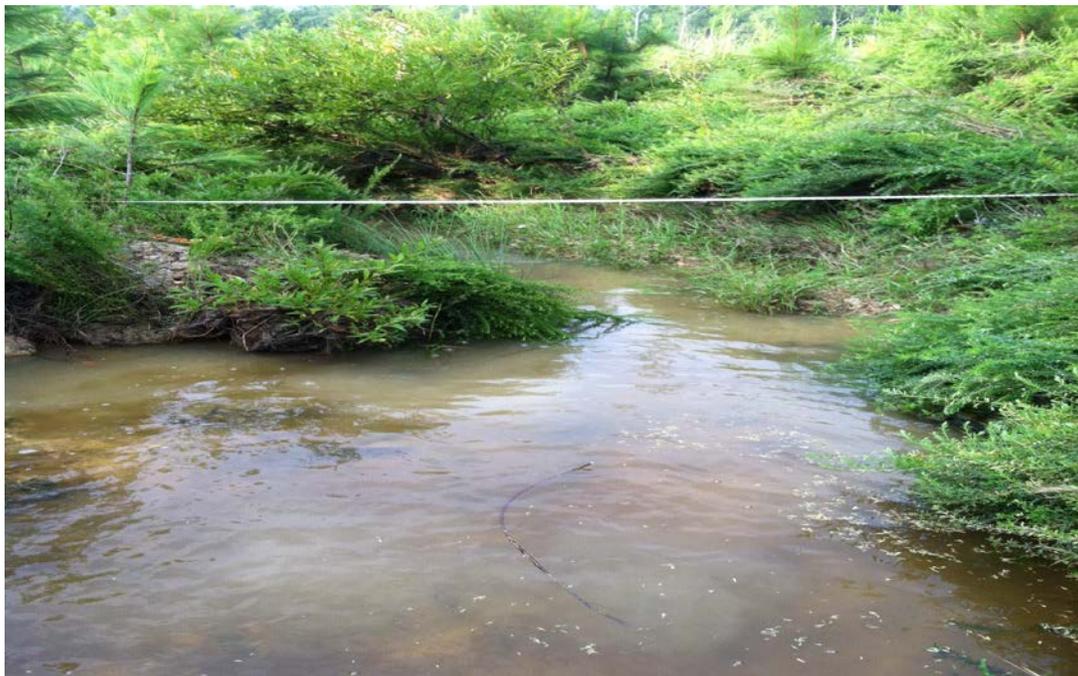
Cross Section #1 Riffle

Photo of Cross Section #1

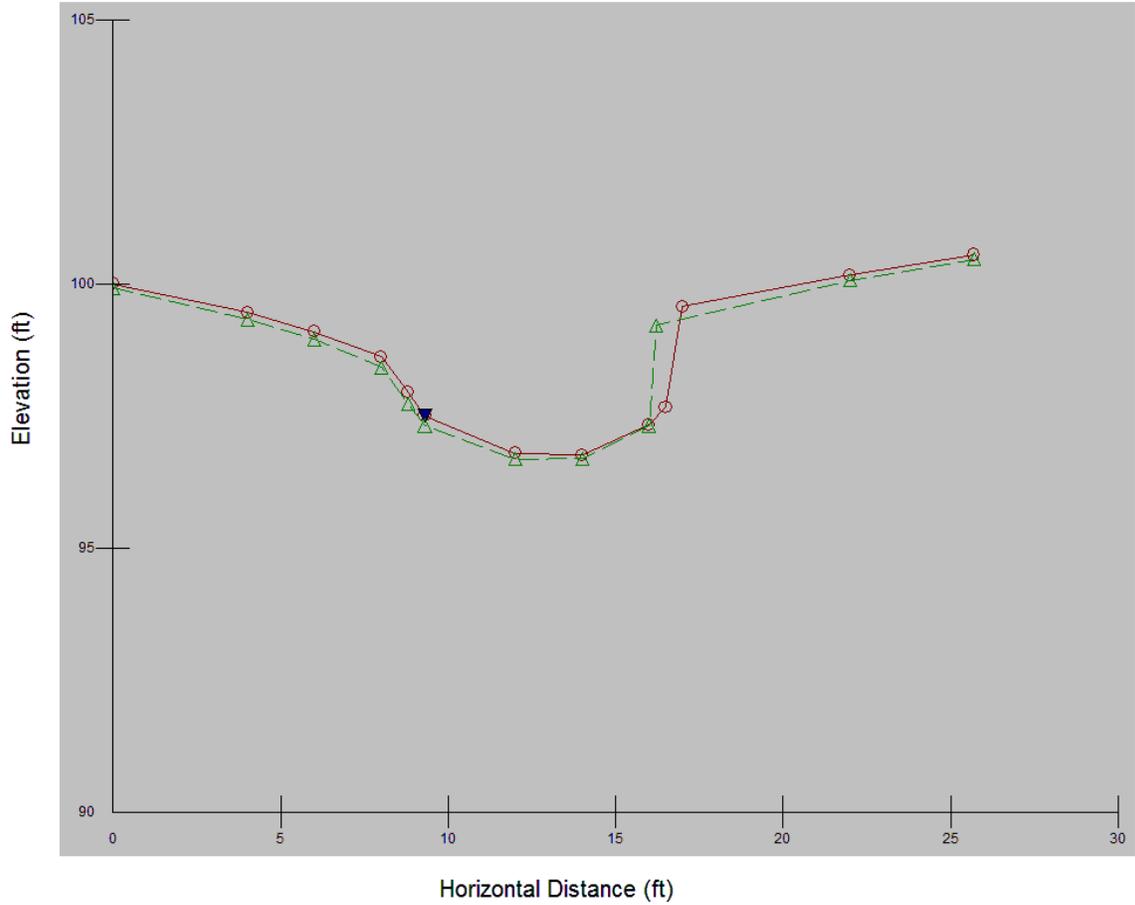
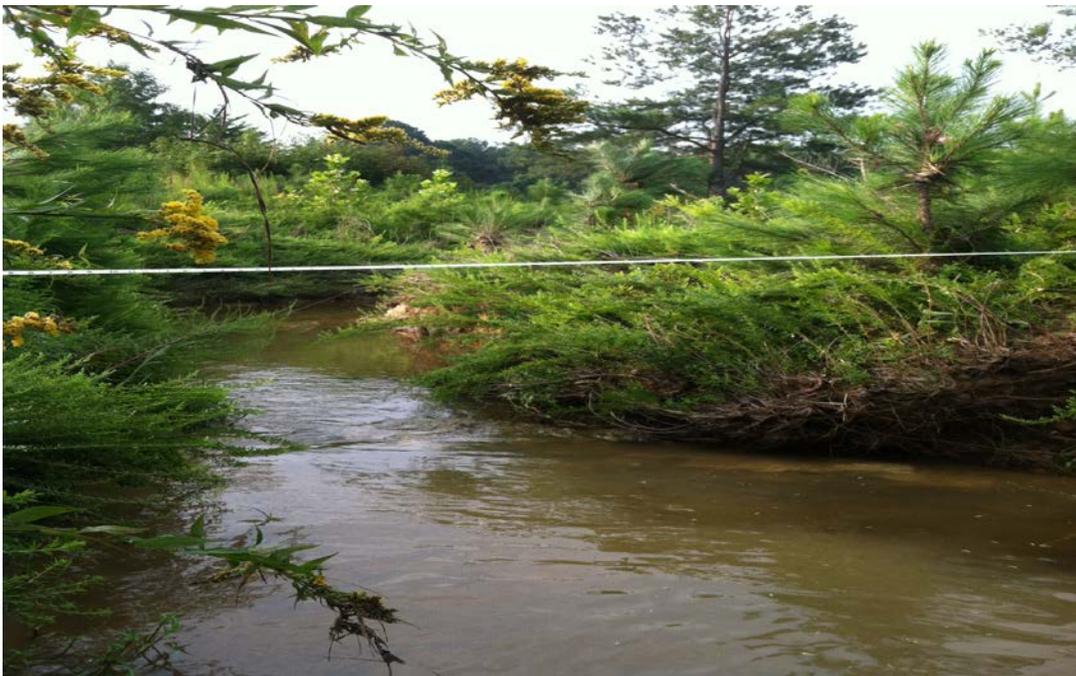
Cross Section #2 Pool

Photo of Cross Section #2

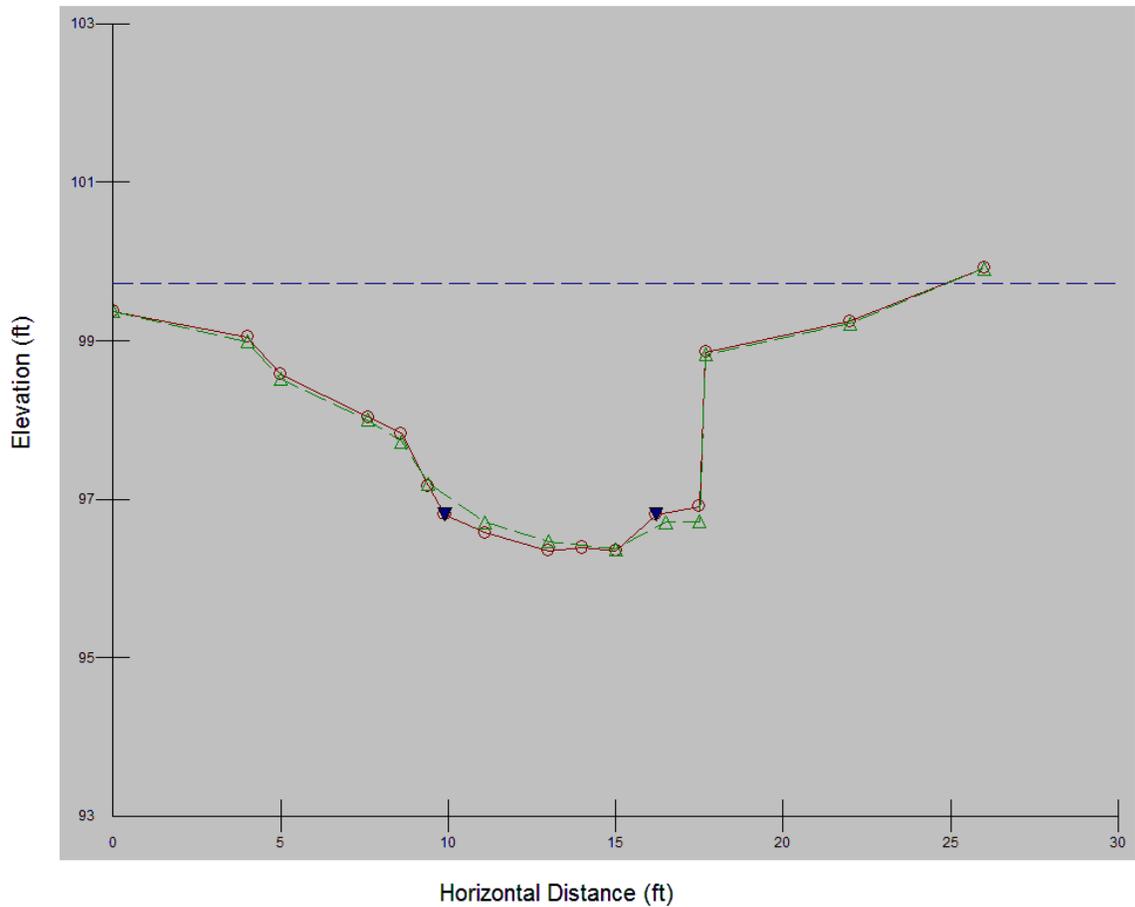
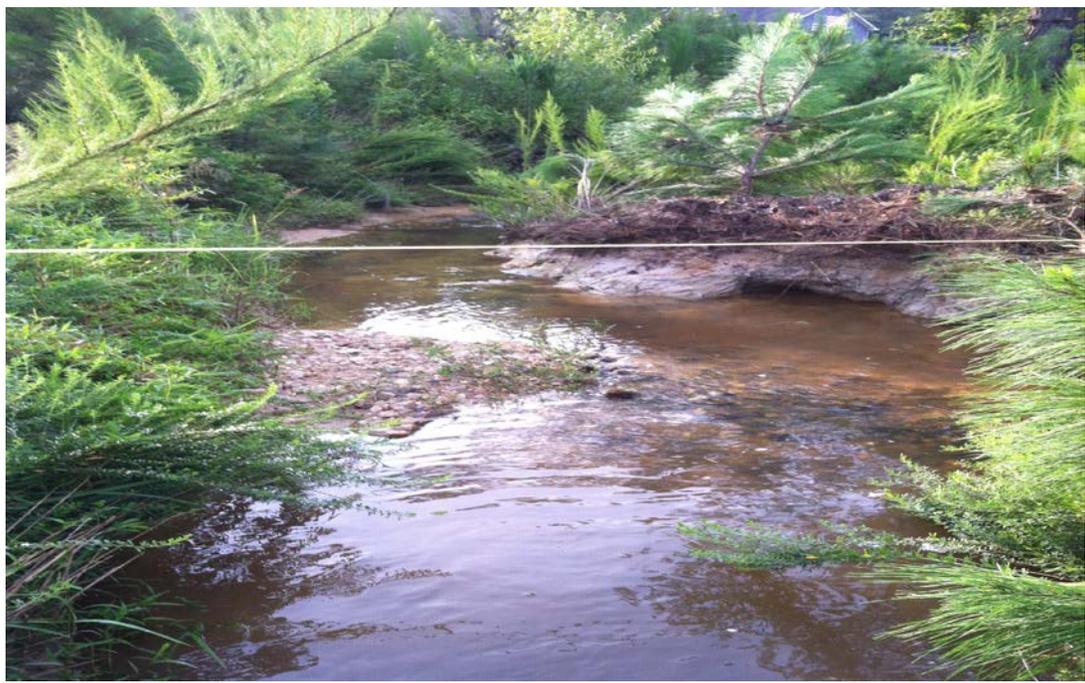
Cross Section #3 Riffle

Photo of Cross Section #3

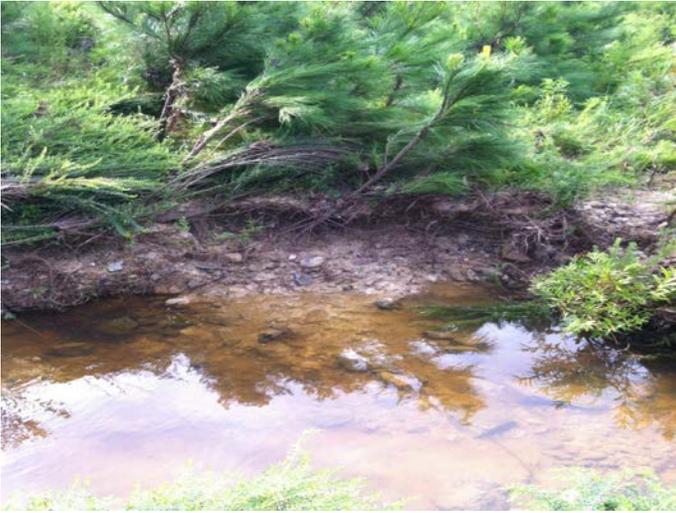
Left Bank Scouring @ Sta.320+80-L

NCDOT plans to scope a consultant to review the site to see what could be done to repair the eroding banks. NCDOT will continue to monitor the stream stability at the UT to Reedy Branch site in 2015.

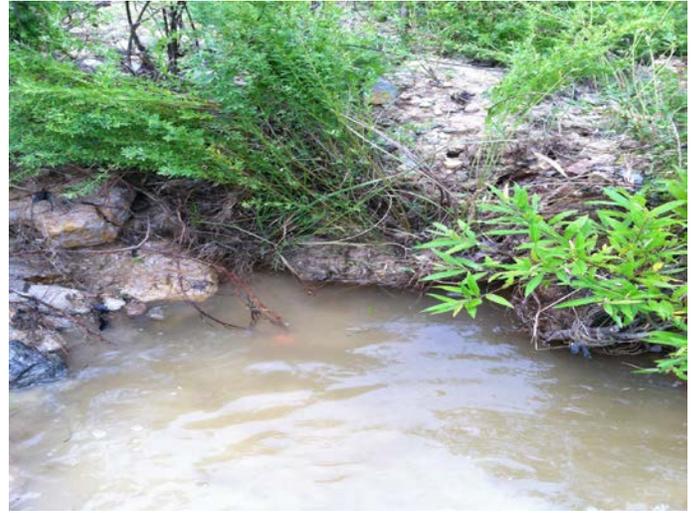
Bank Pin #1 set horizontal into bank @ Sta. 320+80-L-

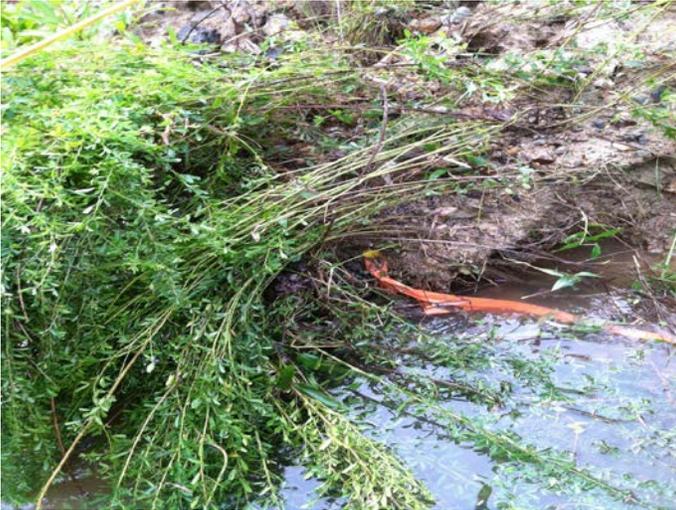
Bank Pin #2 set perpendicular into bank @ Sta. 320+80-L-

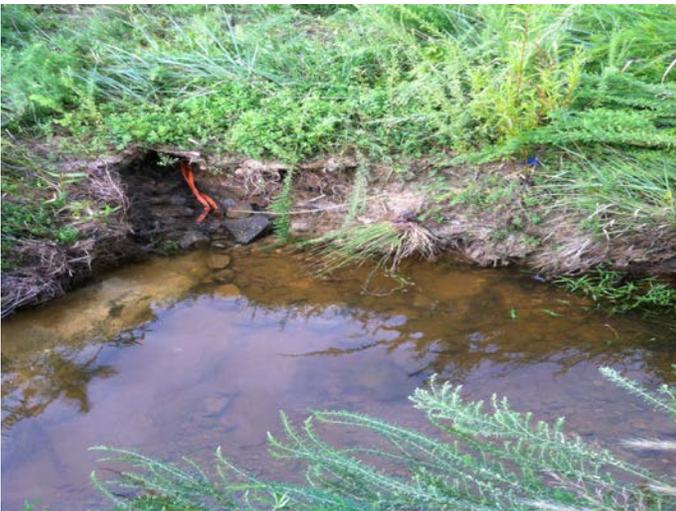
Right Bank Scouring @ Sta. 320+20-L-

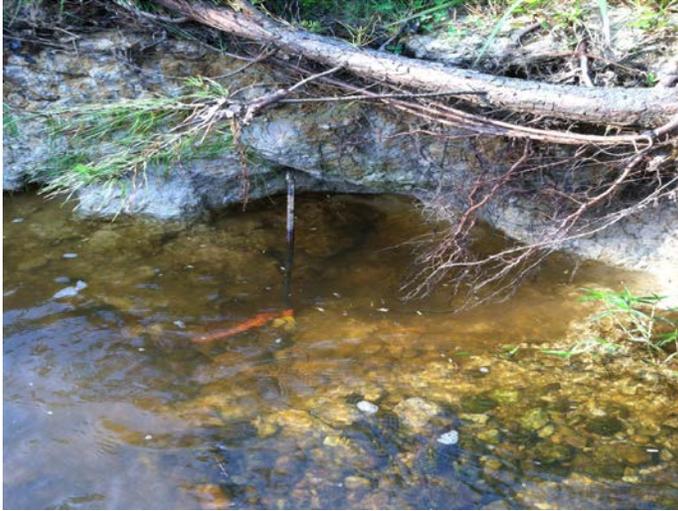
Bank Pin #4 @ Sta. 319+50

On August 18, 2014, NCDOT monitored the site by re-shooting the cross sections (see cross section graphs & photos below), measuring the bank pins (see bank pin photos below), and taking photos of the site (see site photos below). The 3 cross sections showed that the stream was stable along these sections, except for, the right bank at Cross Section #2 which showed some right bank scouring. The 4 bank pins showed that the majority of these areas are eroding. Bank Pin #1 showed the bank had eroded approximately 2 feet, Bank Pin #2 showed no bank erosion, Bank Pin #3 showed the bank had eroded approximately 1.53 feet, and Bank Pin #4 showed the bank had eroded approximately 1.82 feet over a 3 month period.

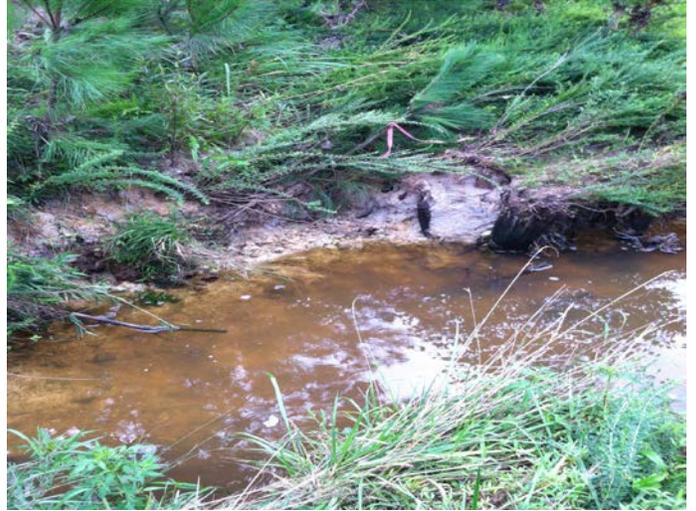
Left Bank Erosion @ Sta. 319+00-L-

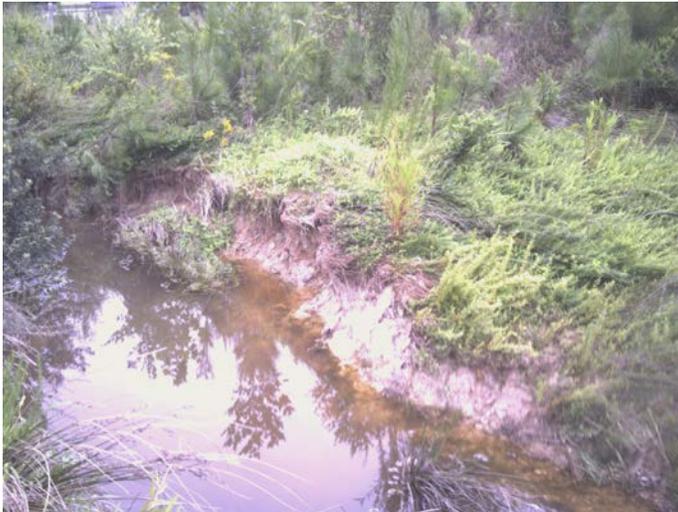
Left bank scouring @ Sta. 318+50

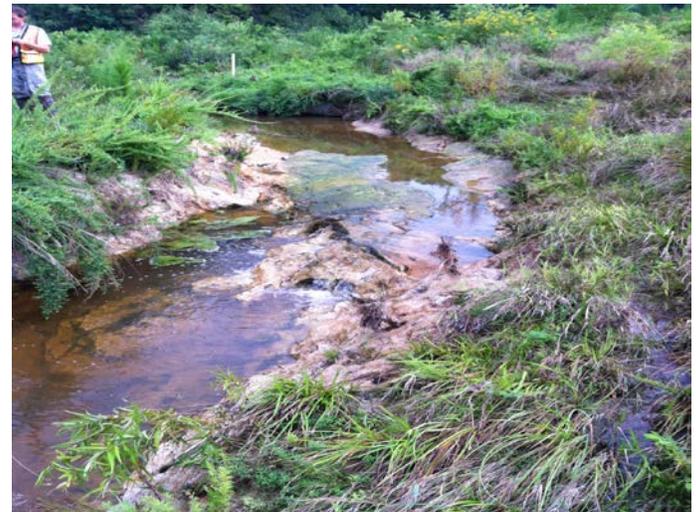
Right bank scouring and headcut @ Sta. 317+70-L-
