Monitoring Data Record

Project Title: R-2635C Western Wake Freeway COE Action ID: 2007-02903-292

Stream Name: UT to Reedy Branch – Site 3 DWQ Number: 20071470

Monitoring Year: (2) of 5

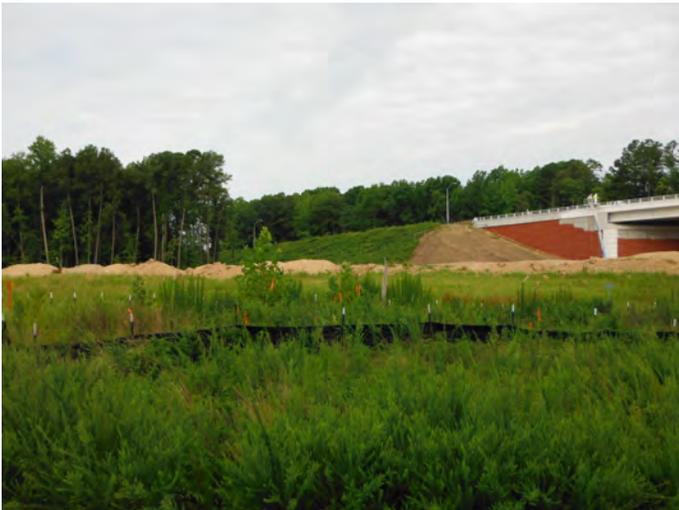
Vegetation Plot #1

Plot #	Tulip Poplar	Sycamore	River Birch	Green Ash	Total (Year 2)	Total (at planting)	Density (Trees Per Acre)
1	2	5	6	18	31	35	602
2	1	5	7	18	31	39	541
Average Density (Trees/Acre)							571

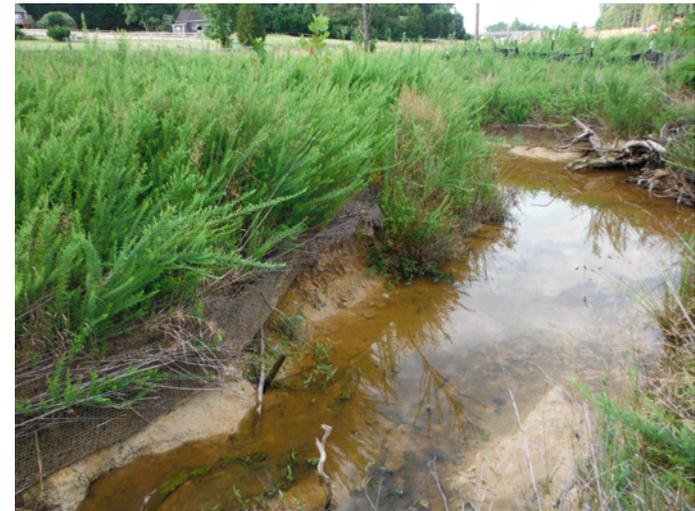
Left Bank Scouring @ STA. 321+50-L-

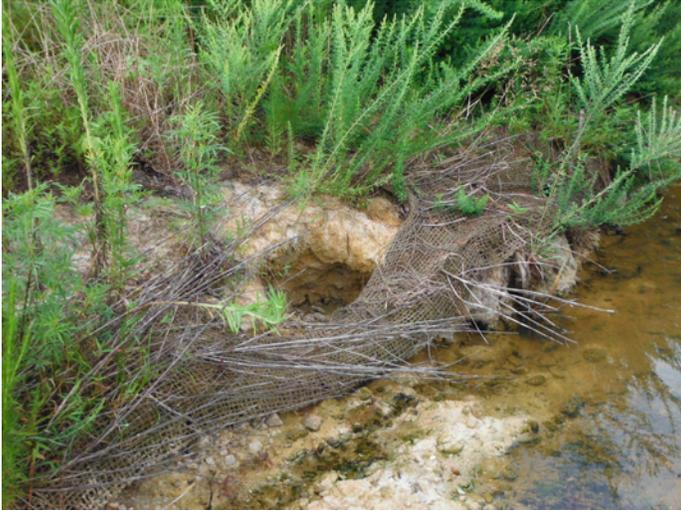
Left bank erosion @ Sta. 319+00-L-

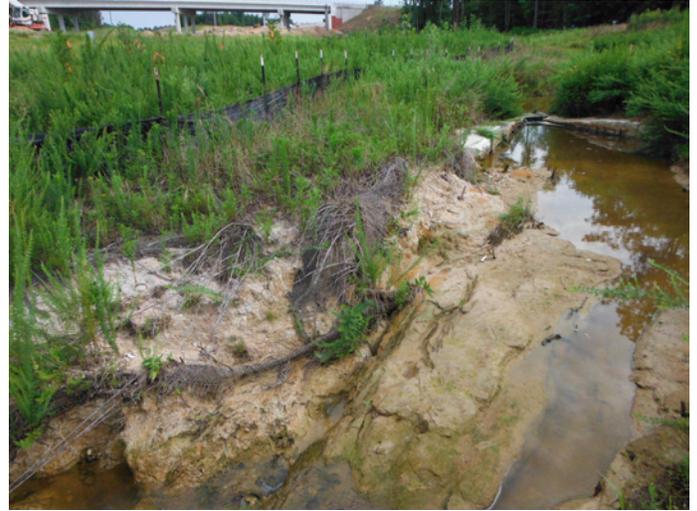
Right bank scouring @ STA. 317+70-L-

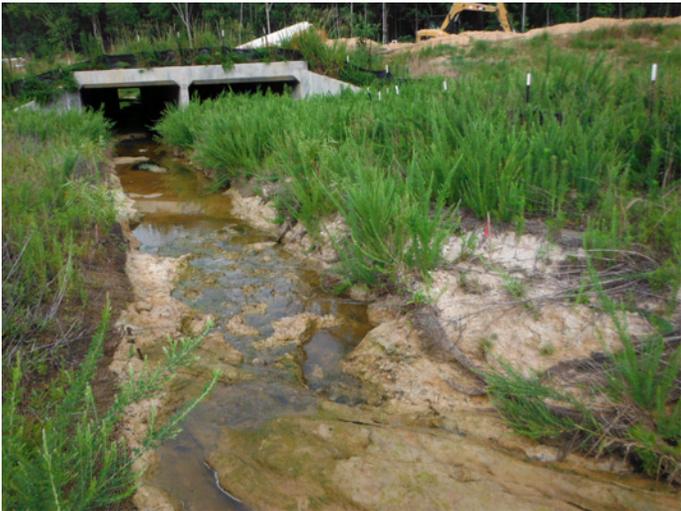
Headcut @ STA. 317+70-L-
