Monitoring Data Record

Project Title: R-2635C Western Wake Freeway COE Action ID: 2007-02903-292  
Stream Name: UT Reedy Branch – Site 3 DWQ Number: 20071470  
City, County and other Location Information: UT Reedy Branch is located along I-540 just south of Beaver Creek Commons Drive in Apex, NC.  
Date Construction Completed: March 2011  
Monitoring Year: ( 3 ) of 5  
Ecoregion: \_\_\_\_\_ 8 digit HUC unit 03020201  
USGS Quad Name and Coordinates: N 35 44' 29" W 78 53' 29"

# UT to Reedy Branch

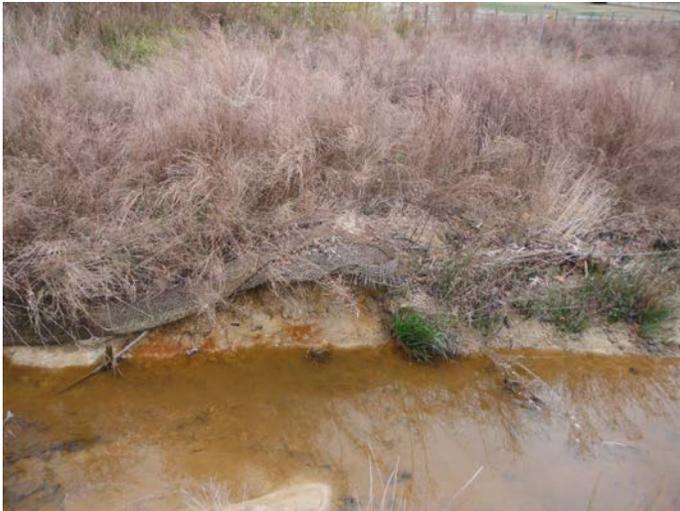
1/14/13	Station 321+50-L- (additional photo)	Station 320+80-L- (additional photo)	Station 319+00-L- (additional photo)	Station 317+70-L- (additional photo)	Station Number
Structure Type					
Is water piping through or around structure?					
Head cut or down cut present?				Headcut downstream of PP#4	
Bank or scour erosion present?	Bank scouring along left bank upstream of PP#2	Bank scouring along left bank downstream of PP#2	Bank erosion on left bank b/t PP#3 and PP#4	Bank scouring on right bank	
Other problems noted?

Left Bank Scouring @ Sta. 321+50-L-

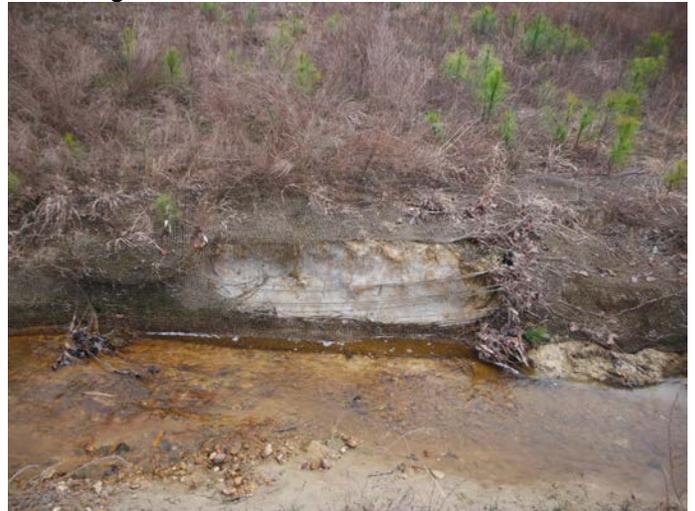
Left Bank Scouring @ Sta.320+80-L-

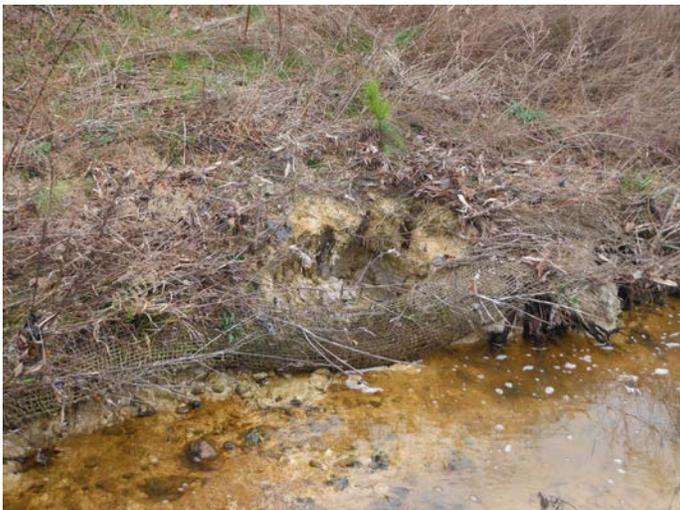
Left bank erosion @ Sta. 319+00-L-

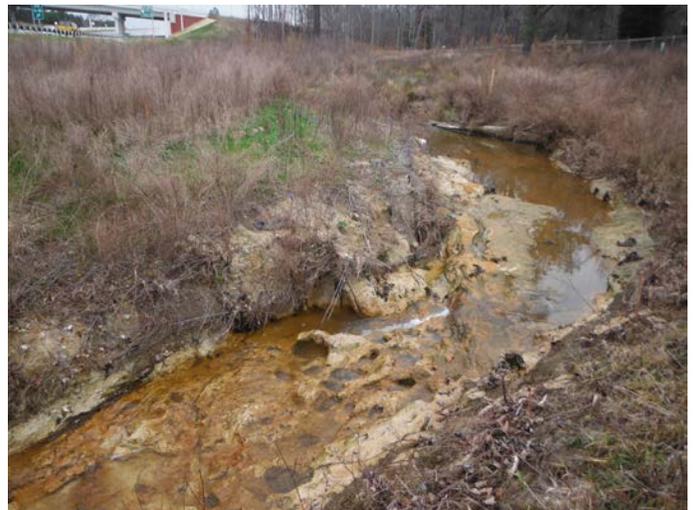
Right bank scouring @ Sta. 317+70-L-

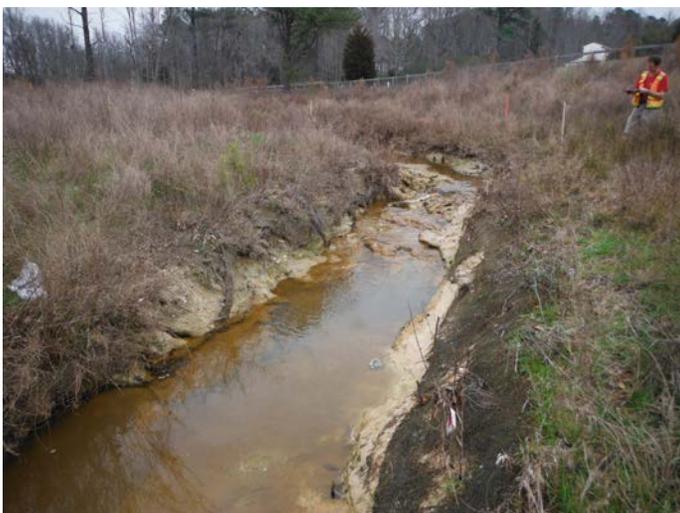
Headcut @ Sta. 317+70-L-
