ANNUAL REPORT FOR 2014

Banks School Road Buffer Mitigation Site
Lenoir County
TIP No. R-2719A
COE Action ID: 200511238
DWQ Project #: 20050787

Prepared By:
Roadside Environmental Unit & Natural Environment Section
North Carolina Department of Transportation
July 2014

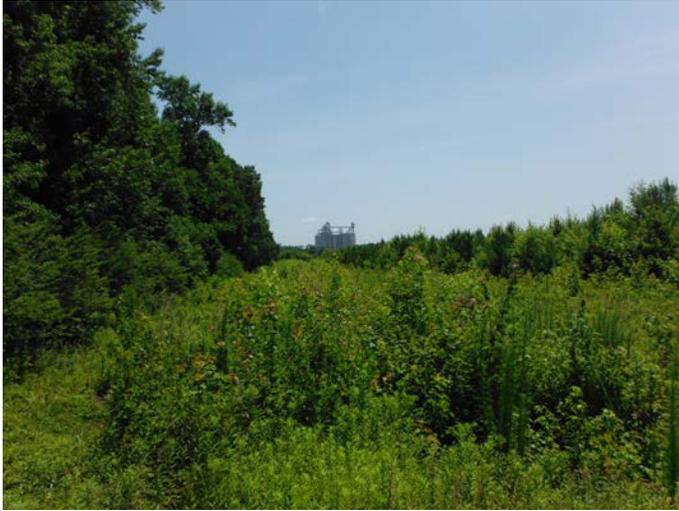
Photo Point #1 looking East at Vegetation Plot #1

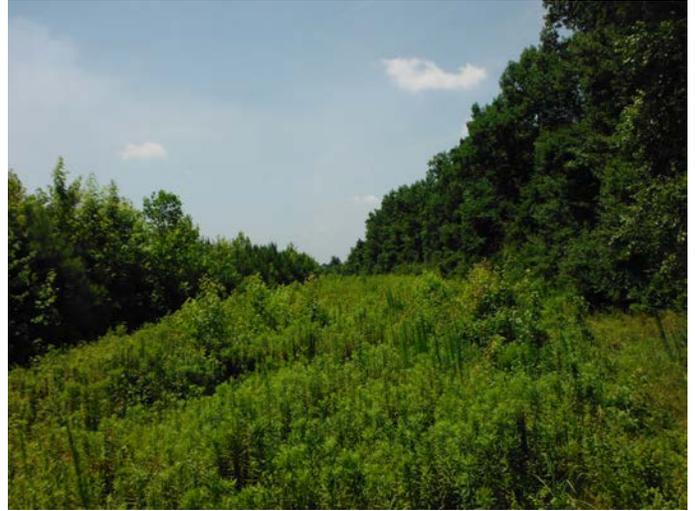
Photo Point #2 looking South

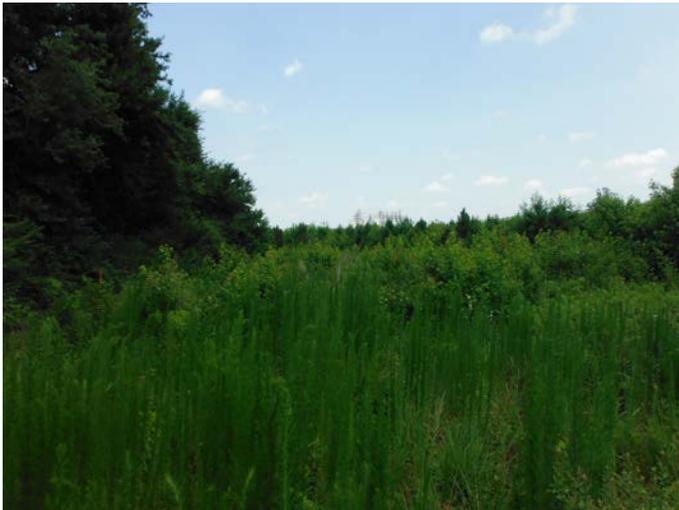
Photo Point #3 looking East at Vegetation Plot #2

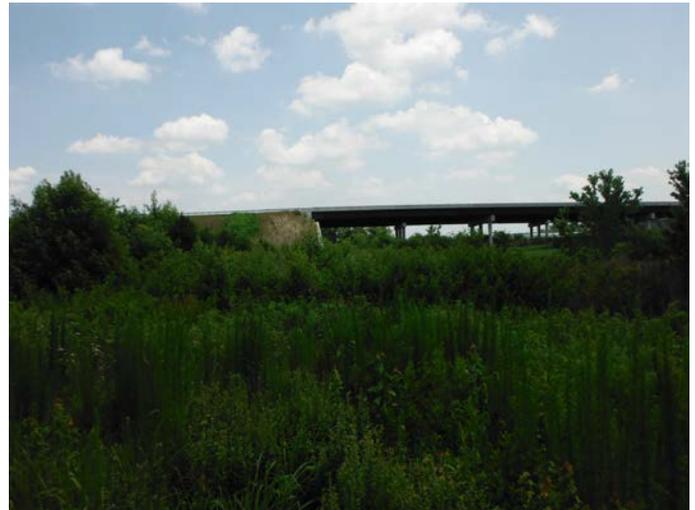
Photo Point #4 looking Southeast toward C.F. Harvey Pkwy

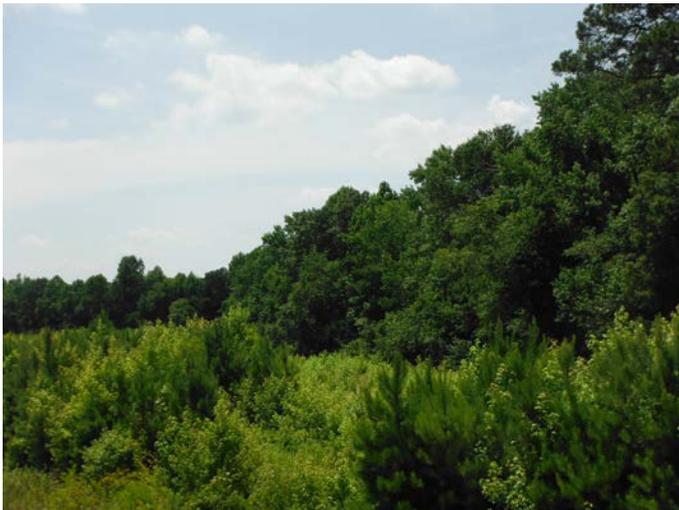
Overview Photo taken from C.F. Harvey Pkwy
June 2014

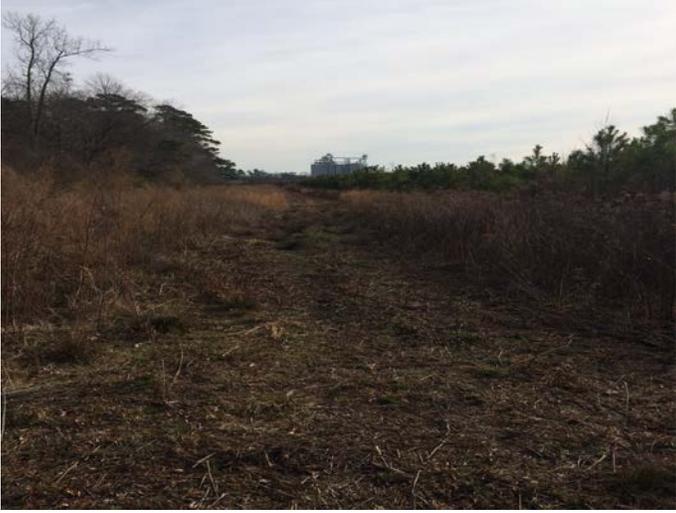
In December 2013, NCDOT personnel noted that a portion of the buffer had been mowed. In February 2014, the mowed portion of the buffer was replanted, locks were installed on all gates into the site, and mitigation signs were installed at the site to prevent further encroachments. See Appendix D for site map of mowed and replanted buffer.

Photo Point #1 looking East at Vegetation Plot #1 of mowed area from December 2013

Site Notes: The area that was mowed was replanted with green ash, river birch, willow oak, swamp chestnut oak, and swamp blackgum in February 2014 and has re-vegetated very well. Other species noted onsite included sweetgum, dogwood, red maple, pine, sycamore, tulip poplar, and various grasses.

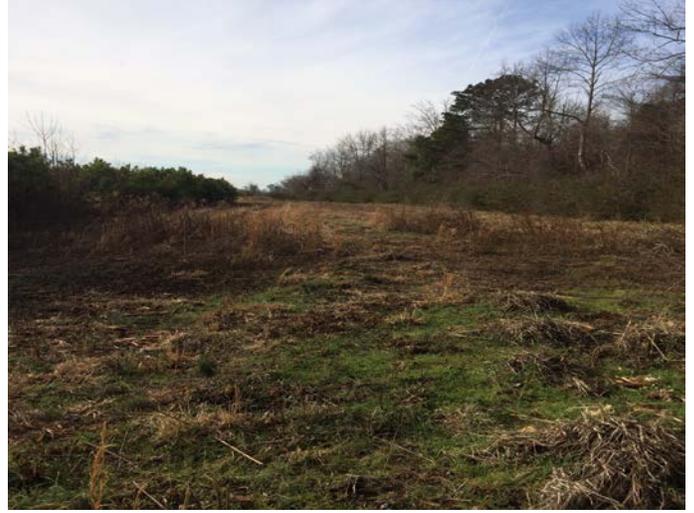
Photo Point #2 looking South at mowed area from December 2013

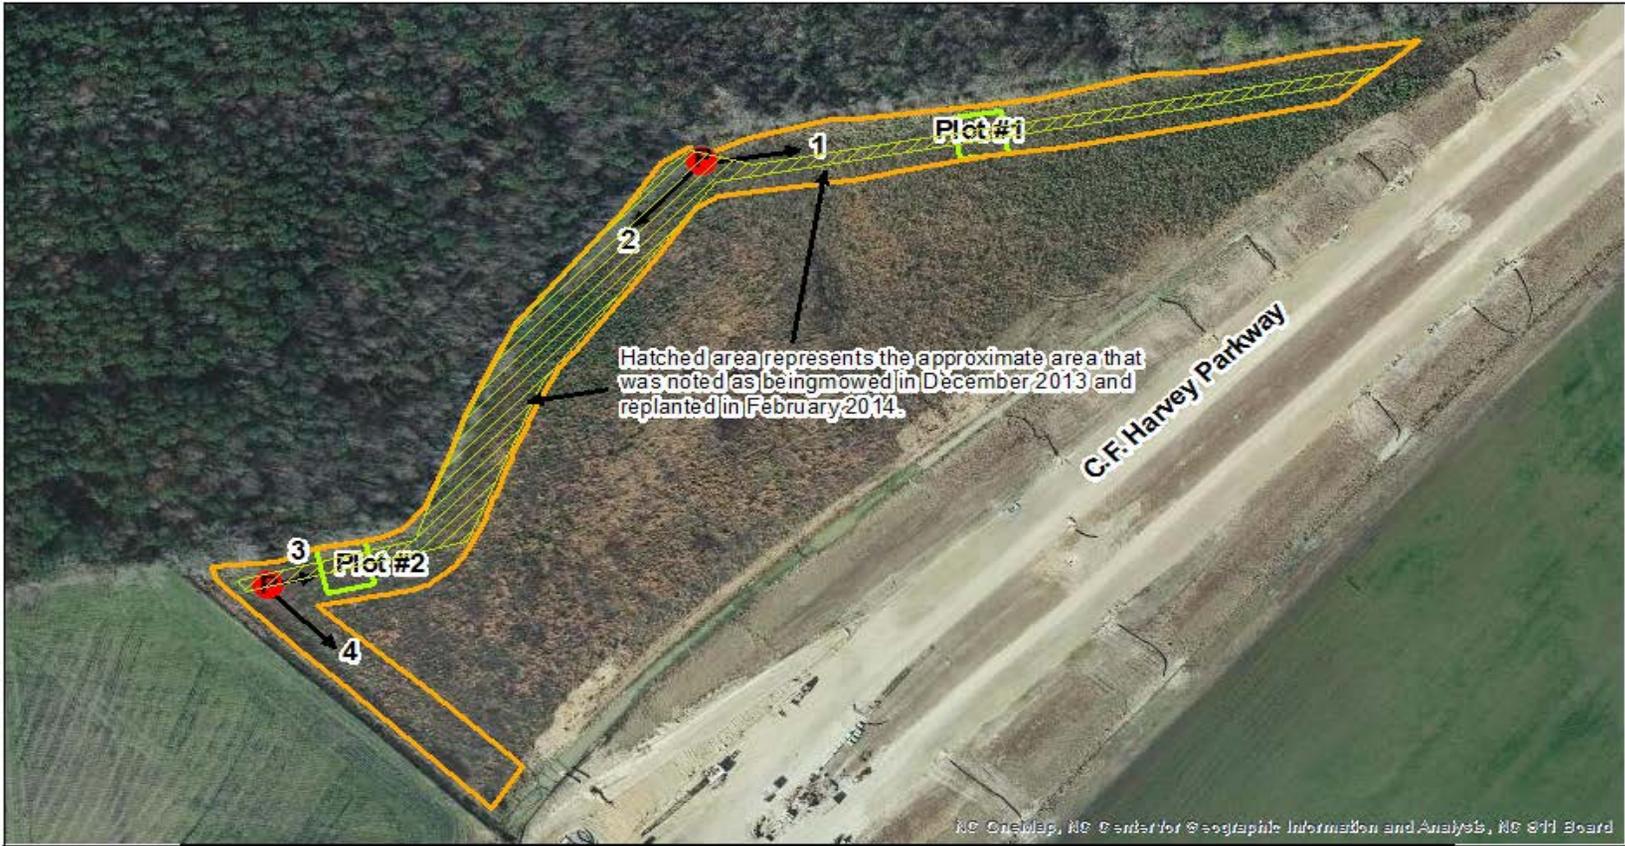
Appendix D. Site Map of Mowed and Replanted Area

<p>R-2719A BANKS SCHOOL ROAD BUFFER MITIGATION SITE MOWED AND REPLANTED AREA LENIOR COUNTY, NORTH CAROLINA</p> <p>0 150 300 600 Feet</p>
