Monitoring Data RecordProject Title: R-2719A Crescent Road COE Action ID: 200802460WQC Number: 003763Stream Name: UT to Falling CreekCity, County and other Location Information: UT to Falling Creek is located at the intersection of the future Crescent Road and US 70 in Kinston, Lenoir Co.Date Construction Completed: 3/3/11 Monitoring Year: ( 4 ) of 5Ecoregion: \_\_\_\_\_ 8 digit HUC unit 03020202USGS Quad Name and Coordinates: 35.261881, -77.683669**Rosgen Classification:** \_\_\_\_\_Length of Project: 2,393' Urban or Rural: Rural Watershed Size: \_\_\_\_\_Monitoring DATA collected by: M. Green, and J. YoungDate: 1/23/15

Year 4 Winter – January 2015

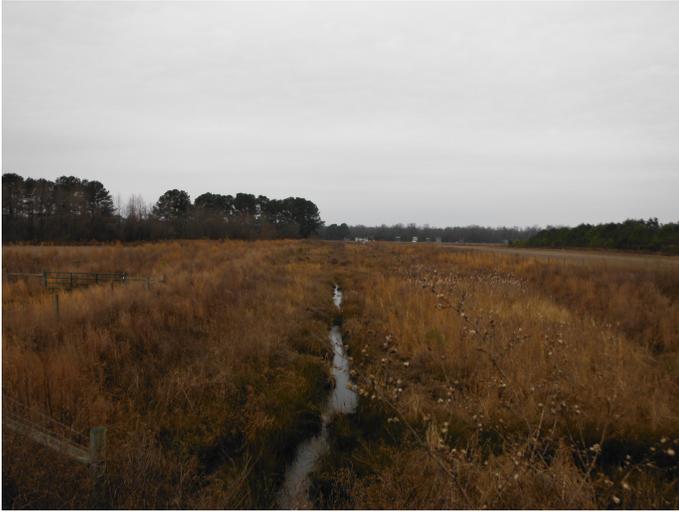
Overview photo looking upstream from US 70

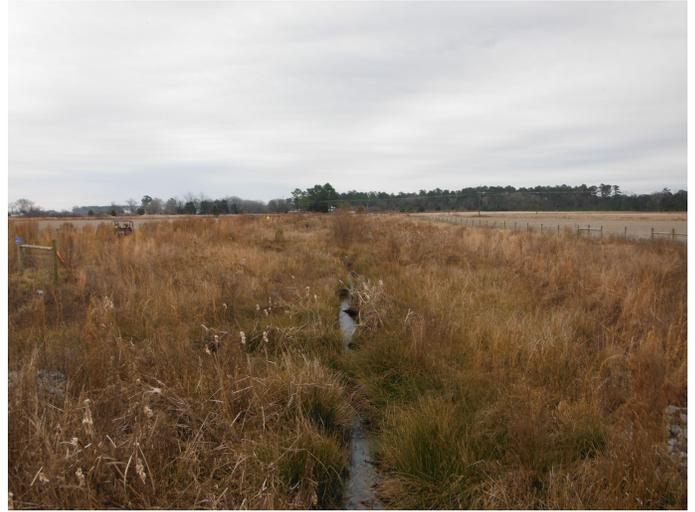
Overview photo looking downstream from US 70
