ANNUAL REPORT FOR 2011

Setman Branch Mitigation Site
Rowan County
TIP No. R-2911E

Prepared By:
Natural Environment Unit & Roadside Environmental Unit
North Carolina Department of Transportation
September 2011

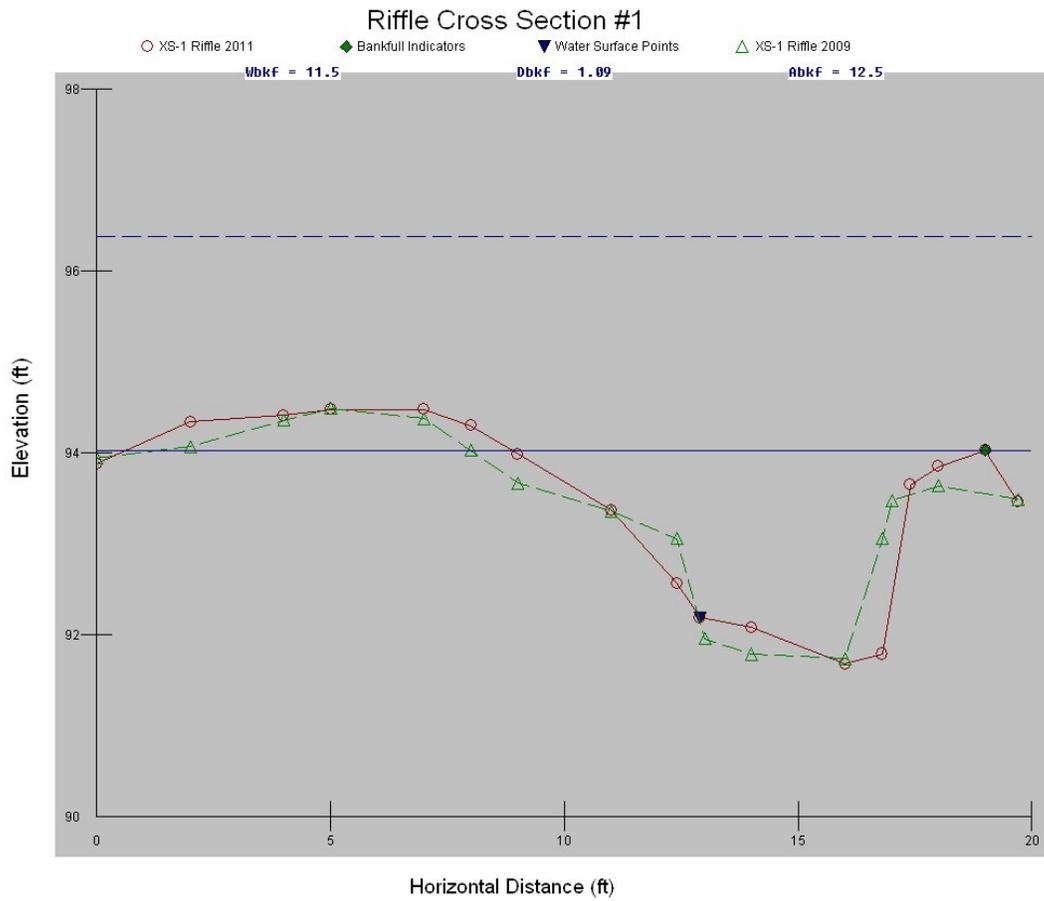
Cross-Section #1 (Riffle) Abbreviated Morphological Summary

- ◆ Cross-Section #1. Setman Branch, Station 179+00, midpoint of riffle

Based on comparisons of all three years of cross section data, the riffle cross section appears stable with little or no active bank erosion. A graph of the cross section is presented in Appendix A. Future survey data will vary depending on actual location of rod placement and alignment, however, this information should remain similar in appearance.
