Monitoring Data Record

Project Title: R-3415 NC 67 Widening COE Action ID: 200520314
Stream Name: UT Lineberry Creek (Site 1) DWQ Number: 05-0061
City, County and other Location Information: NC 67 4.4 miles west of Boonville and just west of Raccoon Run Road (Sta. 81+00 -L- RT.); Yadkin County
Date Construction Completed: Streambank repairs completed in June 2010 and final planting completed in January 2011. Monitoring Year: (3) of 3
Ecoregion: _____ 8 digit HUC unit 03040101
USGS Quad Name and Coordinates: N 36 14' 39", W 80 47' 7"

UT LINEBERRY CREEK (SITE 1)

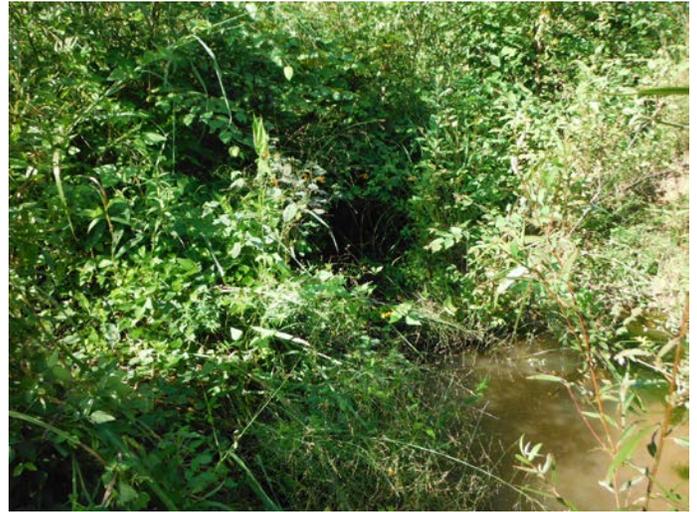
PP#2 Downstream

UT Lineberry Creek (Site 1) is stable for the Year 3 monitoring evaluation. NCDOT planted black willow and silky dogwood live stakes along the previously noted eroded right bank at Sta. 80+00 and left bank at Sta. 79+60 in January 2013 (see PP#2 downstream photo of right bank). The previously noted headcut at Sta. 80+50 has made its way up to the crossvane and the crossvane has stopped the headcut (see additional photos). All of these areas were stable at the time of monitoring. NCDOT proposes to discontinue channel stability monitoring.

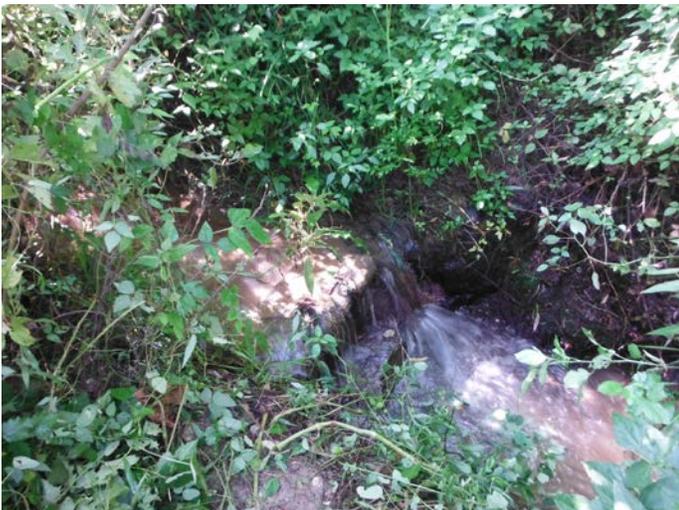
Crossvane b/t PP#1 and PP#2 where headcut stopped

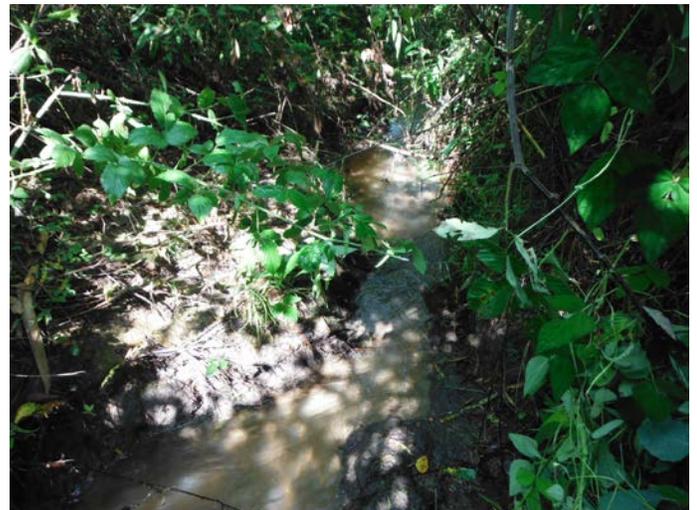
Stream channel where headcut was previously noted is stable
