Monitoring Data Record

Project Title: R-3415 NC 67 Widening COE Action ID: 200520314
Stream Name: UT Lineberry Creek (Site 1) DWQ Number: 05-0061
City, County and other Location Information: NC 67 4.4 miles west of Boonville and just west of Raccoon Run Road (Sta. 81+00 -L- RT.); Yadkin county
Date Construction Completed: Streambank repairs completed in June 2010 and final planting completed in January 2011. Monitoring Year: (2) of 3
Ecoregion: _____ 8 digit HUC unit 03040101
USGS Quad Name and Coordinates: N 36 14' 39", W 80 47' 7"

UT LINEBERRY CREEK (SITE 1)

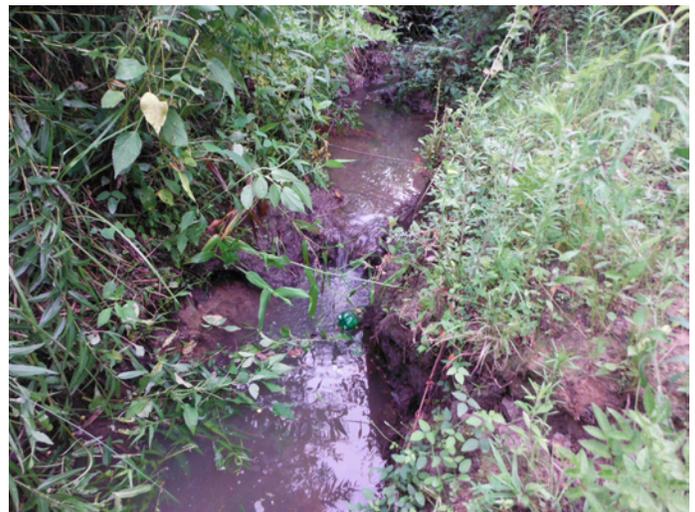
UT Lineberry Creek (Site 1) is experiencing some areas of instability for the Year 2 monitoring evaluation. See the areas noted below. NCDOT plans to install live stakes along the eroded banks to help stabilize these areas. NCDOT will continue to monitor the channel stability at this stream relocation.

Headcut @ Sta. 80+50-L- RT.

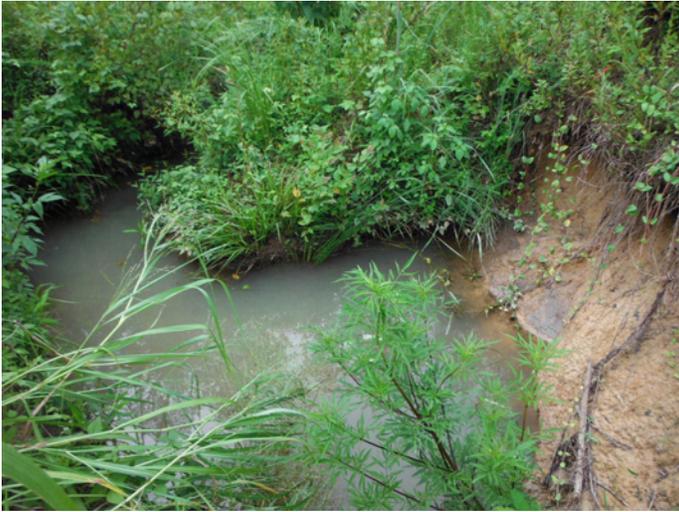
Bank erosion along right bank @ Sta. 80+00-L- RT.

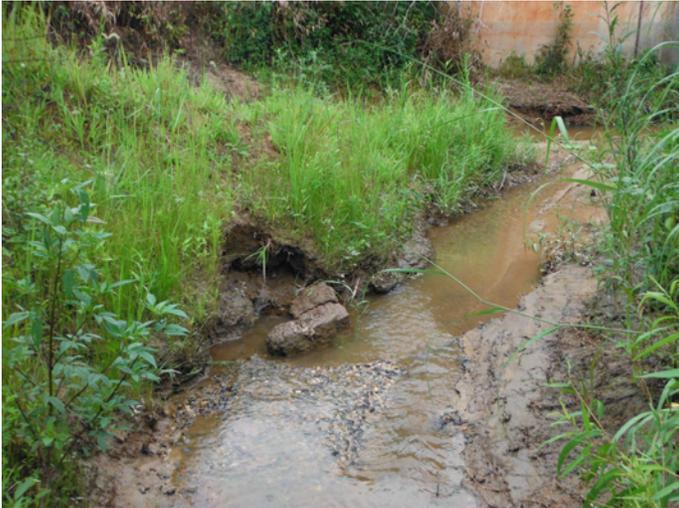
Bank erosion along left bank @ Sta. 79+60-L- RT.
