Monitoring Data Record

Project Title: U-2524AB (Site 3) COE Action ID: 200321137

Stream Name: UT #3 Reddicks Creek DWQ Number: 030909

City, County and other Location Information: Greensboro Western Loop, Guilford Co.
Sta. 34+00 to Sta. 37+10 -L-

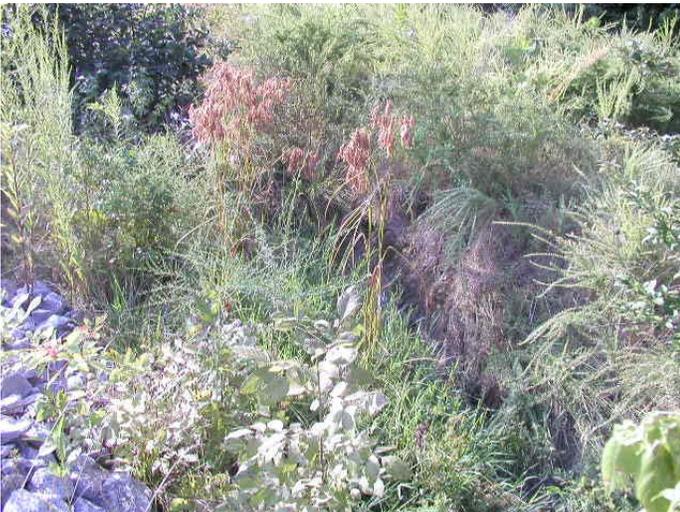
Photo Point #6 (Upstream)
Year 5 Summer – September 2011

The UT #3 Reddicks Creek stream relocation is stable for the Year 5 Summer evaluation, except for, some minor bank scouring noted on the left bank at Photo Point #6 (upstream) which had little or no change since the last evaluation. A site visit was conducted on August 2, 2011 with the regulatory agencies and NCDOT personnel present. NCDOT proposes to discontinue monitoring at this stream relocation.

9/1/11	PP#6 (Upstream) Sta. 36+80	Station Number	Station Number	Station Number	Station Number
Structure Type					
Is water piping through or around structure?					
Head cut or down cut present?					
Bank or scour erosion present?	Minor bank scouring on left bank
