Monitoring Data Record

Project Title: U-2524AC (Greensboro Western Urban Loop) COE Action ID: 200321137
Stream Name: Long Branch (Site 2BA) DWQ Number: 030909
City, County and other Location Information: Greensboro Western Loop, Guilford Co.
(Remediation Plans Sta. 10+00 to 29+86)
Date Construction Completed: 2-29-08 Monitoring Year: (4) of 5
Ecoregion: _____ 8 digit HUC unit 03030002
USGS Quad Name and Coordinates: _____

Long Branch

Year 4 Summer – September 2011

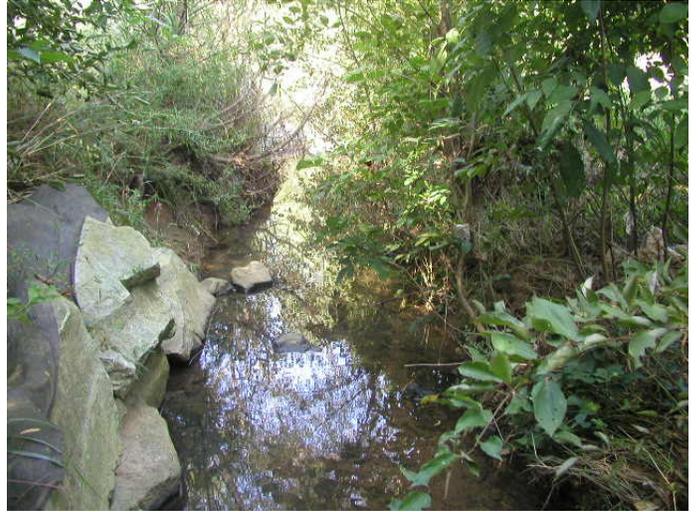
Photo Point #1 (Downstream)

9/1/11	Sta. 11+50 PP#1 Downstream Photo	Sta. 17+50	Sta. 20+00 PP#5 Downstream Photo	Sta. 23+00	Sta. 27+00 PP#9 Upstream and Downstream Photo
Structure Type					
Is water piping through or around structure?					
Head cut or down cut present?					
Bank or scour erosion present?	Minor bank scouring on left bank downstream of boulder protection	Minor bank scouring on right bank	Minor bank scouring on left bank downstream of boulder protection	Minor bank scouring on left bank downstream of boulder protection	Minor bank scouring on right and left bank
