Monitoring Data Record

Project Title: U-2524AC COE Action ID: 200321137
Stream Name: Woodlyn Way DWQ Number: 030909
City, County and other Location Information: Greensboro, Guilford Co., The stream is located off of the Greensboro Western Loop @ Sta. 57+80 and goes downstream until it intersects with East Woodlyn Way Date Construction Completed: Water was turned into the stream on February 1, 2007 and streambank reforestation was completed on February 15, 2007.
Monitoring Year: (5) of 5
Ecoregion: _____ 8 digit HUC unit 03030002
USGS Quad Name and Coordinates: _____
Rosgen Classification: Proposed reach is a C5 stream type
Length of Project: 1,250' Urban or Rural: Urban Watershed Size: _____
Monitoring DATA collected by: J. Young & P. Allen Date: 8/31/11
Applicant Information:
Name: NCDOT Roadside Environmental Unit
Address: 1425 Rock Quarry Road Raleigh, NC 27610
Telephone Number: (919) 861-3772 Email address: mlgreen@ncdot.gov

This is the Year 5 Summer evaluation of the Woodlyn Way Stream Restoration Project. The stream is stabilized for this evaluation, except for, some bank scouring noted on the left bank at Sta. 11+60 and a slight headcut at Sta. 10+10. Both of these areas s

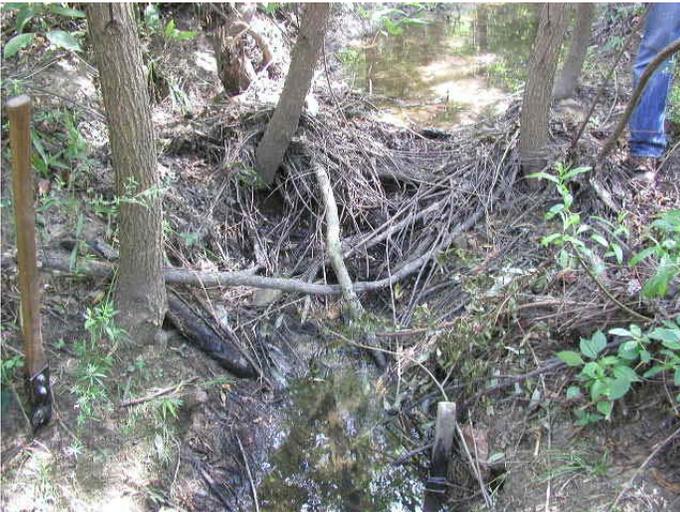
8/31/11	Sta. 11+60	Sta. 10+10 Additional Photo	Station Number	Station Number	Station Number
Structure Type					
Is water piping through or around structure?					
Head cut or down cut present?		Slight headcut			
Bank or scour erosion present?	Bank scouring on left bank

Headcut downstream of PP#9 @ Sta. 10+10
