Monitoring Data Record

Project Title: U-2524AC COE Action ID: 200321137
Stream Name: Woodlyn Way DWQ Number: 030909
City, County and other Location Information: Greensboro, Guilford Co., The stream is located off of the Greensboro Western Loop @ Sta. 57+80 and goes downstream until it intersects with East Woodlyn Way Date Construction Completed: Water was turned into the stream on February 1, 2007 and streambank reforestation was completed on February 15, 2007.
Monitoring Year: (5) of 5
Ecoregion: _____ 8 digit HUC unit 03030002
USGS Quad Name and Coordinates: _____

This is the Year 5 Winter evaluation of the Woodlyn Way Stream Restoration Project. The stream is stabilized for this evaluation, except for, some bank scouring noted on the left bank at Sta. 11+60. This area of bank scouring shows little or no change since the last evaluation. Also a headcut has formed at Sta. 10+10 downstream of PP#9, however this area is stable at this time. NCDOT will continue monitoring this stream restoration project.

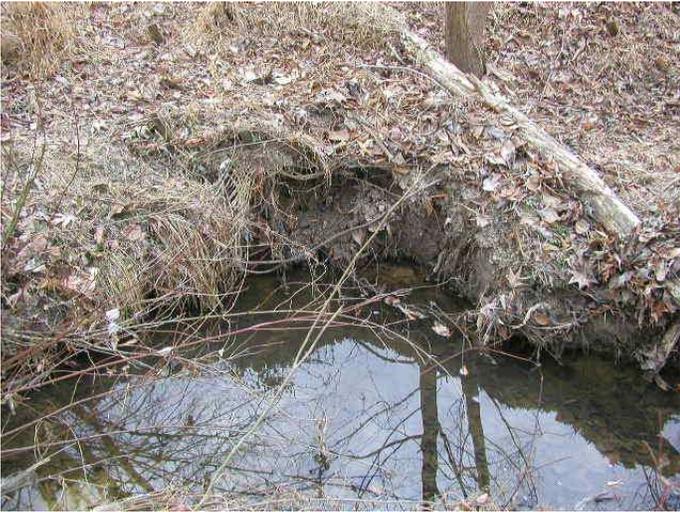
Bank scouring on left bank @ Sta. 11+60

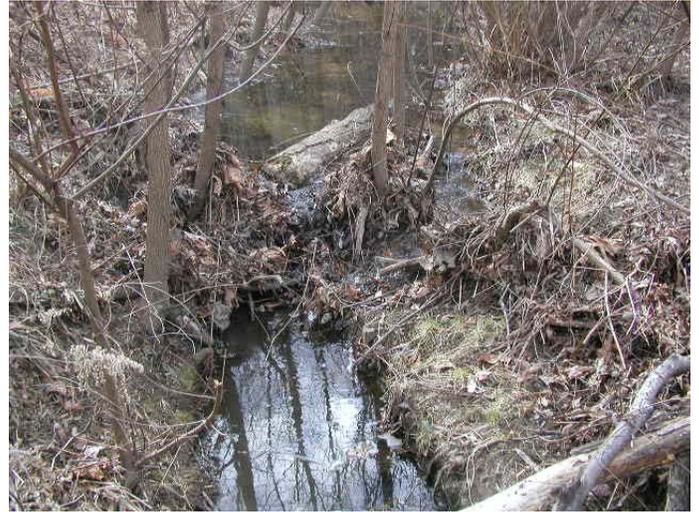
Headcut downstream of PP#9 @ Sta. 10+10
