Monitoring Data Record

Project Title: U-2524AC (Greensboro Western Urban Loop) COE Action ID: 200321137

Stream Name: Long Branch (Site 2BA) DWQ Number: 030909

Year 5 Summer – June 2012

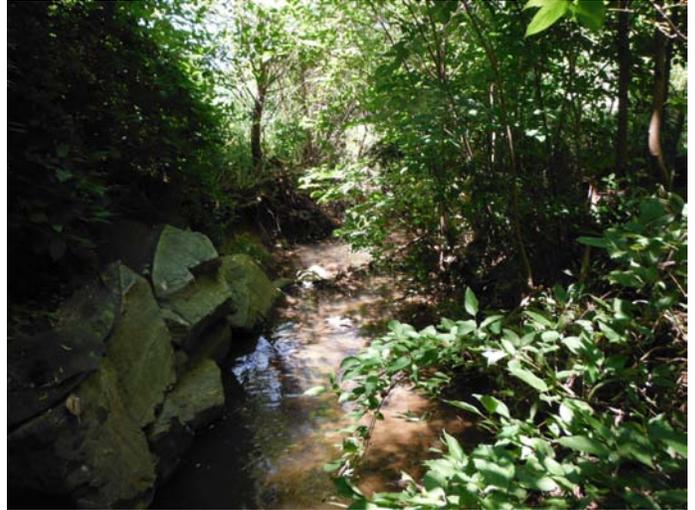
Photo Point #1 (Downstream)

6/26/12	Sta. 11+50 PP#1 Downstream Photo	Sta. 17+50	Sta. 20+00 PP#5 Downstream Photo	Sta. 23+00	Sta. 27+00 PP#9 Upstream and Downstream Photo
Structure Type					
Is water piping through or around structure?					
Head cut or down cut present?					
Bank or scour erosion present?	Minor bank scouring on left bank downstream of boulder protection	Minor bank scouring on right bank	Minor bank scouring on left bank downstream of boulder protection	Minor bank scouring on left bank downstream of boulder protection	Minor bank scouring on right and left bank (vertical banks)
