Monitoring Data Record

Project Title: Henderson Western Loop (U-2527) COE Action ID: 199708127

Stream Name: UT to Red Bud Creek DWQ Number: 031494

City, County and other Location Information: Henderson, Vance County
(Sta. 40+80 to 47+20)

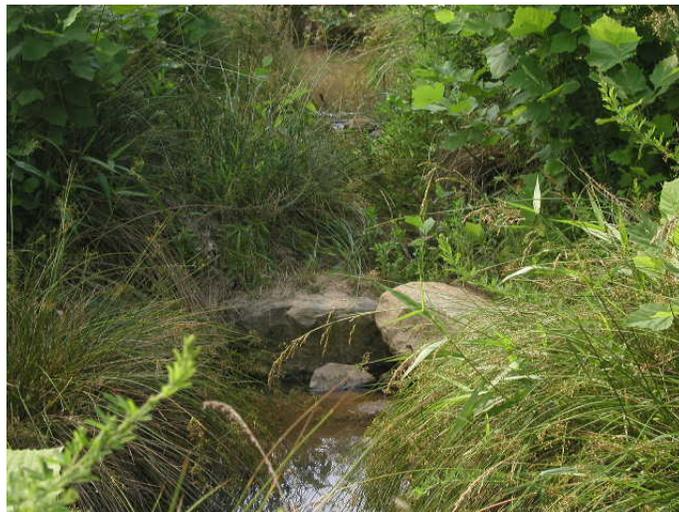
The stream is highly stabilized for the Year 3 summer evaluation. All cross vanes are functioning properly except for a cross vane located at approx. Sta. 41+20. This cross vane has a slight headcut and water piping around the left arm of the structure. NCDOT will continue to monitor this stream relocation.

6/12/08	Sta. 41+20	Station Number	Station Number	Station Number	Station Number
Structure Type	Crossvane				
Is water piping through or around structure?	Water is piping around left arm of the crossvane				
Head cut or down cut present?	Slight Headcut				
Bank or scour erosion present?					
Other problems noted?

Crossvane @ Sta. 41+20 with headcut and water piping around left arm
