Monitoring Data Record

Project Title: U-3462 Smith Ave. Ext. COE Action ID: 19982173

Stream Name: Charles Branch and UT to Charles Branch DWQ Number: 20081177

Year 1 Summer – July 2012

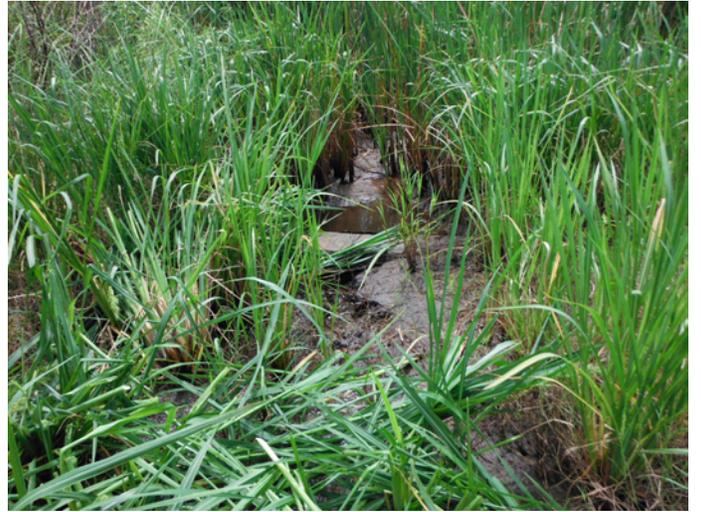
Photo Point #2 (Downstream) – UT to Charles Branch

Charles Branch and the UT to Charles Branch are stable for Year 1 Summer evaluation, except for, the lower log sill on the UT to Charles Branch. Water was piping under the lower log sill and a slight headcut had developed. This area is highly vegetated as seen in Photo Point #2 Downstream. NCDOT will see if any remedial action is warranted at this time. NCDOT will continue to monitor channel stability.

Date Inspected	Station Number	Station Number	Station Number	Station Number	Station Number
7-31-12	33+50-L- RT.				
Structure Type	log sill				
Is water piping through or around structure?	water piping under log sill				
Head cut or down cut present?	slight headcut				
Bank or scour erosion present?					
Other problems noted?

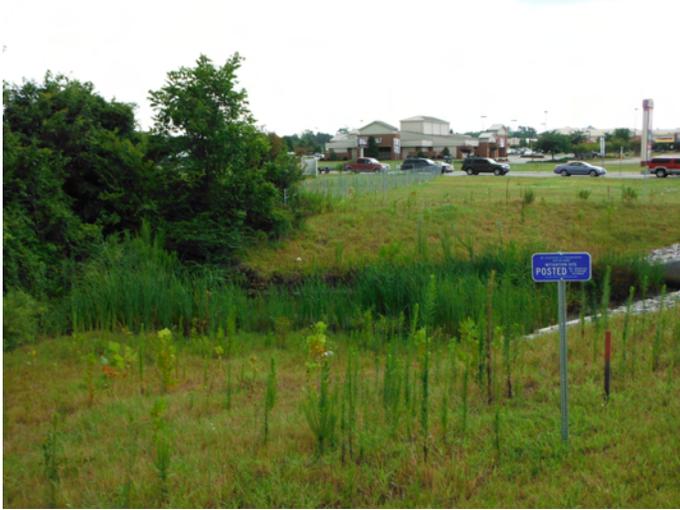
**ADDITIONAL COMMENTS:** Streambank reforestation was completed in January 2012. Black willow and silky dogwood live stakes were planted along the streambank and green ash, sycamore, and tulip poplar bareroot seedlings were planted in the buffer. Planted vegetation is surviving. NCDOT will continue to monitor plant survival.

Overview photo of buffer

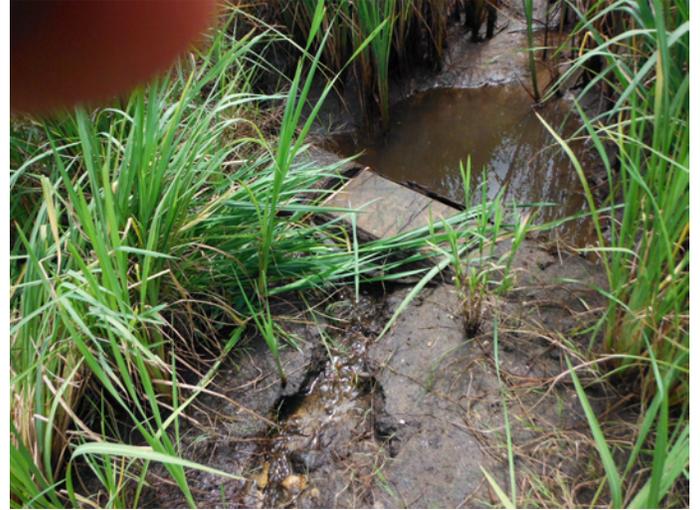
Additional photo of water piping under log sill
