Monitoring Data Record

Project Title: U-3462 Smith Ave. Ext. COE Action ID: 19982173

Stream Name: Charles Branch and UT to Charles Branch DWQ Number: 20081177

Year 2 Winter – February 2013

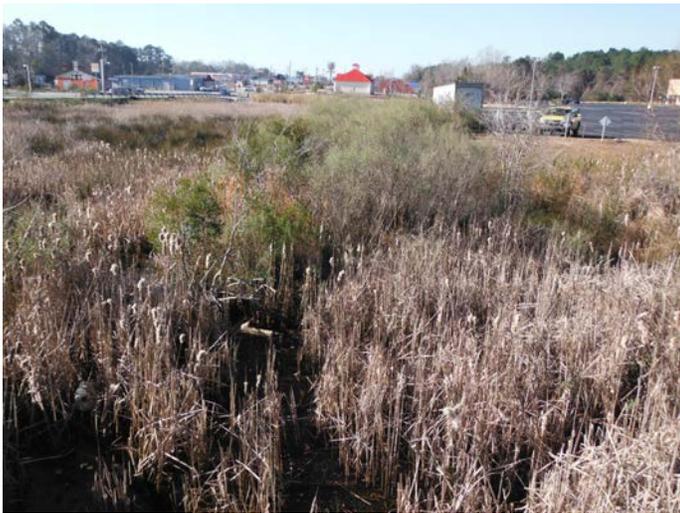
Photo Point #3 (Downstream) – Charles Branch

Charles Branch and the UT to Charles Branch are stable for Year 2 Winter evaluation. The lower log sill which had water piping under it during the last evaluation was repaired on 10-15-12. This log sill was inundated with water at the time of monitoring due to a beaver dam located downstream on the main channel of Charles Branch. USDA will be contacted to breach the dam and trap the beavers that are onsite. NCDOT will continue to monitor channel stability.

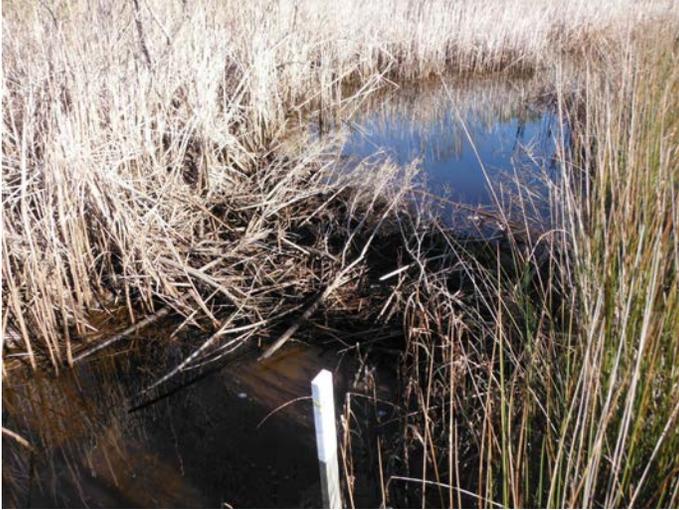
Beaver dam along main channel b/t PP#3 and PP#4
