Monitoring Data Record

Project Title: U-3462 Smith Ave. Ext. COE Action ID: 19982173

Stream Name: Charles Branch and UT to Charles Branch DWQ Number: 20081177

Monitoring Year: ( 3 ) of 5

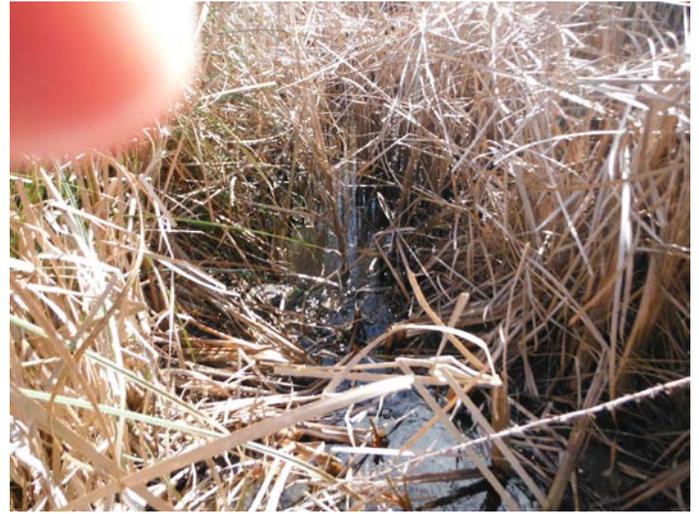
Photo Point #2 (Downstream) – UT to Charles Branch

Charles Branch and the UT to Charles Branch are stable for Year 3 Winter evaluation. The lower log sill along the UT to Charles Branch which had water piping under it was repaired on 10-15-12. This log sill had water flowing over top of the structure at the time of monitoring visit (see Photo Point #2 Downstream). The beaver dam located along Charles Branch has been breached (see additional photo). NCDOT will continue to monitor for channel stability.

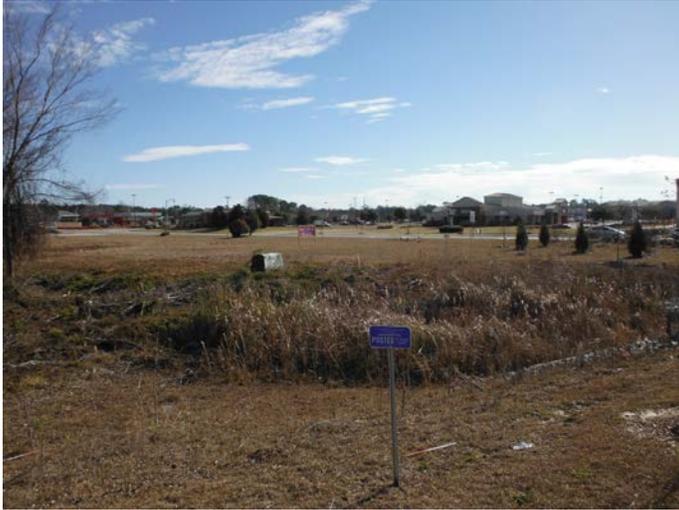
Buffer overview at PP#1

**ADDITIONAL COMMENTS:** Streambank reforestation was completed in January 2012. Black willow and silky dogwood live stakes were planted along the streambank and green ash, sycamore, and tulip poplar bareroot seedlings were planted in the buffer. Planted vegetation is surviving. Additional live staking was completed on the right bank around the log sills on 2-6-13. NCDOT will continue to monitor plant survival.

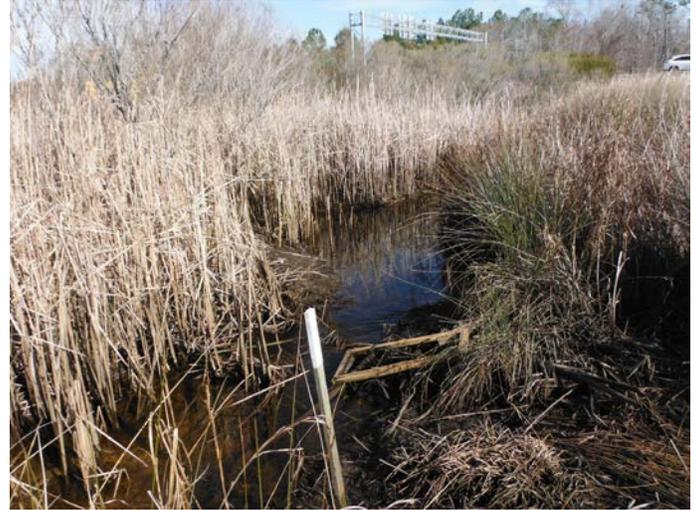
Breached beaver dam
