Monitoring Data RecordProject Title: U-4026B (Davis Drive) COE Action ID: 200120448Stream Name: Tributary to Burdens Creek (Site 9) DWQ Number: 051972City, County and other Location Information: Durham County, Davis Drive (Sta. 284+50RT.)Date Construction Completed: 12/5/07 Monitoring Year: (5) of 5Ecoregion: _____ 8 digit HUC unit 03030002

Year 5 Winter – January 2012

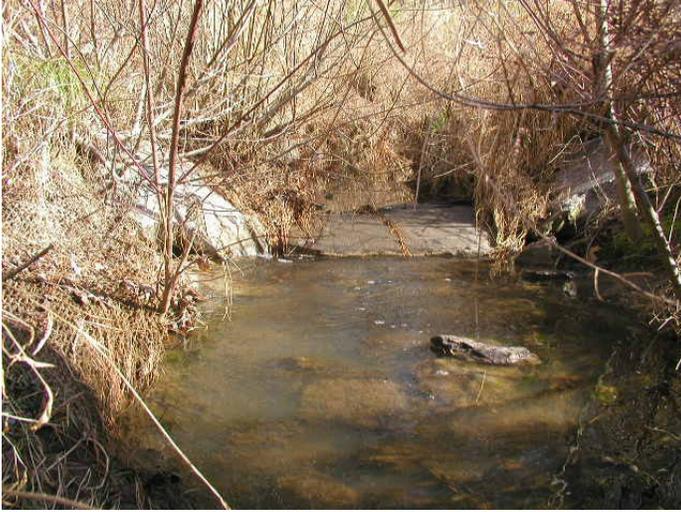
The Tributary to Burdens Creek is stable for Year 5 Winter evaluation. A bankfull event has occurred since last monitoring evaluation. A rock sill at Sta. 285+60-L- (just downstream of photo point #3) which had water piping through the structure during the last evaluation was now flowing over top of the rock sill. NCDOT will continue to monitor this stream relocation.

Rock Sill @ Sta. 285+60-L- (downstream of PP#3)
